Water Research Laboratory

Gumma Gumma Swamp Hydrologic Investigation

WRL Technical Report 2013/03
July 2013

by
D S Rayner, W C Glamore and J E Ruprecht

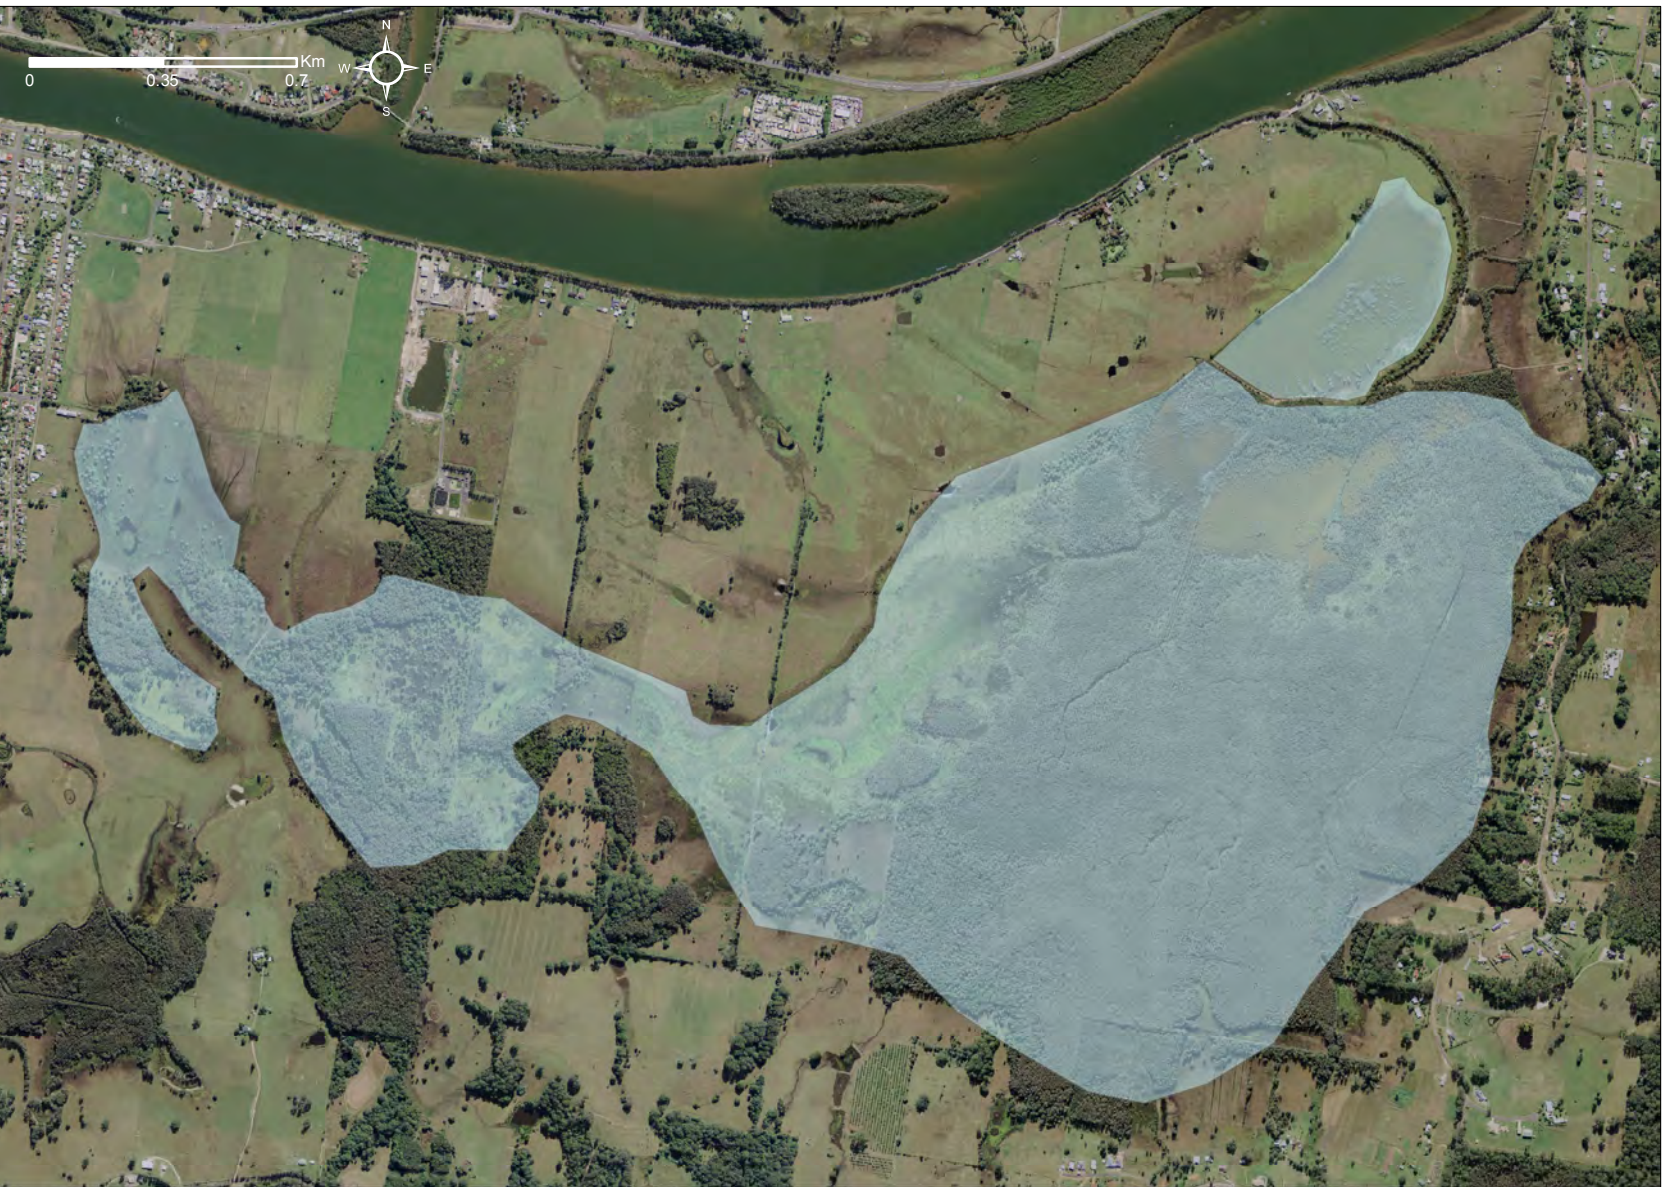
**Areas of Gumma Gumma Swamp LiDAR Data Modified Based on Field Survey
(Underwater at Time of LiDAR Survey)**

Based on the ground-truthing exercise noted above, the area of the wetland underwater at the time of LiDAR data collection was removed from the interpolated Digital Elevation Model (DEM) (Figure 3.2). Survey points taken in open water areas were extrapolated across the entire area to create a revised estimated bathymetry. The revised bathymetry was merged with the surrounding LiDAR data to create a new DEM (Figure 3.3). This DEM was constructed specifically for the purpose of calculating storage relationships and assessing pond connectivity. It should not be used for any other purpose.

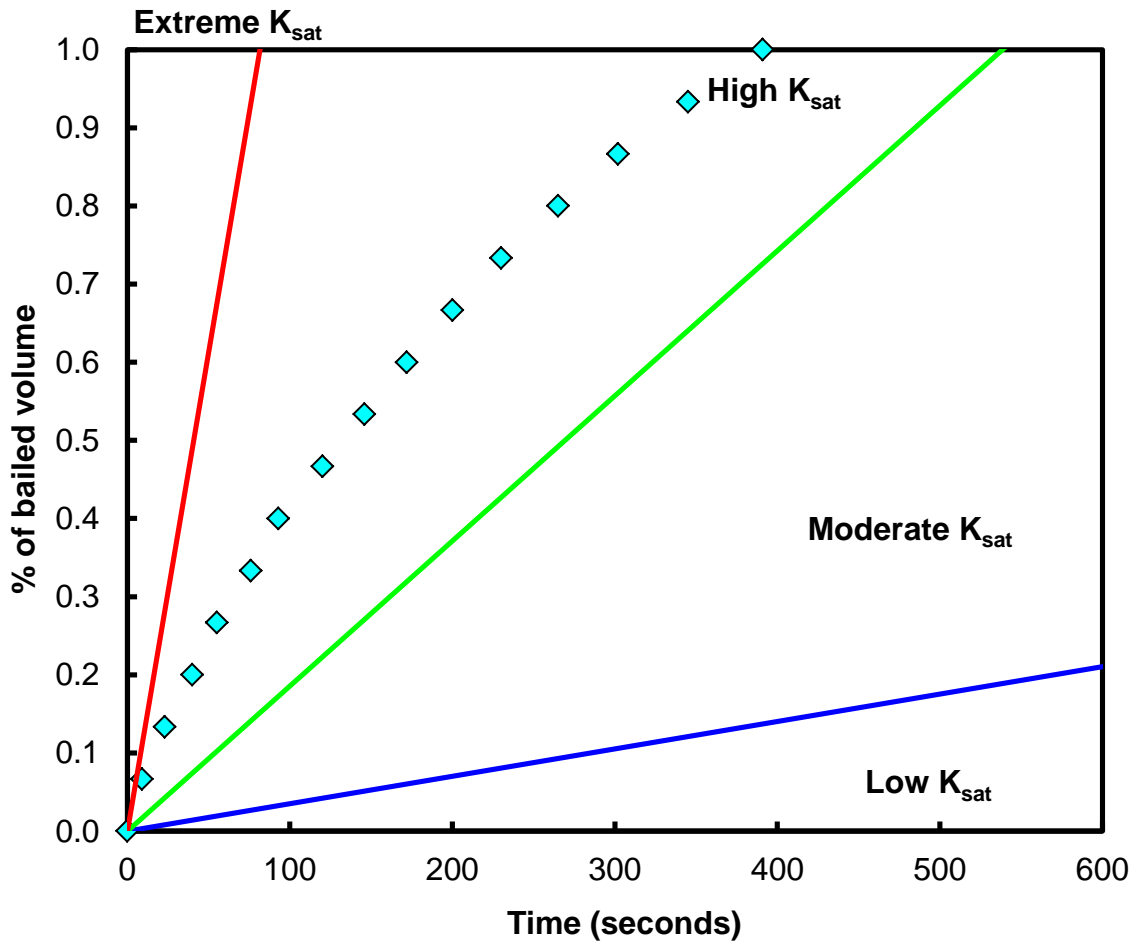
Bulk Hydraulic Conductivity Test Pit: 3a

Rate indicated in chart	Approximate K_{sat} (m/day)
Extreme	~100
High	15 to 100
Moderate	1.5 to 15
Low	< 1.5

WetlandCare Australia staff were trained by WRL to undertake the groundwater assessment. A total of 7 locations were sampled across the wetland over the two-day field investigation (Figure 3.4). Two pits (1 and 4) did not produce water within the required 0.5 m to 0.75 m depth. Testing of groundwater by Kemsley (1997) during a dry period identified the level of the water table to be between 0.4 m to 1.0 m below the soil surface for the south-eastern extent of the wetland. Testing by WetlandCare Australia noted average groundwater depths between 0.3 m to 0.4 m below ground surface. The K_{sat} results for the pits are presented in Figures 3.5 to 3.9.

Groundwater testing results indicated that groundwater transport at Gumma Gumma is a potentially significant source of acid, iron and aluminium and a major contributor to poor water quality discharging to Gumma Creek. All pits with shallow groundwater were observed to have moderate to high hydraulic conductivity (Figures 3.5 to 3.9). Furthermore, low soil pH was observed at the majority of test locations. Moderate acid sulphate soil content was recorded for Pits 2a and 3a.
