## Riverbank Vulnerability Assessment using a Decision Support System: Clarence River (Rogans Bridge to Ulmarra)

WRL Technical Report 2014/12  
December 2014

By W C Glamore, I R Coghlan, J E Ruprecht, F Flocard and C D Drummond

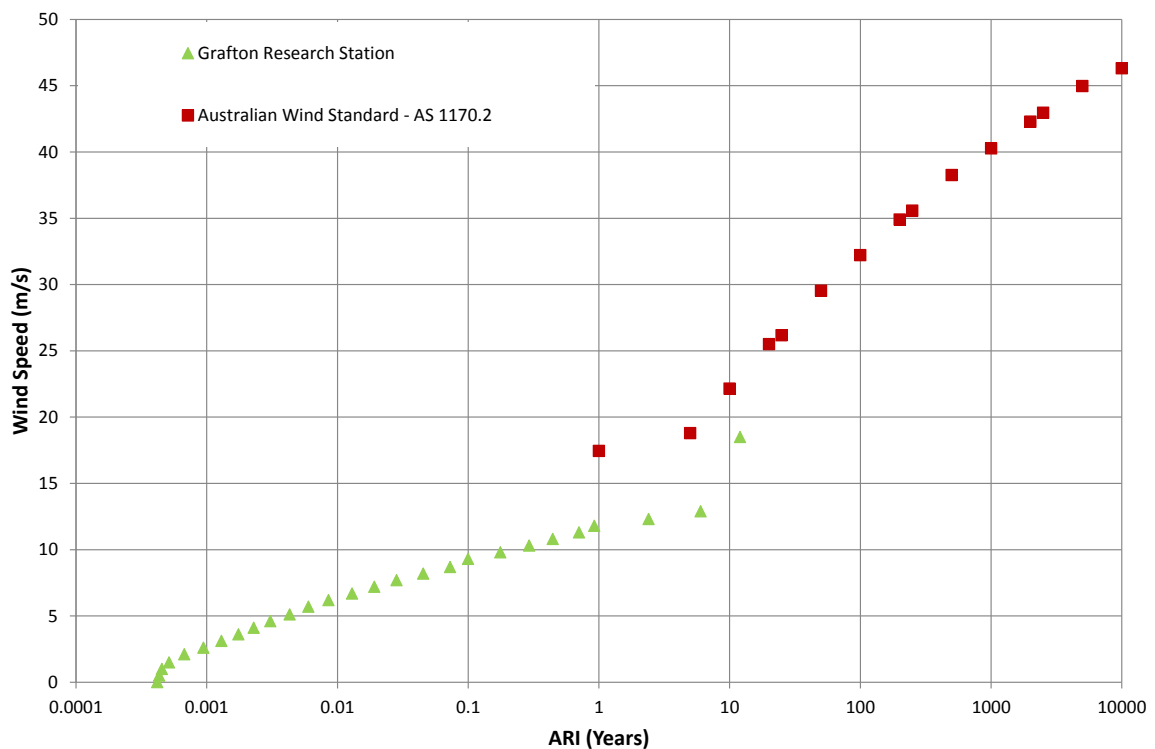
**Figure 2-8: Sustained Wind Speeds (10 Minute) – All Directions – Grafton Research Station and AS 1170.2**

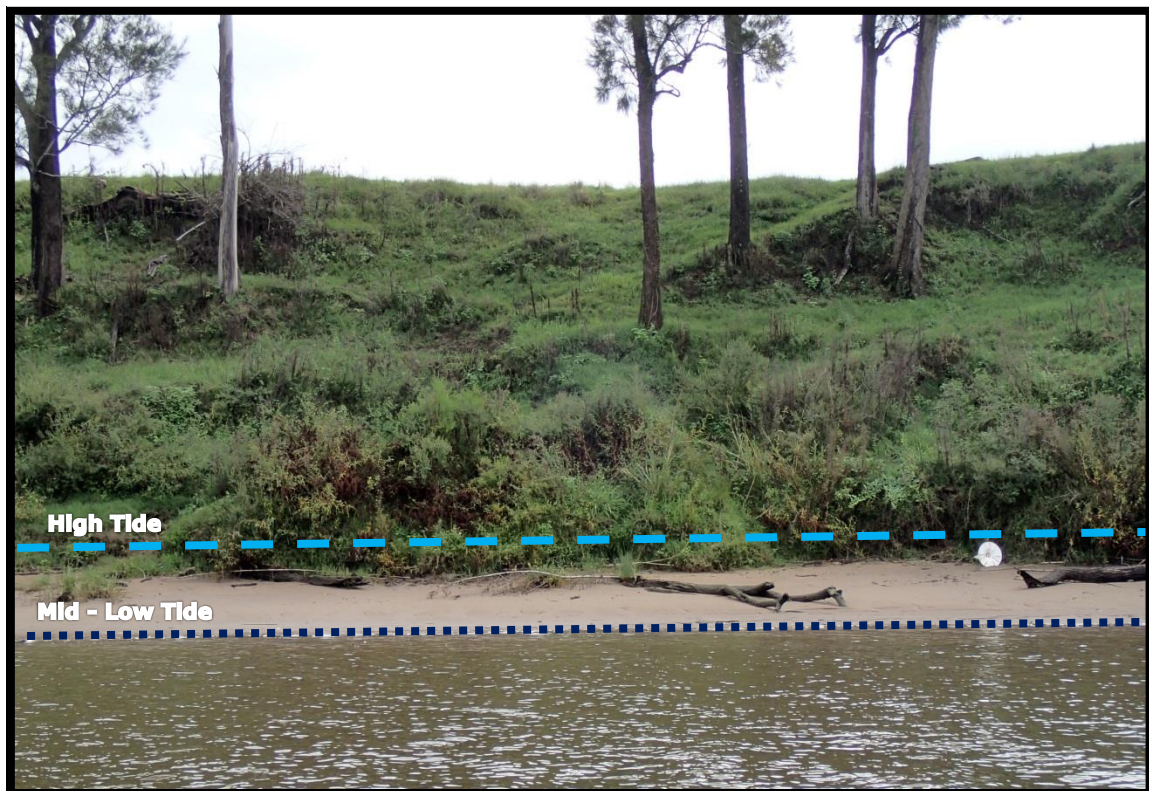
**Figure 3-1: Effect of Water Level on Erosion Potential Assessment**

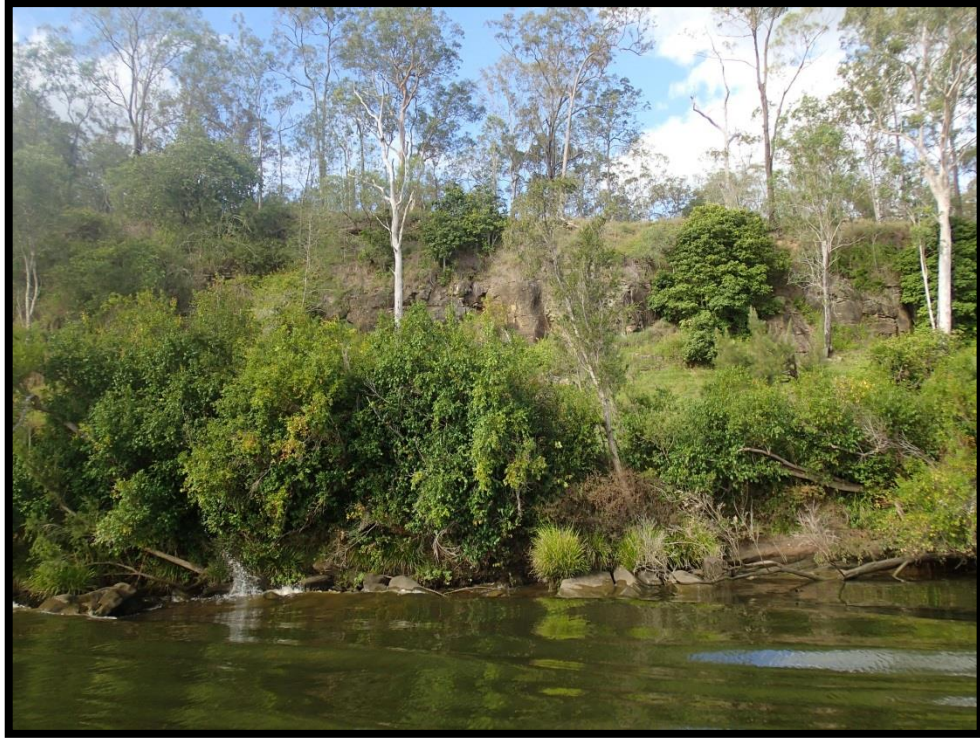
**Figure 3-4: Rock Cliffs (Stretch R6)**

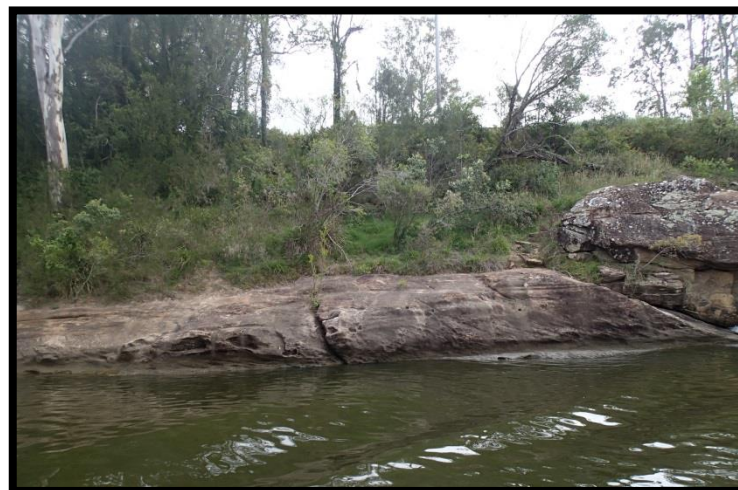
**Figure 3-5: Significant Bedrock Protecting River Banks from Erosion (Stretch L13)**

Armouring of the riverbank is a major influencing factor in the assessment of riverbank erosion potential. Substantial reaches of the study area are naturally armoured by large rock ledges or cliffs (Figure 3-4 and Figure 3-5), while other reaches have been artificially armoured (Figure 3-6 and Figure 3-7). This armouring, whether it be natural or artificial, generally provides erosion potential ratings of 'Highly Resistant'.

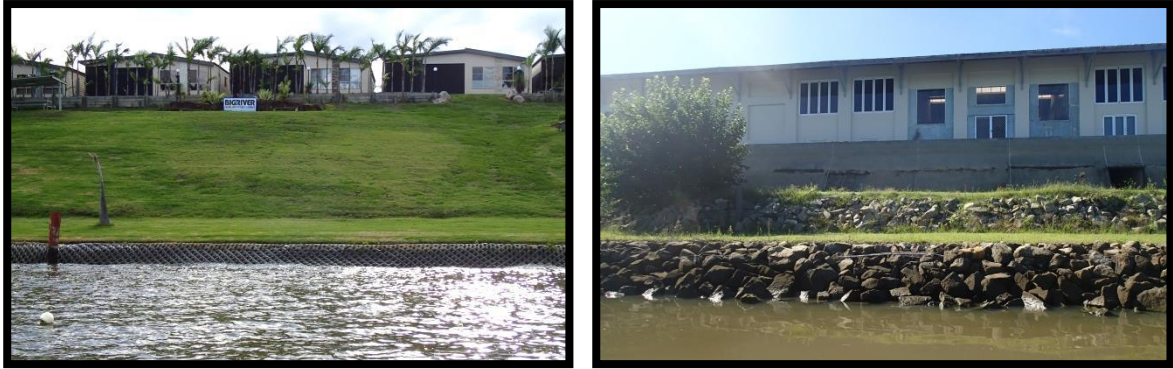
**Figure 3-6: Armoring at Transects R25C and R73C**

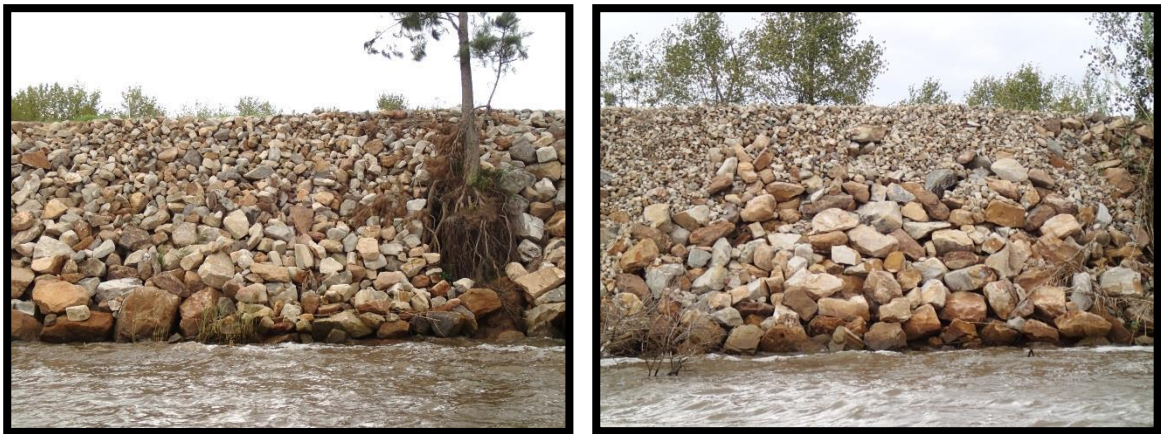
**Figure 3-7: Armoring at Transects L63A and L63B**

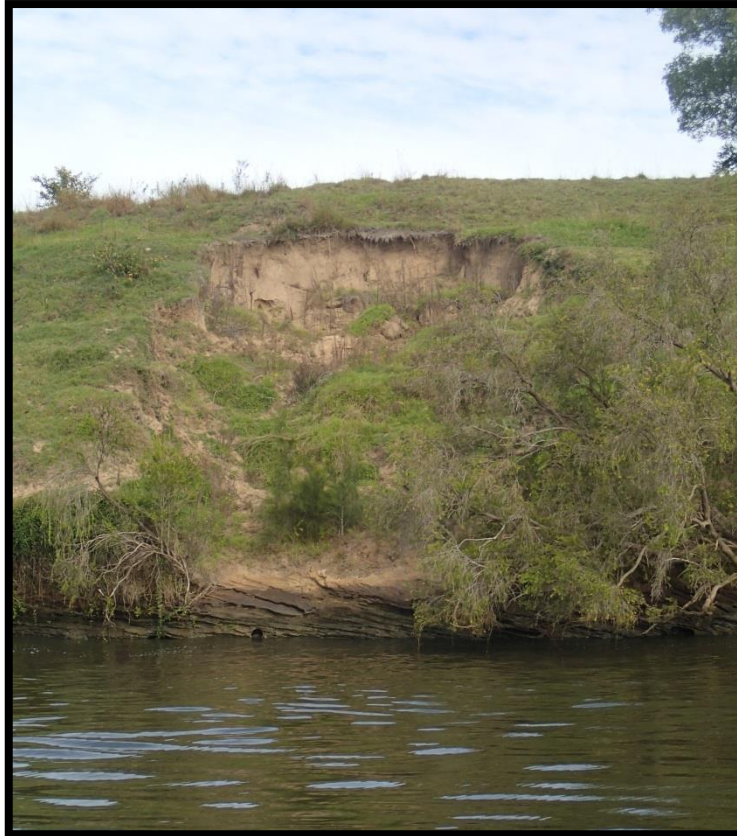
**Figure 3-8: Erosion on Upper Bank Above Completely Armoured Wave Zone**

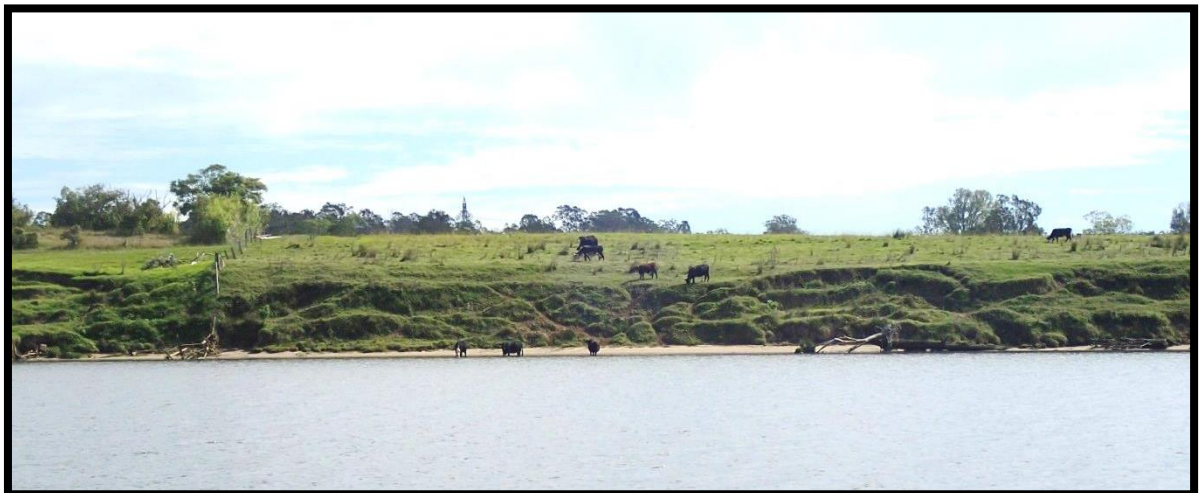
**Figure 3-9: Stock Present on the Riverbanks**

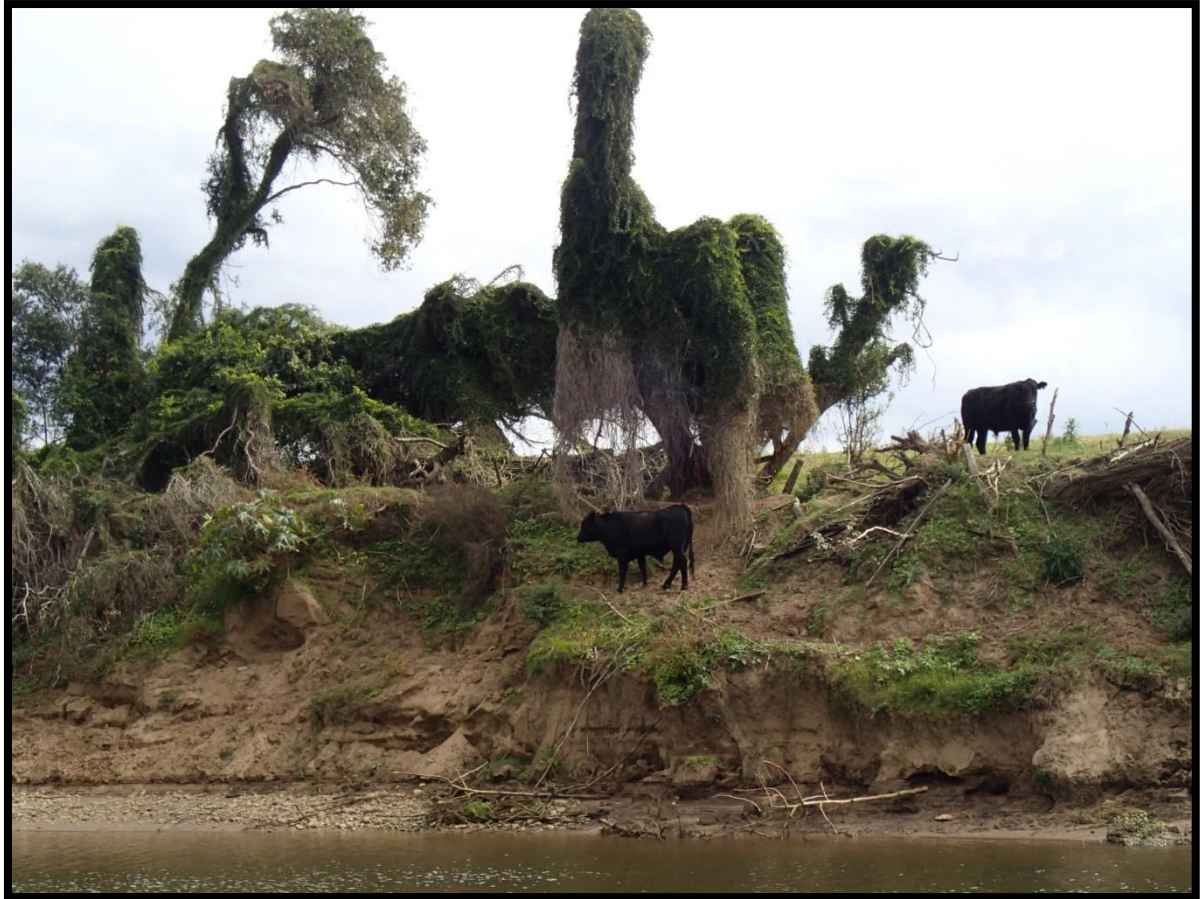
**Figure 3-10: Stock Present on the Riverbanks (Stretch L4)**

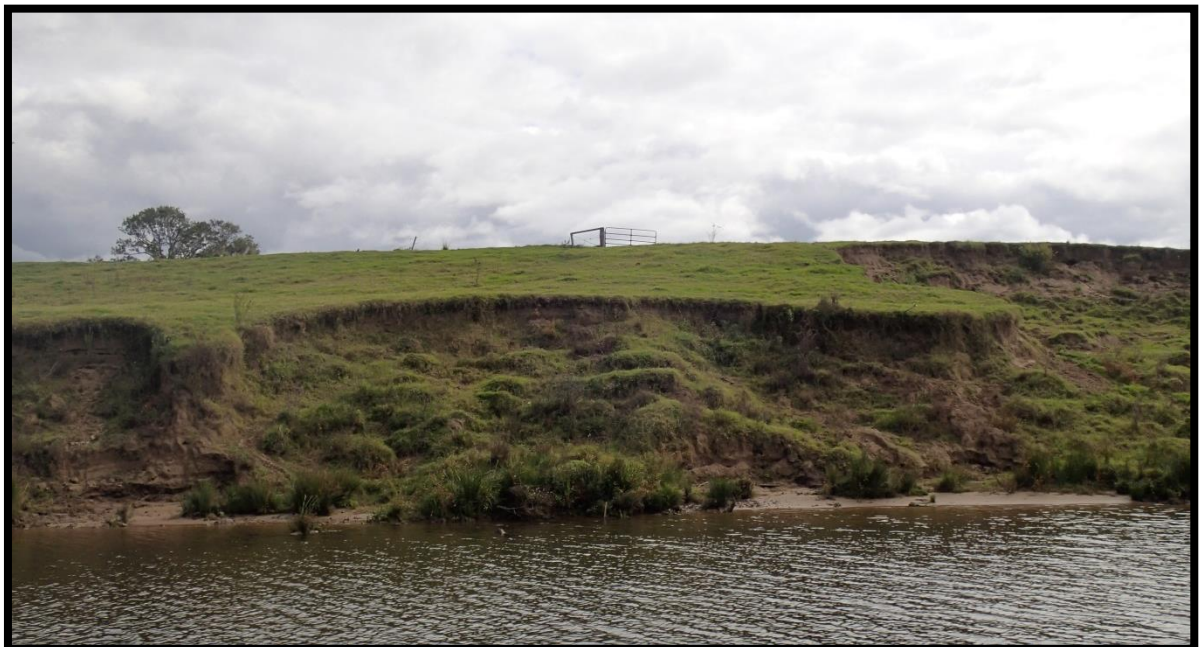
**Figure 3-11: Significant Erosion, Slumping and Undercutting of Riverbanks where Stock Access is Present at Stretch L5**

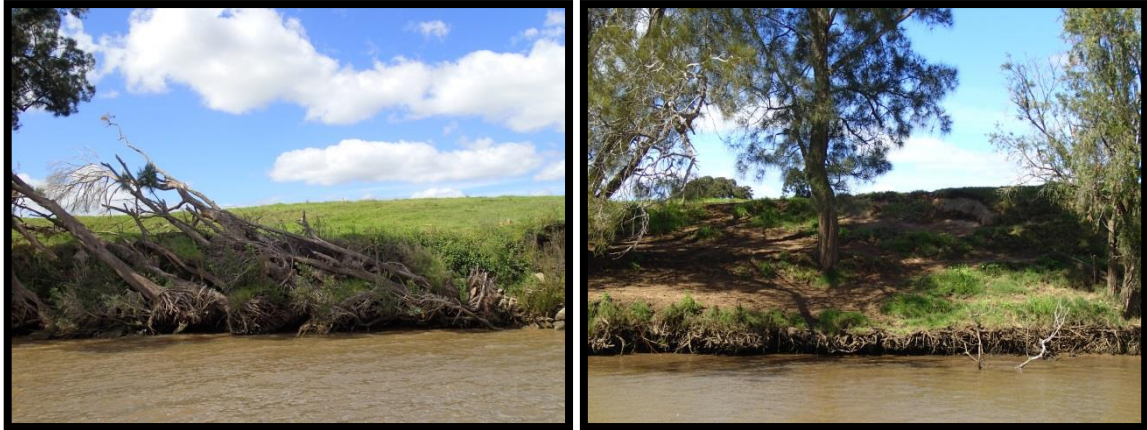
**Figure 3-12: Significant Undercutting of Riverbanks with Stock Access Present at Stretches R54A and R63B**

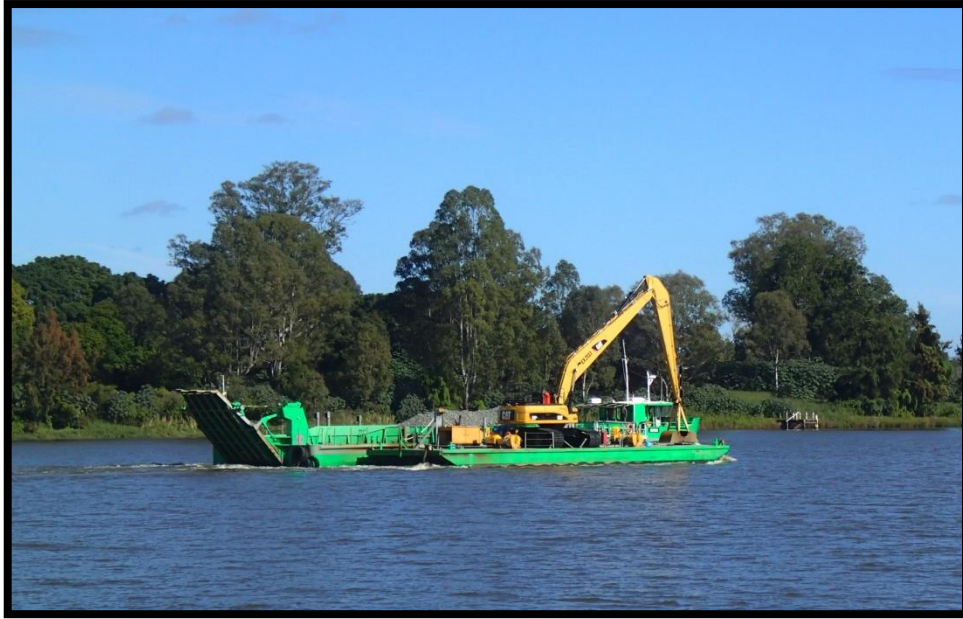
**Figure 3-15: Extractive Industry Equipment Operating within the Clarence River Study Area**

NSW Department of Trade and Investment (T&I) - Crown Lands Division has issued three extractive industry licenses for five different zones within the Clarence River study area (Figure 3-14). While there are no set extraction limits for these licenses, Table 3-3 shows the mass of material extracted in the 12 months to 31 January 2014 (NSW T&I, 2014). Figure 3-15 shows a photograph of this extractive industry equipment operating on the Clarence River during WRL's field assessment.

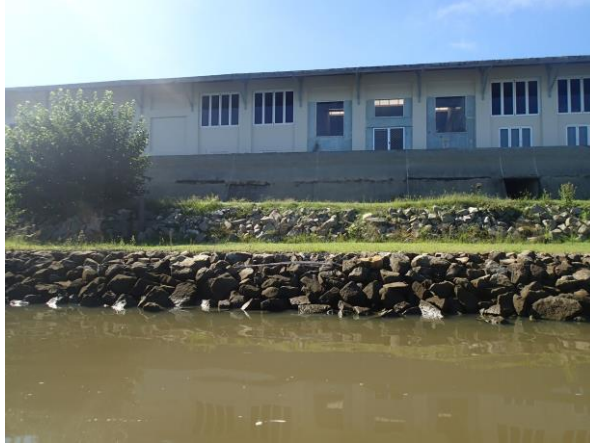
When the SEE was published, it was asserted that this same section of bank still occupied a particularly high stress zone at Ulmarra Bend. The RMP (2000) determined that properly designed and maintained rock placement would limit direct riverbank erosion by river currents and improve bank stability. Based on the outcomes of the DSS assessment undertaken by WRL, it was shown that Ulmarra Bend is now moderately to highly resistant to erosion due to the presence of rock revetment walls (Section 3.2.1). Figure A-3 shows the existing rock revetment works and concrete seawall protecting the old Butter Factory at Ulmarra.

**Figure A-3: Existing Rock Revetment Works and Concrete Seawall, Old Butter Factory (Ulmarra)**

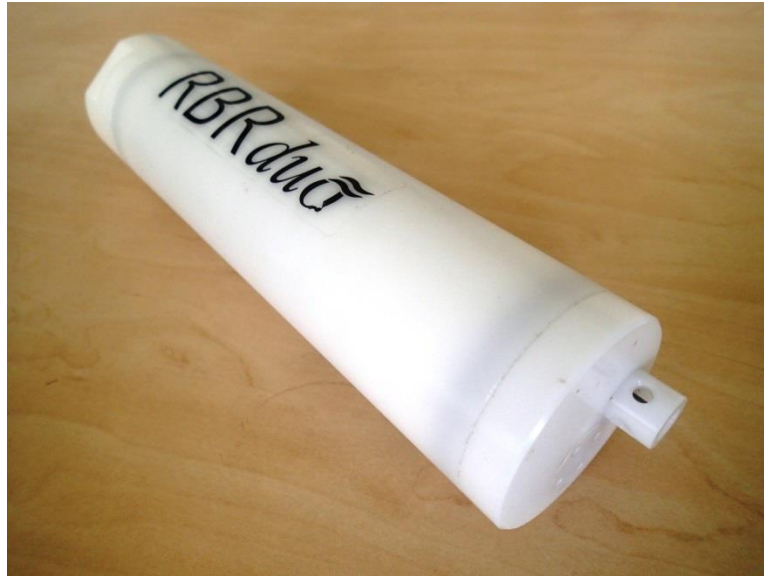
To measure the propagation of a wave train from a test vessel, an array of equipment was deployed across the site. A 250 m sailing line was set-up using four floating buoys. At distances of 22, 35 and 75 m from the sailing line, three submersible wave probes were deployed. Each probe was a battery powered RBRduo TD pressure transducer which logged data internally at 6 Hz (Figure D-2). These wave probes were secured to a portable mounting rig composed of modular pipe lengths and a "pod" (a large weight with stabilising feet) at its base (Figure D-3). Following deployment, GPS waymarks were taken at each sailing line float and each wave probe.

Figure D-2: RBRduo Wave Probe

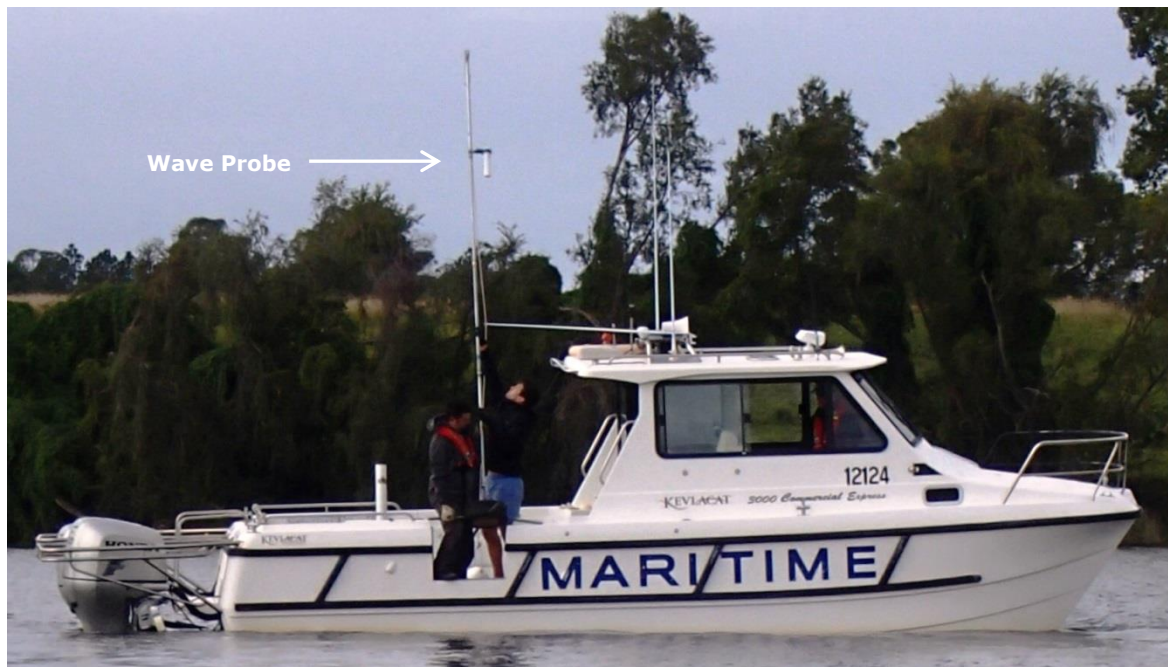
Figure D-3: Wave Probe Deployment

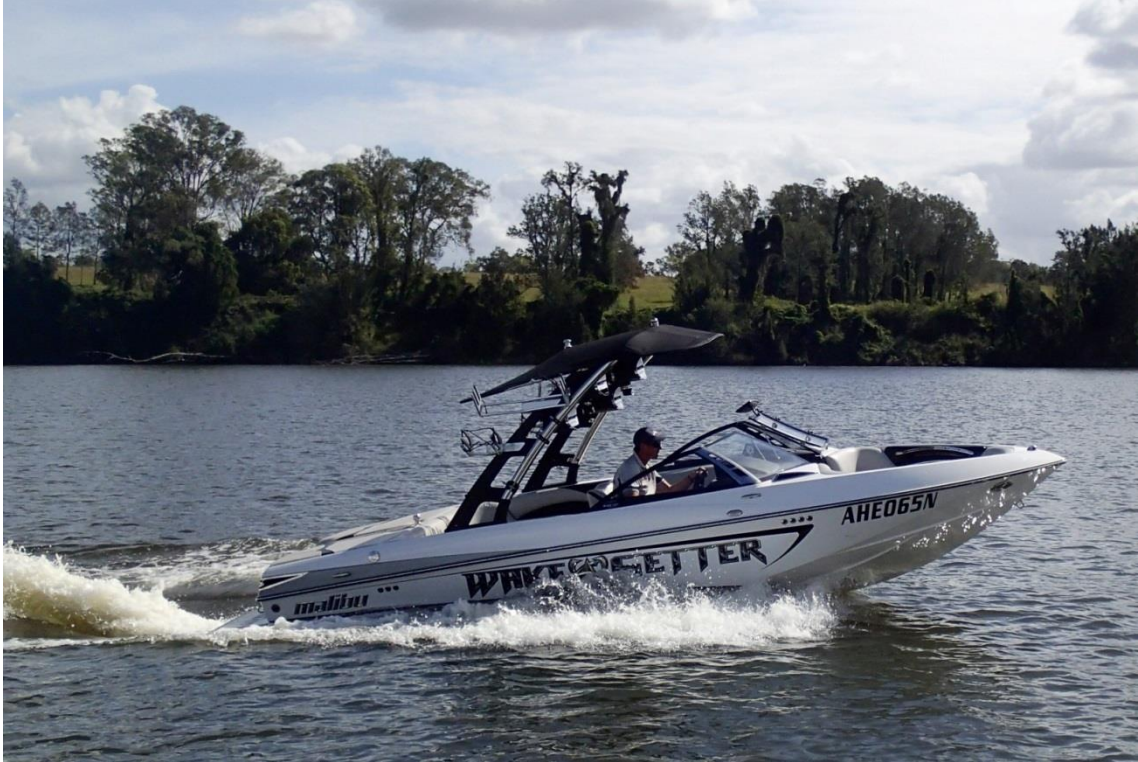
**Figure D-4: Boat 1 - Malibu Wakesetter VLX (2014)**

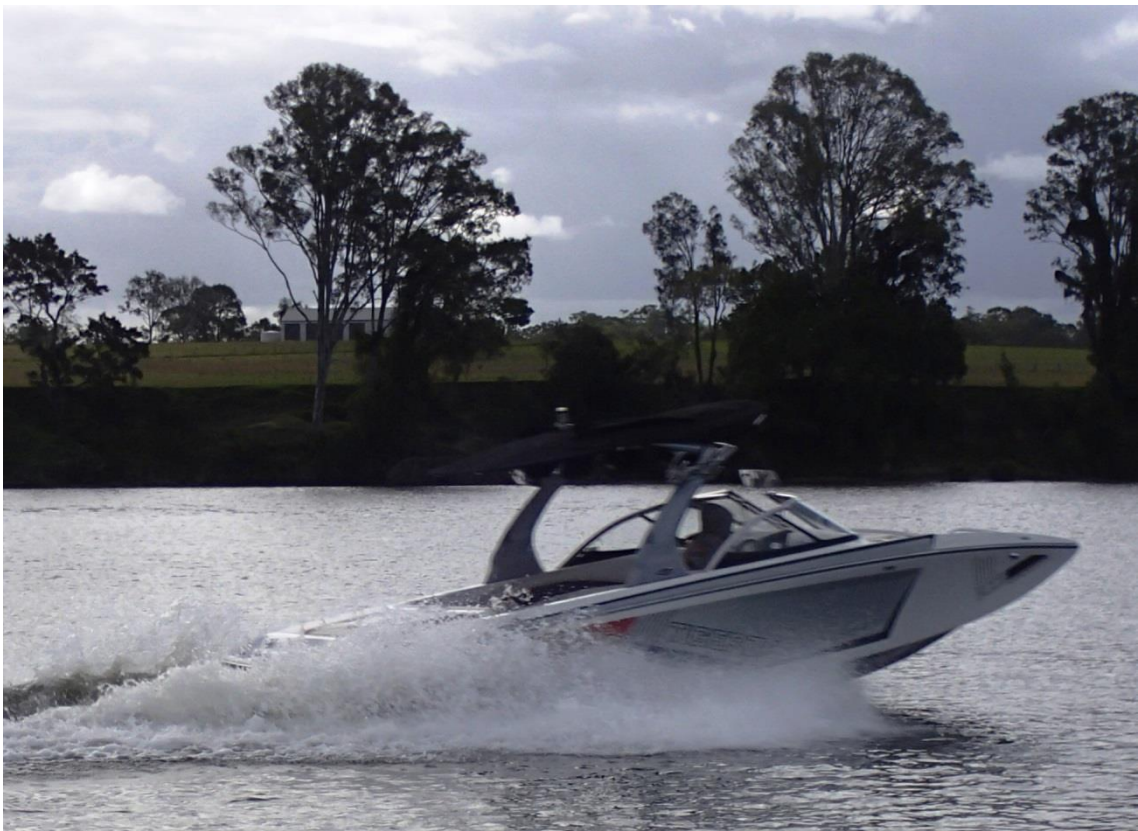
**Figure D-5: Boat 2 - Tigé RZ2 Platinum Edition (2011)**

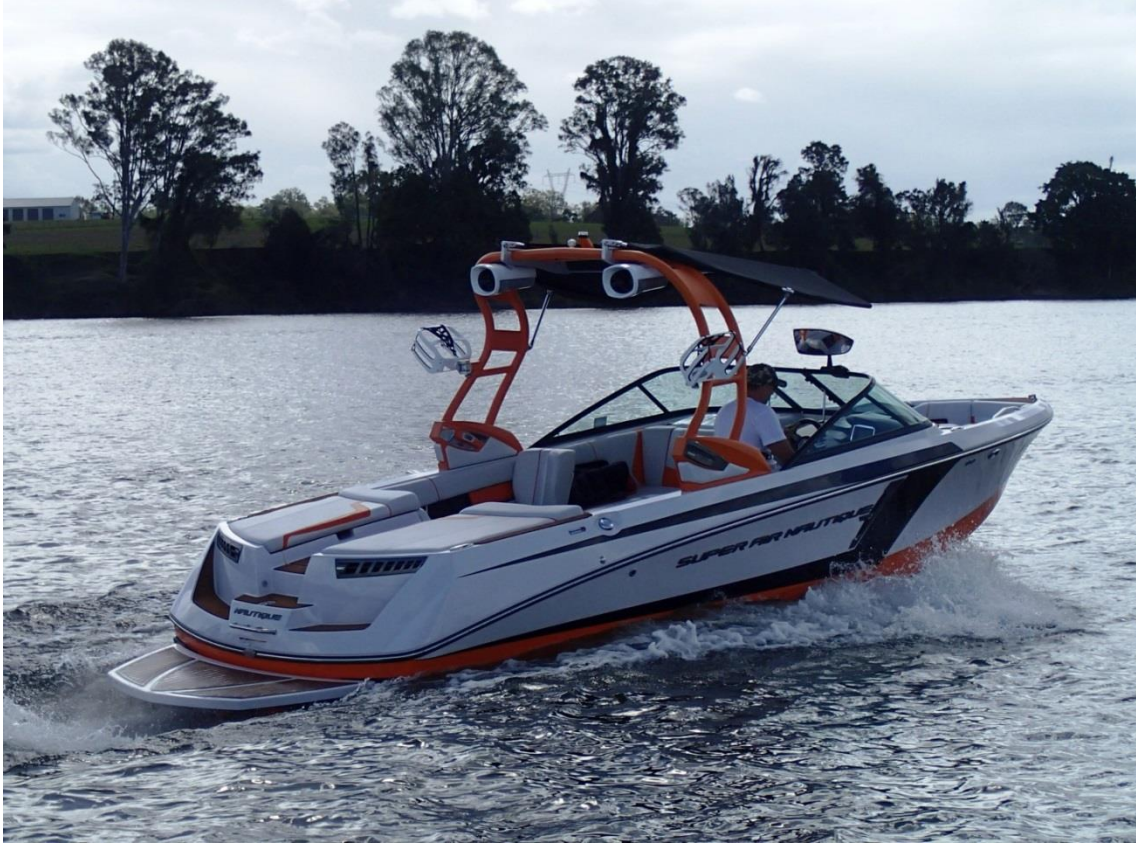
**Figure D-6: Boat 3 - Super Air Nautique G23 (2014)**

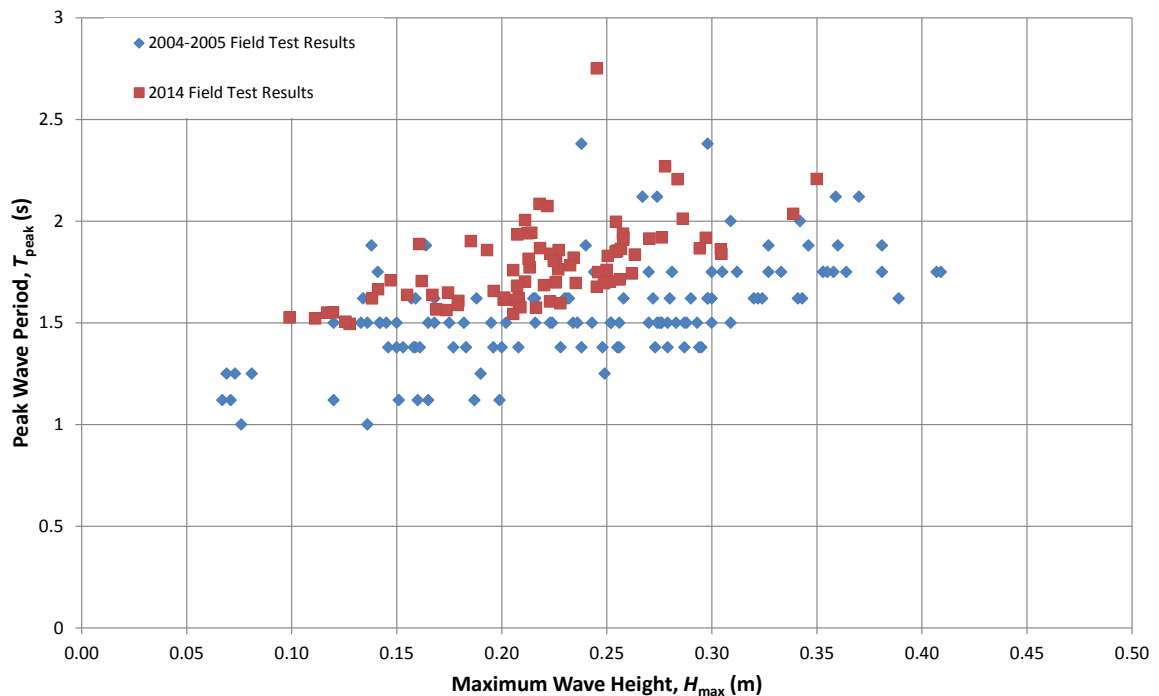
**Figure D-10: Comparison of WRL 2004-05 and Clarence River 2014 Wakeboard Field Test Results**

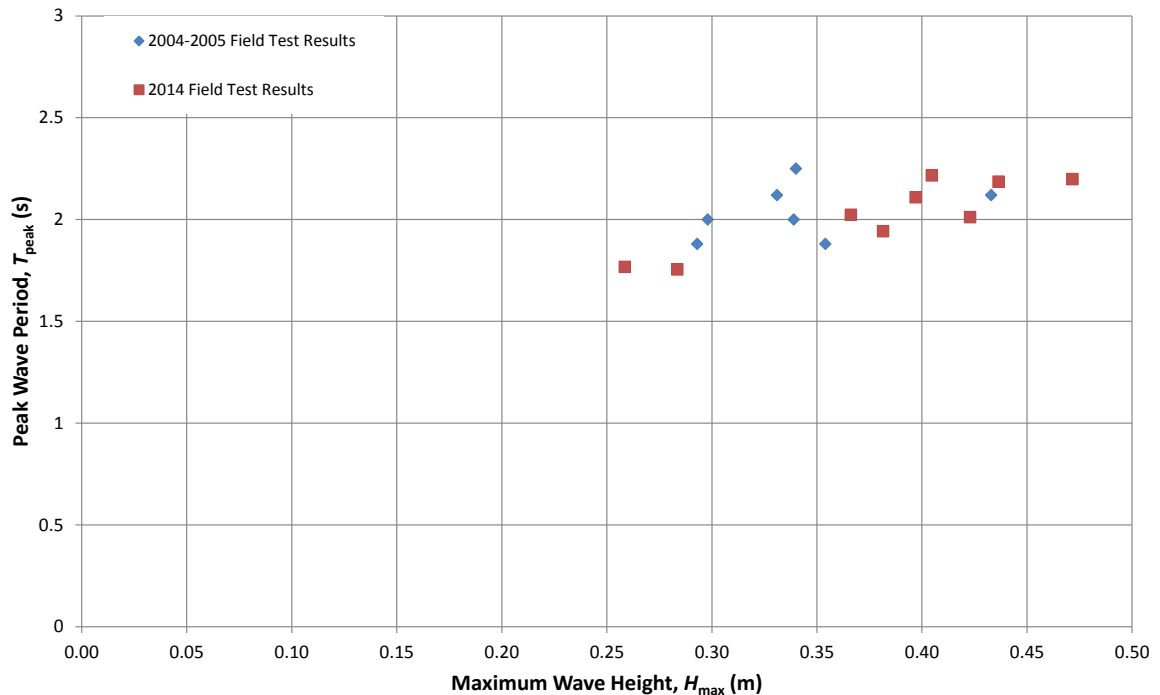
**Figure D-11: Comparison of WRL 2004-05 and Clarence River 2014 Wakesurf Field Test Results**

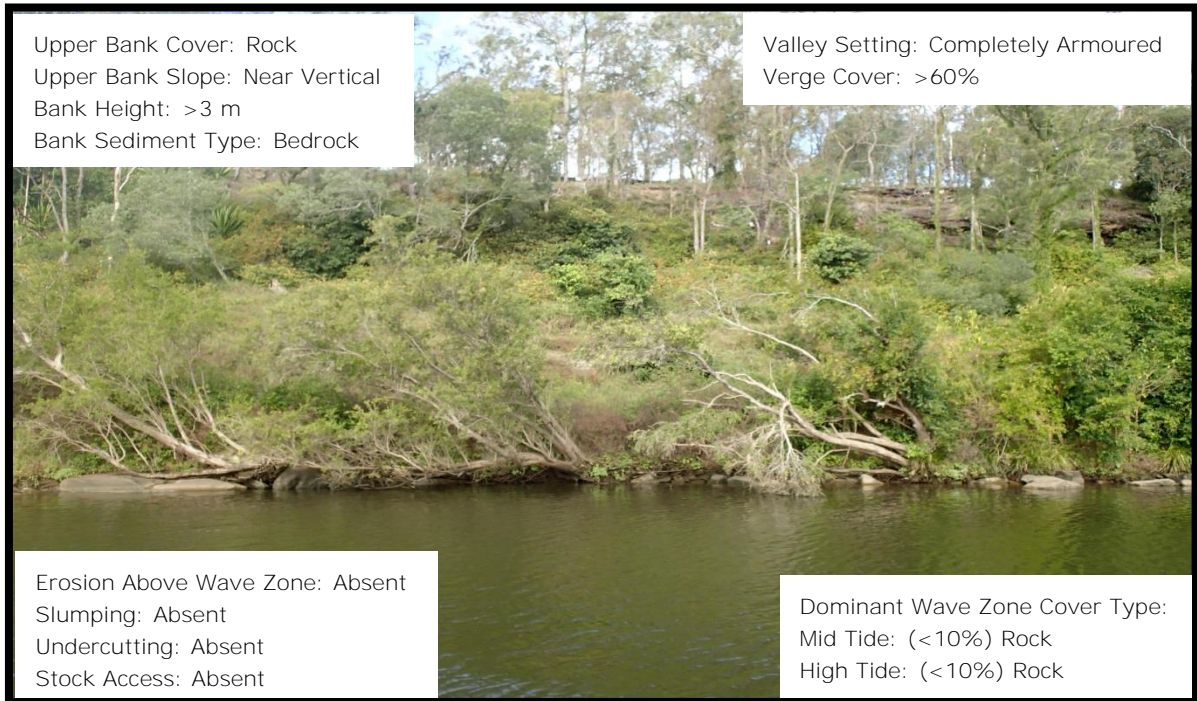
**Highly Resistant – R5A**

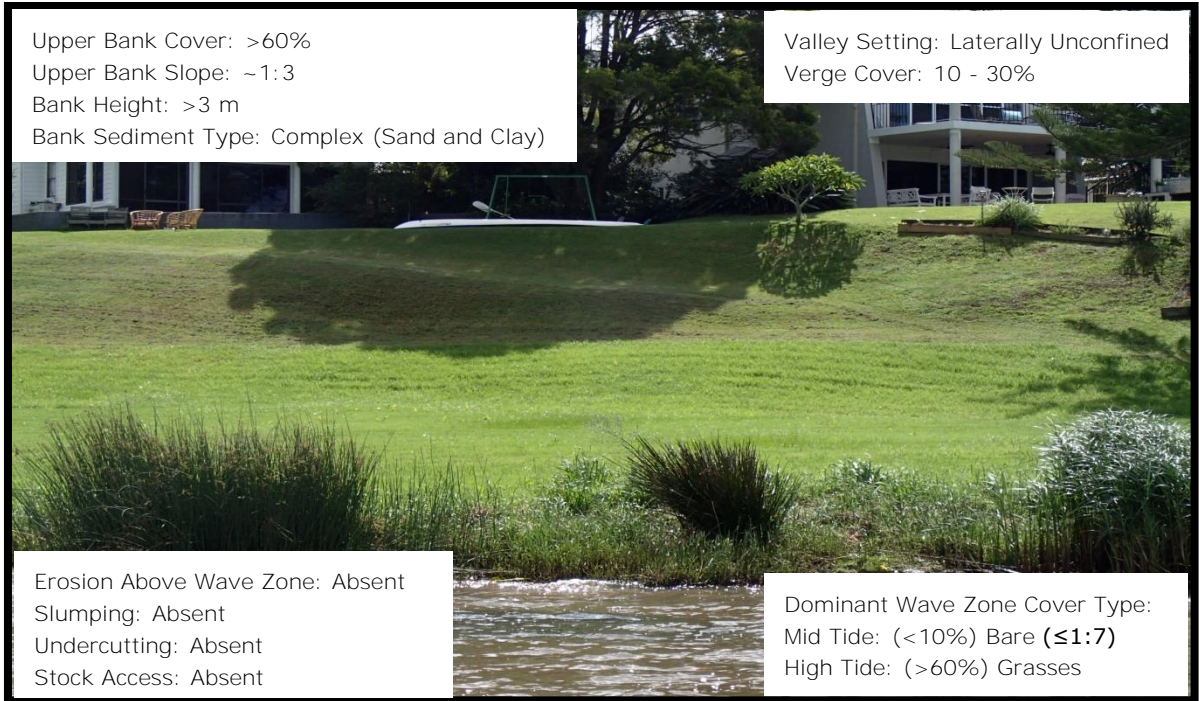
**Moderately Resistant – L51A**

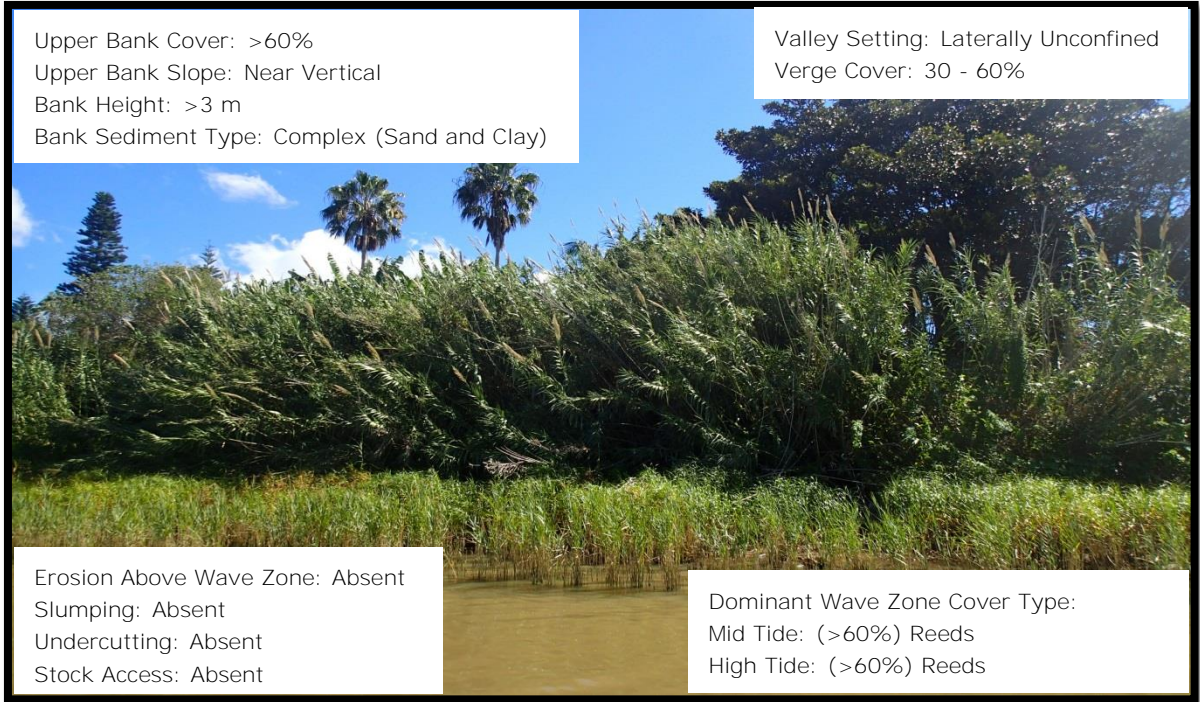
**Moderately Resistant – L67A**

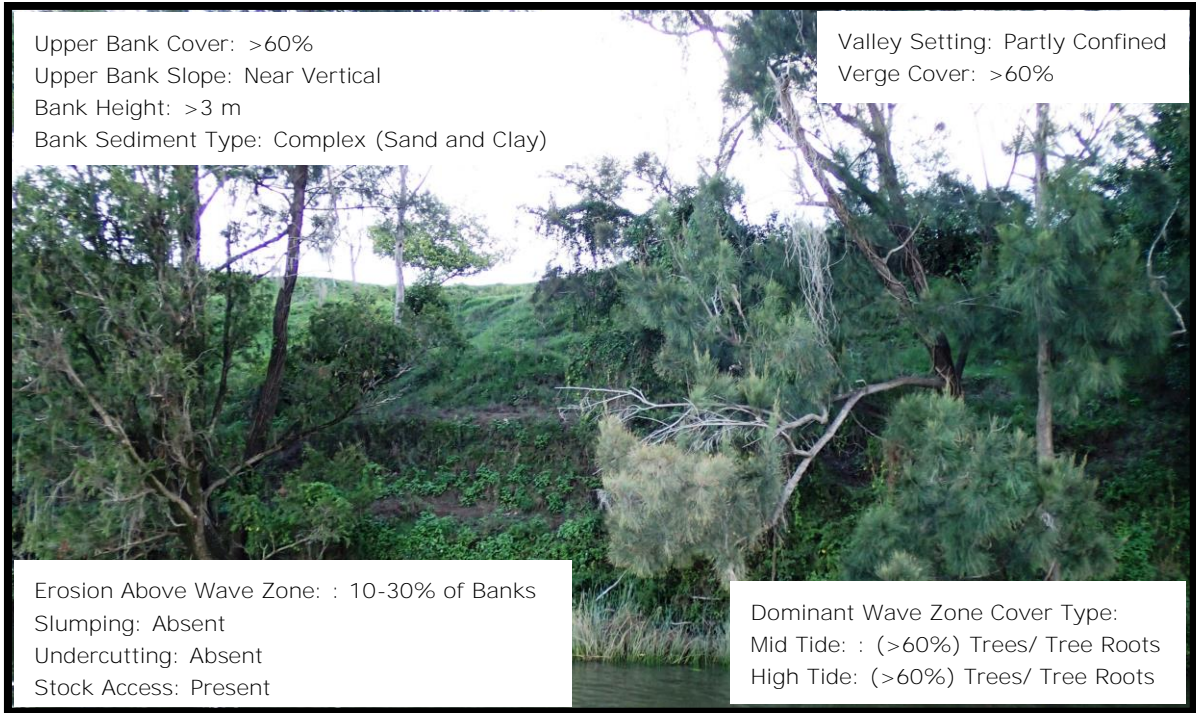
**Mildly Resistant – R21B**

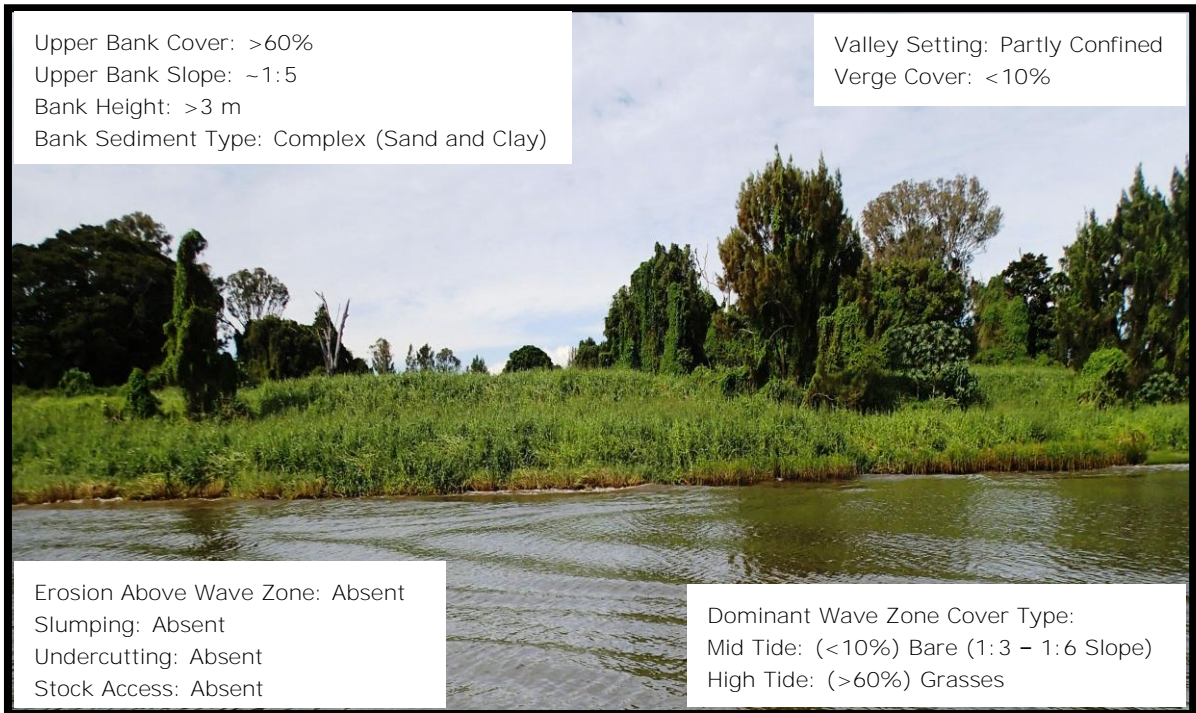
**Mildly Resistant – RE58A**

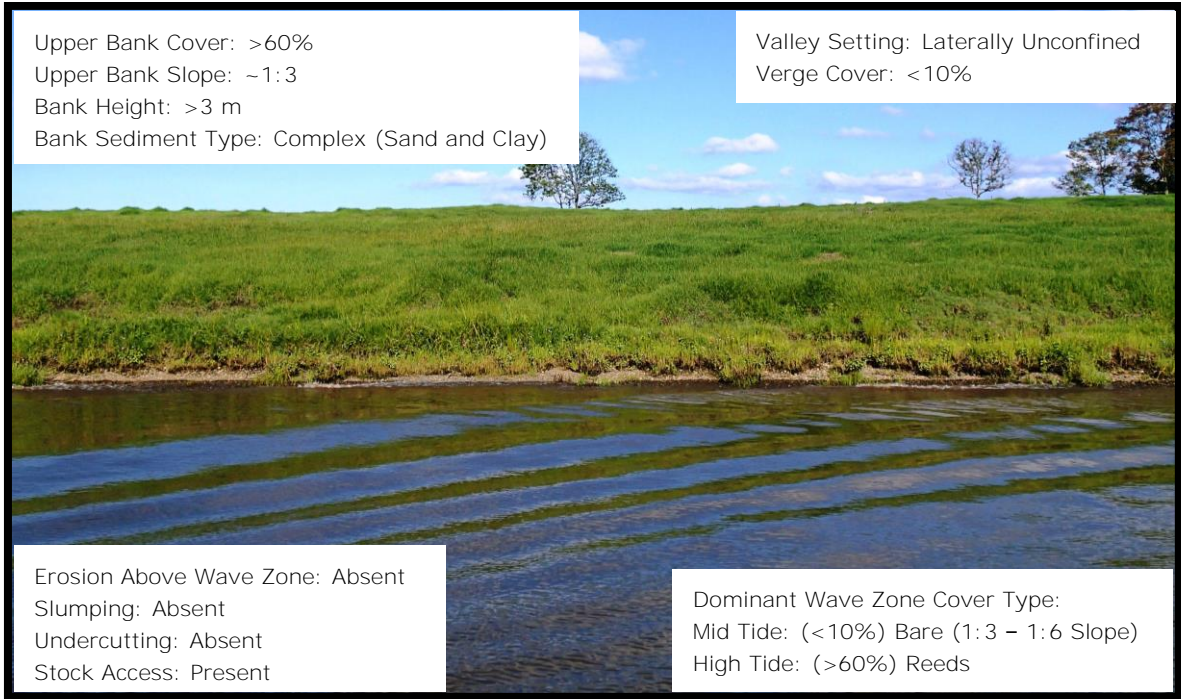
**Moderately Erosive – L32C**

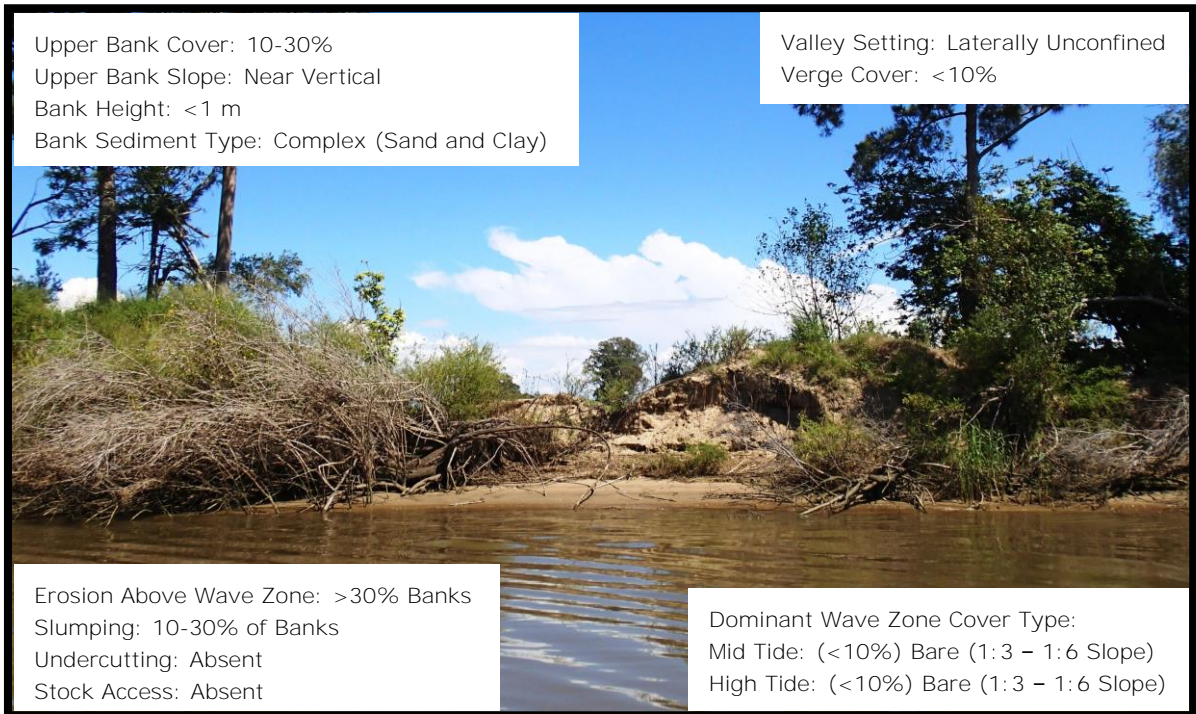
**Moderately Erosive – RS43A**

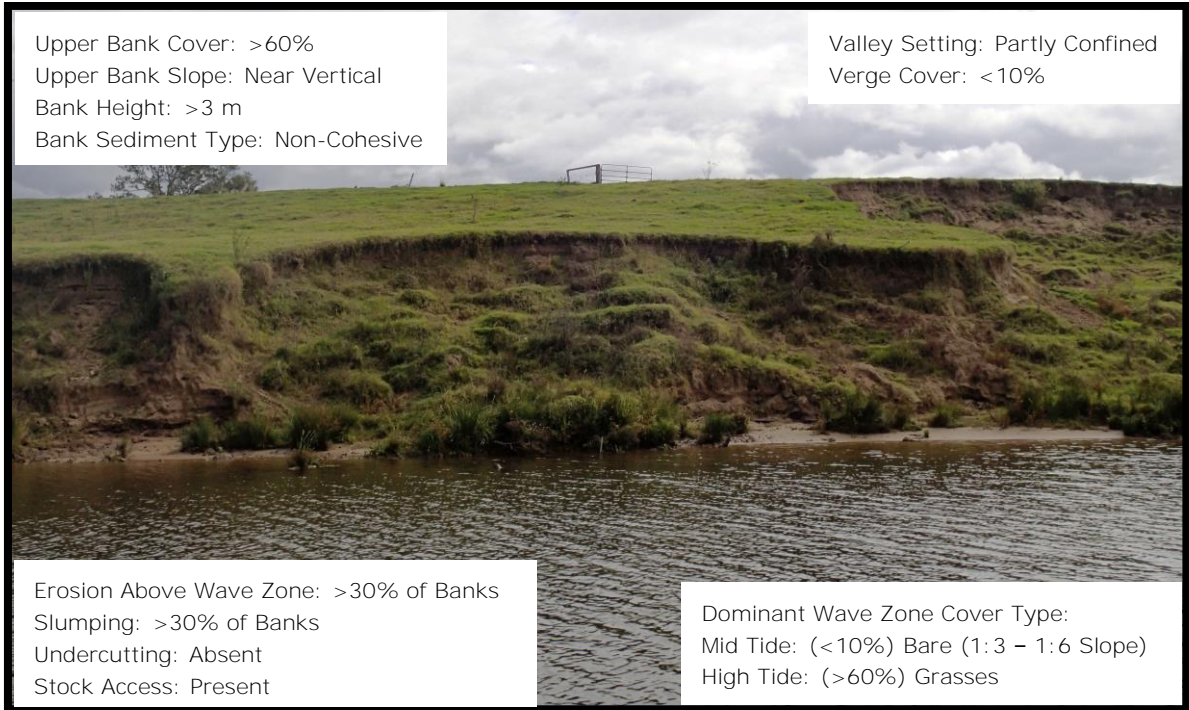
**Highly Erosive – L5C**

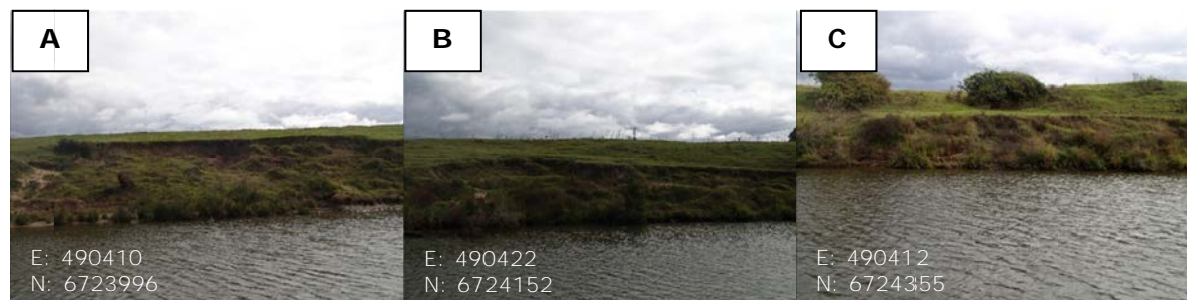
**Site Description:** The site is located on the left bank of the Clarence River downstream of Rogans Bridge. The site is located on an inside-bank and is exposed to moderate fetch lengths from north-east/south-east directions. The site was poorly vegetated in the riparian zone and contained no native understorey regeneration at the time of the inspection. The bank height was greater than three (3) metres with a near vertical upper bank slope. Significant erosion across all three transects, slumping at transect 'A' and transect 'B' and vegetation undercutting at transect 'C', was observed at the time of the inspection.

**Management Assessment:** Site-specific land and water based management options were assessed to reduce riverbank erosion. Land based interventions include removal of exotic vegetation and weeds, native revegetation (with bioengineering where possible), battering, toe protection and stock management. Water based interventions considered the placement of buoys to reduce nearshore boat traffic.

**Recommendation:** WRL recommend a combination of land and water based management interventions for this stretch. Stock management, in combination with the removal of exotic vegetation, battering of the upper bank to create terraces with a back-slope of 1H:3V, toe protection, and native revegetation (planting of sedges, shrubs and trees) of the upper bank and verge, should be used to stabilise the riverbank in the riparian zone across the entire stretch. Cut riverbank material should be used for toe renourishment to protect revegetation works. In addition, buoys should be placed at the mid-river width from the shore in this river stretch.
