## Riverbank Vulnerability Assessment using a Decision Support System: Clarence River (Rogans Bridge to Ulmarra)

WRL Technical Report 2014/12  
December 2014

By W C Glamore, I R Coghlan, J E Ruprecht, F Flocard and C D Drummond

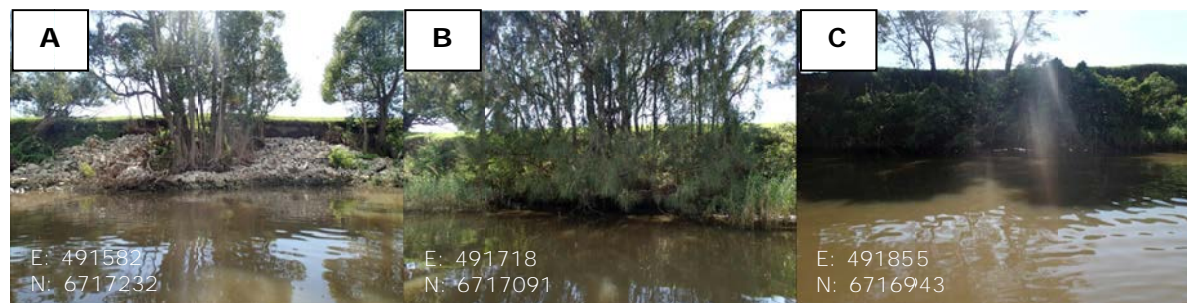
**Site Description:** The site is located on the left bank of the Clarence River directly opposite Peanut and Susan Island. The site is located on a straight section of the river and is exposed to moderate fetch lengths from west/south-west directions. The site was poorly vegetated in the wave zone but relatively well vegetated on the upper bank at the time of the inspection. The site contained limited native vegetation and limited to no verge cover. The bank height was greater than three (3) metres with a near vertical upper bank slope. Significant erosion at transect 'A' and transect 'C', with vegetation undercutting at transect 'B' and transect 'C' and slumping at transect 'A', was observed at the time of the inspection. Rock protection has been used at transect 'A' without sufficient engineering design.

**Management Assessment:** Site-specific land and water based management options were assessed to reduce riverbank erosion. Land based interventions include removal of exotic vegetation and weeds, native revegetation (with bioengineering where possible), battering, stock management, armoring and rock fillets. Water based interventions considered the placement of buoys to reduce nearshore boat traffic.

**Recommendation:** WRL recommend a combination of land and water based management interventions for this stretch. Stock management, in combination with the removal of exotic vegetation, and native revegetation (planting of sedges, shrubs and trees) of the upper bank and verge should be used to stabilise the riverbank in the riparian zone across the entire stretch. Existing rock protection at transect 'A' should be removed and the upper bank battered to create terraces with a back-slope of 1H: 3V. Investigate the potential for rock fillets in conjunction with toe armoring to encourage phragmites growth. A 'no wash' zone should be implemented inside Peanut Island.

**Justification:** Stock management is required to prevent ongoing riverbank destabilisation and damage caused by stock access. Revegetation will establish local native vegetation to stabilise riverbank sediments by generating a network of roots and partially absorbing wave attack. Note that buoys are not satisfactory as a stand-alone management option for this stretch.

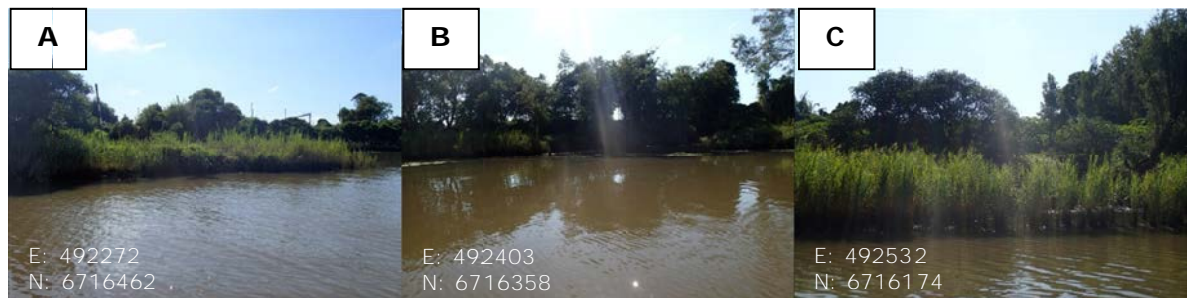
**Site Description:** The site is located on the left bank of the Clarence River at the entrance to Carrs Creek, directly opposite Susan Island. The site is located on a straight section of the river and is exposed to moderate fetch lengths from west/south-west directions. The site was relatively well vegetated in the wave zone and on the upper bank at the time of the inspection. The site contained limited native vegetation and limited to no verge cover. The bank height was greater than three (3) metres with a near vertical upper bank slope. No significant erosion, slumping or vegetation undercutting was observed at the time of the inspection.

**Management Assessment:** Site-specific land and water based management options were assessed to reduce riverbank erosion. Land based interventions include removal of exotic vegetation and weeds, native revegetation (with bioengineering where possible) and stock management. Water based interventions considered the placement of buoys to reduce nearshore boat traffic.

**Recommendation:** WRL recommend a combination of land and water based management interventions for this stretch. Stock management, in combination with the removal of exotic vegetation, and native revegetation (planting of sedges, shrubs and trees) of the upper bank and verge should be used to stabilise the riverbank in the riparian zone across the entire stretch. In addition, buoys should be placed at the mid-river width from the shore in this river stretch while revegetation is established.

**Justification:** Stock management is required to prevent ongoing riverbank destabilisation and damage caused by stock access. Revegetation will establish local native vegetation to stabilise riverbank sediments by generating a network of roots and partially absorbing wave attack. Note that buoys are satisfactory as a stand-alone management option for this stretch.

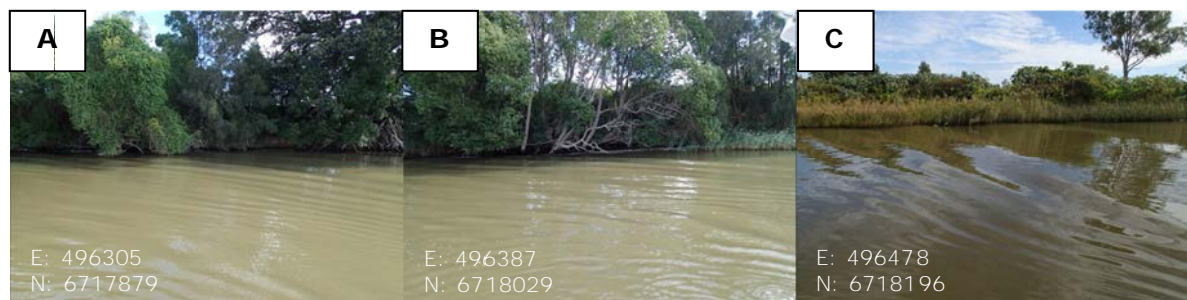
**Site Description:** The site is located on the left bank of Elizabeth Island on the Clarence River. The site is exposed to moderate fetch lengths from north-east/south-east directions. The site was poorly vegetated in the wave zone but relatively well vegetated on the upper bank at the time of the inspection. The site contained limited native vegetation and limited to no verge cover. The bank height was greater than three (3) metres with a near vertical upper bank slope. Moderate erosion at transect 'A', with significant vegetation undercutting at transect 'A' and transect 'B' was observed at the time of the inspection.

**Management Assessment:** Site-specific land and water based management options were assessed to reduce riverbank erosion. Land based interventions include removal of exotic vegetation and native revegetation. Water based interventions considered the placement of buoys to reduce nearshore boat traffic.

**Recommendation:** WRL recommend a combination of land and water based management interventions for this stretch. Planting of native trees in combination with the removal of exotic vegetation should be used to stabilise the riverbank on the island across the entire stretch. In addition, buoys should be placed at the mid-river width from the shore in this river stretch while revegetation is established.

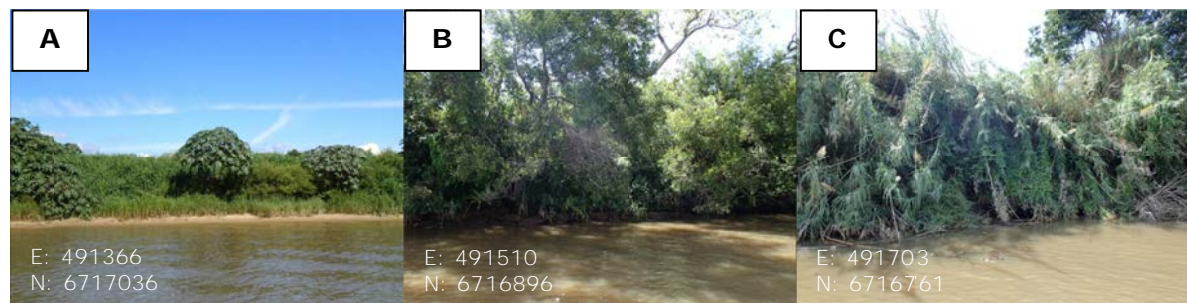
**Site Description:** The site is located on the left bank of Peanut Island on the Clarence River. The site is exposed to moderate fetch lengths from north-west/south directions. The site was poorly vegetated in the wave zone but relatively well vegetated on the upper bank at the time of the inspection. The site contained limited native vegetation and limited to no verge cover. The bank height was greater than three (3) metres with a near vertical upper bank slope. Minor vegetation undercutting at transect 'A' was observed at the time of the inspection.

**Management Assessment:** Site-specific land and water based management options were assessed to reduce riverbank erosion. Land based interventions include removal of exotic vegetation, native revegetation and managed retreat. Water based interventions considered the placement of buoys to reduce nearshore boat traffic.

**Recommendation:** WRL recommend a managed retreat (or 'do-nothing' option) for this stretch. Revegetation and buoys are not sufficient to reduce the riverbank vulnerability rating to 'Monitor'.

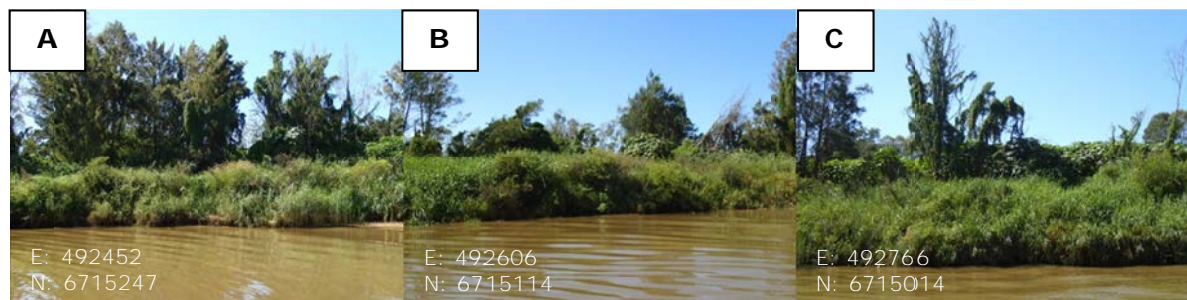
**Site Description:** The site is located on the left bank of Susan Island on the Clarence River. The site is exposed to moderate fetch lengths from west/south-east directions. The site was well vegetated in the wave zone and on the upper bank at the time of the inspection. The site contained abundant native understorey regeneration and relatively good verge cover. The bank height was greater than three (3) metres with a 1H:5V bank slope. Significant vegetation undercutting at transect 'A' and transect 'B' was observed at the time of the inspection.

**Management Assessment:** Site-specific land and water based management options were assessed to reduce riverbank erosion. Land based interventions include removal of exotic vegetation, native revegetation and renourishment. Water based interventions considered the placement of buoys to reduce nearshore boat traffic.

**Recommendation:** WRL recommend a combination of land and water based management interventions for this stretch. Planting of native trees, in combination with renourishment is recommended across the entire stretch. It is also encouraged that buoys are placed at the mid-river width from the shore in this stretch while revegetation is established.

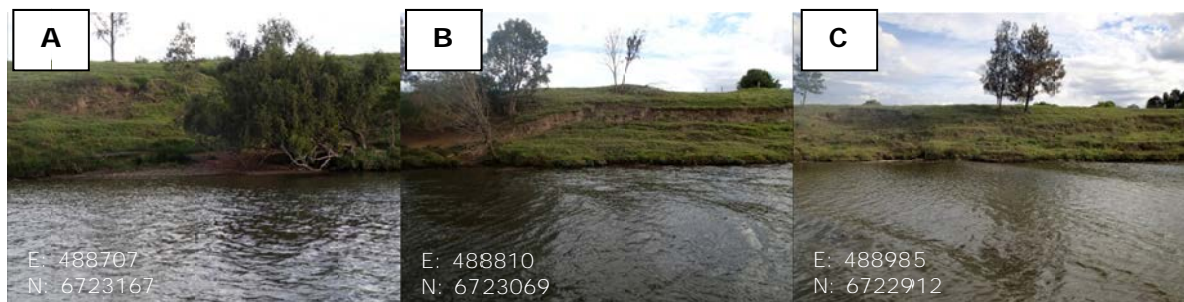
**Site Description:** The site is located on the right bank of the Clarence River downstream of Rogans Bridge. The site is located on a straight section of the river and is exposed to moderate fetch lengths from north/north-east directions. The site was poorly vegetated in the wave zone but relatively well vegetated on the upper bank at the time of the inspection. The site contained limited native vegetation and no verge cover. The bank height was greater than three (3) metres with a near vertical upper bank slope. Significant erosion at transect 'A' and transect 'B' was observed at the time of the inspection.

**Management Assessment:** Site-specific land and water based management options were assessed to reduce riverbank erosion. Land based interventions include removal of exotic vegetation and weeds, native revegetation (with bioengineering where possible), reshaping and stock management. Water based interventions considered the placement of buoys to reduce nearshore boat traffic.

**Recommendation:** WRL recommend a combination of land and water based management interventions for this stretch. Stock management, in combination with reshaping and native revegetation (planting of sedges, shrubs and trees) of the upper bank and verge should be used to stabilise the riverbank in the riparian zone across the entire stretch. Cut riverbank material should be used for toe renourishment to protect revegetation works where possible. In addition, buoys should be placed at the mid-river width from the shore in this stretch.

**Justification:** Stock management is required to prevent ongoing bank destabilisation and damage caused by stock access. Buoys, revegetation with renourishment will establish local native vegetation to stabilise bank sediments by generating a network of roots and partially absorbing wave attack. Reshaping can be used to remove near-vertical erosion scarps. Note that buoys are not satisfactory as a stand-alone management option for this stretch.

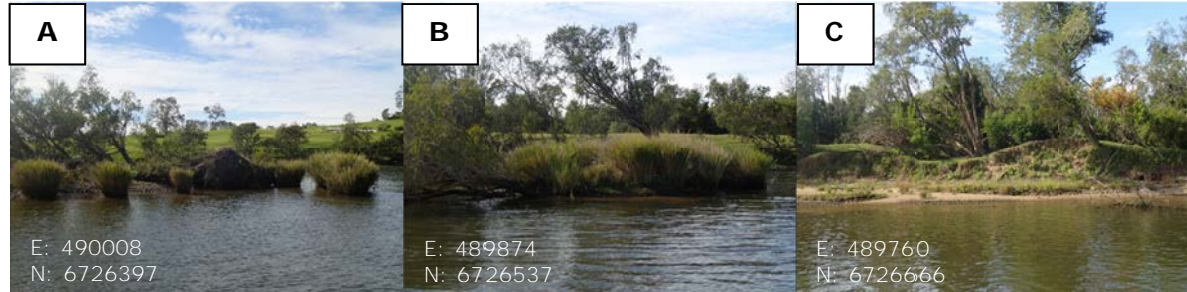
**Site Description:** The site is located on the right bank of the Clarence River opposite to the entrance of Whiteman Creek. The site is located on a straight section of the river and is exposed to moderate fetch lengths from west/south directions. The site was poorly vegetated in the wave zone but relatively well vegetated on the upper bank at the time of the inspection. The site contained limited native vegetation and good verge cover at transect 'C'. The bank height for this stretch was generally greater than three (3) metres with an upper bank slope ranging between 1H:7V at transect 'A' to near-vertical at transect 'C'. Significant erosion at transect 'A' and transect 'C' was observed at the time of the inspection.

**Management Assessment:** Site-specific land and water based management options were assessed to reduce riverbank erosion. Land based interventions include removal of exotic vegetation and weeds, native revegetation (with bioengineering where possible), renourishment and stock management. Water based interventions considered the placement of buoys to reduce nearshore boat traffic.

**Recommendation:** WRL recommend a combination of land and water based management interventions for this stretch. Stock management, in combination with the removal of exotic vegetation, and native revegetation (planting of sedges, shrubs and trees) of the upper bank and verge should be used to stabilise the riverbank in the riparian zone across the entire stretch. Renourishment is encouraged. In addition, buoys should be placed at the mid-river width from the shore in this stretch.

**Justification:** Stock management is required to prevent ongoing riverbank destabilisation and damage caused by stock access. Reshaping is not recommended at locations where the upper bank is well vegetated. Note that buoys are satisfactory as a stand-alone management option for this stretch.

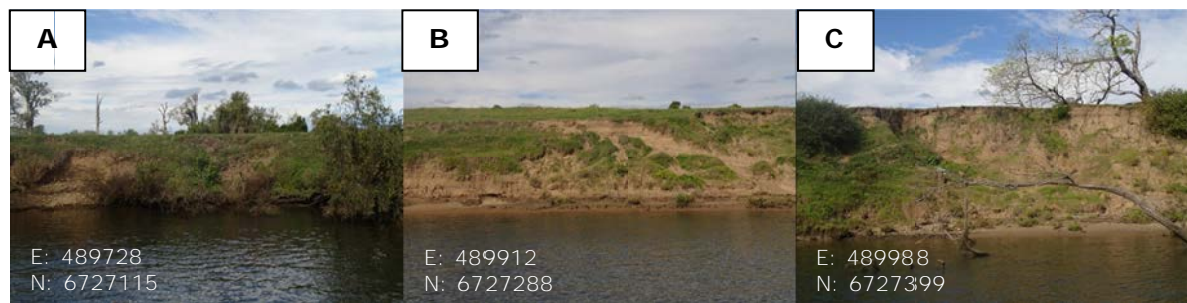
**Site Description:** The site is located on the right bank of the Clarence River. The site is located on a straight section of the river and is exposed to moderate fetch lengths from west/south directions. The site was poorly vegetated in the wave zone and on the upper bank at the time of the inspection. The site contained limited native vegetation and no verge cover at each transect. The bank height was greater than three (3) metres with a near-vertical upper bank slope. Significant erosion across the entire stretch was observed at the time of the inspection.

**Management Assessment:** Site-specific land and water based management options were assessed to reduce riverbank erosion. Land based interventions include removal of exotic vegetation and weeds, native revegetation (with bioengineering where possible), battering and stock management. Water based interventions considered the placement of buoys to reduce nearshore boat traffic.

**Recommendation:** WRL recommend a combination of land and water based management interventions for this stretch. Stock management, in combination with the removal of exotic vegetation, battering of the upper bank to create terraces with a back-slope of 1H: 3V and native revegetation (planting of sedges, shrubs and trees) of the upper bank and verge should be used to stabilise the riverbank in the riparian zone across the entire stretch. Cut riverbank material should be used for toe renourishment to protect revegetation works. In addition, buoys should be placed at the mid-river width from the shore in this stretch.

**Justification:** Stock management is required to prevent ongoing riverbank destabilisation and damage caused by stock access. Revegetation with renourishment will establish local native vegetation to stabilise riverbank sediments by generating a network of roots and partially absorbing wave attack. Note that buoys are not satisfactory as a stand-alone management option for this stretch.

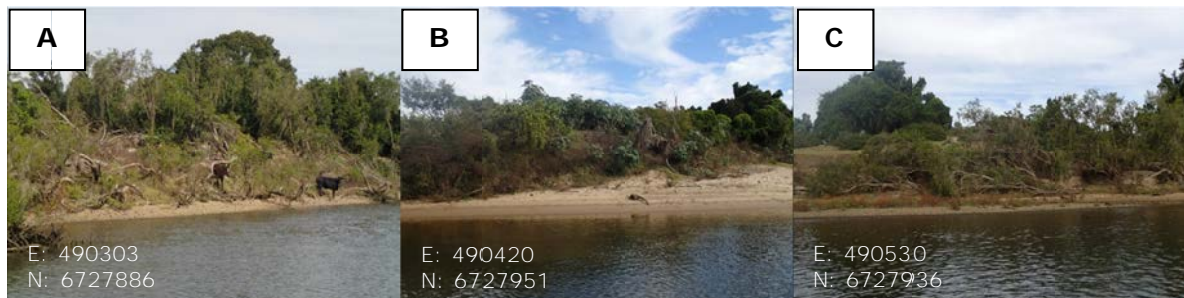
**Site Description:** The site is located on the right bank of the Clarence River in an area known as 'Seelands'. The site is located on an inside-bank and is exposed to moderate fetch lengths from north/north-west directions. The site was poorly vegetated in the wave zone and on the upper bank at the time of the inspection. The site contained limited native vegetation or verge cover across all sites. The bank height was greater than three (3) metres with a near-vertical upper bank slope. Significant erosion across the entire stretch was observed at the time of the inspection.

**Management Assessment:** Site-specific land and water based management options were assessed to reduce riverbank erosion. Land based interventions include removal of exotic vegetation and weeds, native revegetation (with bioengineering where possible), renourishment and stock management. Water based interventions considered the placement of buoys to reduce nearshore boat traffic.

**Recommendation:** WRL recommend a combination of land and water based management interventions for this stretch. Stock management, in combination with the removal of exotic vegetation, and native revegetation (planting of sedges, shrubs and trees) of the upper bank and verge should be used to stabilise the riverbank in the riparian zone across the entire stretch. Renourishment is encouraged. In addition, buoys should be placed at the mid-river width from the shore in this stretch.

**Justification:** Stock management is required to prevent ongoing riverbank destabilisation and damage caused by stock access. Revegetation with renourishment will establish local native vegetation to stabilise riverbank sediments by generating a network of roots and partially absorbing wave attack. Reshaping is not recommended at locations where the upper bank is well vegetated. Note that buoys are not satisfactory as a stand-alone management option for this stretch.

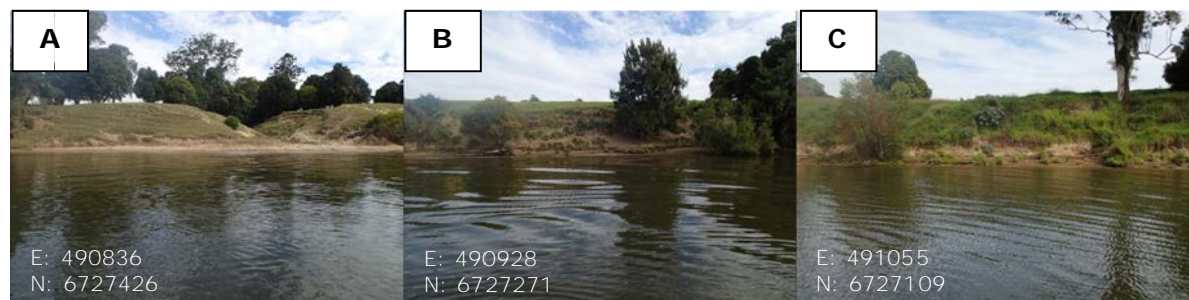
**Site Description:** The site is located on the right bank of the Clarence River upstream of the Big River Holiday Park and Ski Lodge in Grafton. The site is located on a straight section of the river and is exposed to moderate fetch lengths from north/east directions. The site was poorly vegetated in the wave zone and on the upper bank at the time of the inspection. With the exception of transect 'A', the site contained limited native vegetation or verge cover. The bank height was greater than three (3) metres with a near-vertical upper bank slope. Significant erosion across the entire stretch was observed at the time of the inspection.

**Management Assessment:** Site-specific land and water based management options were assessed to reduce riverbank erosion. Land based interventions include removal of exotic vegetation and weeds, native revegetation (with bioengineering where possible), renourishment and stock management. Water based interventions considered the placement of buoys to reduce nearshore boat traffic.

**Recommendation:** WRL recommend a combination of land and water based management interventions for this stretch. Stock management, in combination with the removal of exotic vegetation, and native revegetation (planting of sedges, shrubs and trees) of the upper bank and verge should be used to stabilise the riverbank in the riparian zone across the entire stretch. Renourishment is encouraged. In addition, buoys should be placed at the mid-river width from the shore in this stretch.

**Justification:** Stock management is required to prevent ongoing riverbank destabilisation and damage caused by stock access. Revegetation with renourishment will establish local native vegetation to stabilise riverbank sediments by generating a network of roots and partially absorbing wave attack. Reshaping is not recommended at locations where the upper bank is well vegetated. Note that buoys are satisfactory as a stand-alone management option for this stretch.

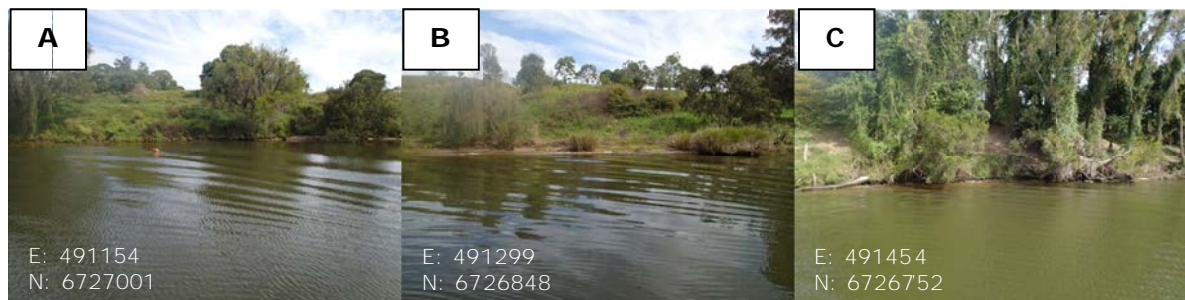
**Site Description:** The site is located on the right bank of the Clarence River upstream of the Big River Holiday Park and Ski Lodge in Grafton. The site is located on a straight section of the river and is exposed to moderate fetch lengths from north/east directions. The site was poorly vegetated in the wave zone, with the exception of transect 'C' which contains bedrock, and was relatively well vegetated on the upper bank at the time of the inspection. The site contained limited native vegetation or verge cover. The bank height was greater than three (3) metres with an upper bank slope of 1H:3V. No erosion, slumping or vegetation undercutting was observed at the time of the inspection. Stock access is permitted at the site.

**Management Assessment:** Site-specific land and water based management options were assessed to reduce riverbank erosion. Land based interventions include removal of exotic vegetation and weeds, native revegetation (with bioengineering where possible) and stock management. Water based interventions considered the placement of buoys to reduce nearshore boat traffic.

**Recommendation:** WRL recommend a combination of land and water based management interventions for this stretch. Stock management, in combination with the removal of exotic vegetation, and native revegetation (planting of sedges, shrubs and trees) of the upper bank and verge should be used to stabilise the riverbank in the riparian zone across the entire stretch. In addition, buoys should be placed at the mid-river width from the shore in this stretch.

**Justification:** Stock management is required to prevent ongoing riverbank destabilisation and damage caused by stock access. Revegetation will establish local native vegetation to stabilise riverbank sediments by generating a network of roots and partially absorbing wave attack. Reshaping is not recommended at locations where the upper bank is well vegetated. Note that buoys are satisfactory as a stand-alone management option for this stretch.

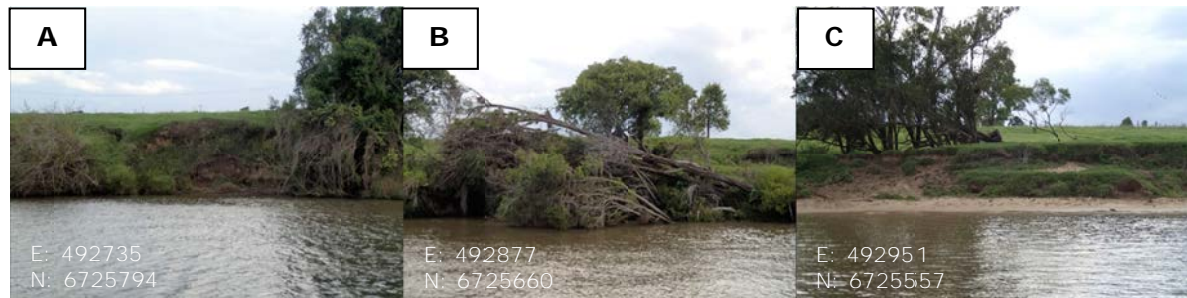
**Site Description:** The site is located on the right bank of the Clarence River upstream of the Big River Holiday Park and Ski Lodge in Grafton. The site is located on an inside-bank and is exposed to moderate fetch lengths from north/north-east directions. The site was poorly vegetated in the wave zone and on the upper bank, with the exception of transect 'B' which contained fallen trees and tree roots, at the time of the inspection. The site contained limited native vegetation and no verge cover. The bank height was greater than three (3) metres with a near-vertical upper bank slope. Significant erosion across the entire stretch, with moderate slumping at transect 'C', was observed at the time of the inspection.

**Management Assessment:** Site-specific land and water based management options were assessed to reduce riverbank erosion. Land based interventions include removal of exotic vegetation and weeds, native revegetation (with bioengineering where possible), battering, stock management and rock fillets. Water based interventions considered the placement of buoys to reduce nearshore boat traffic.

**Recommendation:** WRL recommend a combination of land and water based management interventions for this stretch. Stock management, in combination with the removal of exotic vegetation, battering to create terraces with a back-slope of 1H:3V and native revegetation (planting of sedges, shrubs and trees) of the upper bank and verge should be used to stabilise the riverbank in the riparian zone across the entire stretch. Investigate the potential for rock fillets in conjunction with toe armouring to encourage phragmites growth. In addition, buoys should be placed at the mid-river width from the shore in this stretch.

**Justification:** Stock management is required to prevent ongoing riverbank destabilisation and damage caused by stock access. Rock fillets are recommended as this stretch is upstream of a constriction in the river which provides favourable flow conditions for their use in protecting vegetation. Note that buoys are not satisfactory as a stand-alone management option for this stretch.

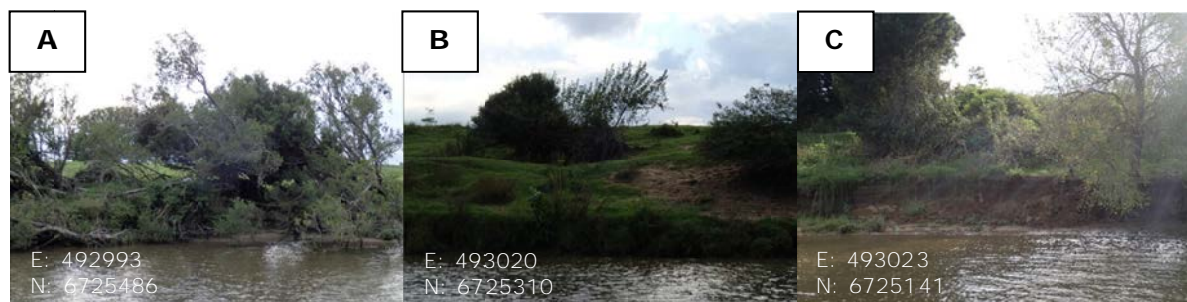
**Site Description:** The site is located on the right bank of the Clarence River upstream of the Big River Holiday Park and Ski Lodge in Grafton. The site is located on an inside-bank and is exposed to moderate fetch lengths from north-east/south-west directions. The site was poorly vegetated in the wave zone and on the upper bank, with the exception of transect 'A' which contained fallen trees and tree roots, at the time of the inspection. The site contained limited native vegetation and no verge cover. The bank height was greater than three (3) metres with a near-vertical upper bank slope. Significant erosion at transect 'A' and transect 'C' was observed at the time of the inspection.

**Management Assessment:** Site-specific land and water based management options were assessed to reduce riverbank erosion. Land based interventions include removal of exotic vegetation and weeds, native revegetation (with bioengineering where possible), reshaping, stock management and rock fillets. Water based interventions considered the placement of buoys to reduce nearshore boat traffic.

**Recommendation:** WRL recommend a combination of land and water based management interventions for this stretch. Stock management, in combination with the removal of exotic vegetation, and native revegetation (planting of sedges, shrubs and trees) of the upper bank and verge should be used to stabilise the riverbank in the riparian zone across the entire stretch. Investigate the potential for rock fillets in conjunction with toe armouring to encourage phragmites growth. In addition, buoys should be placed at a width from the shore in this stretch.

**Justification:** Stock management is required to prevent ongoing riverbank destabilisation and damage caused by stock access. Rock fillets are recommended as this site is at a constriction in the river which provides favourable flow conditions for their use in protecting vegetation. Reshaping is permitted to remove near-vertical erosion scarps. Note that buoys are not satisfactory as a stand-alone management option for this stretch.

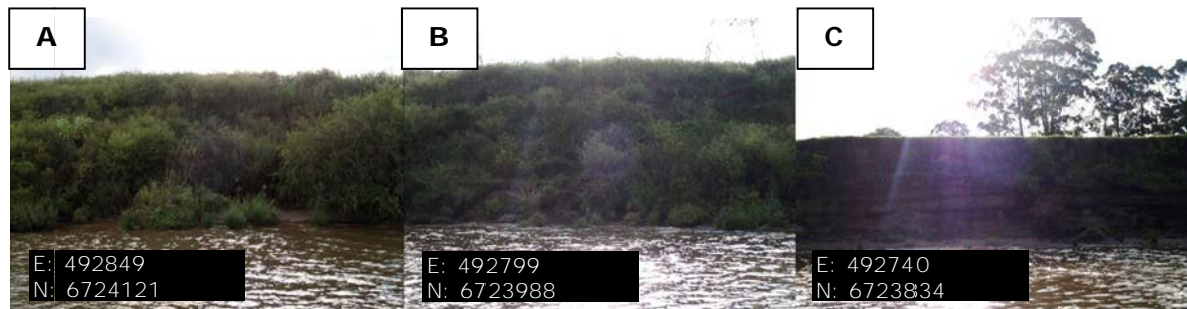
**Site Description:** The site is located on the right bank of the Clarence River downstream of the Big River Holiday Park and Ski Lodge in Grafton. The site is located on an inside-bank and is exposed to moderate fetch lengths from north-east/south-west directions. The site was poorly vegetated in the wave zone and on the upper bank at the time of the inspection. The site contained limited native vegetation and no verge cover. The bank height was greater than three (3) metres with a near-vertical upper bank slope. Significant erosion across the entire stretch, with slumping and undercutting at transect 'C', was observed at the time of the inspection.

**Management Assessment:** Site-specific land and water based management options were assessed to reduce riverbank erosion. Land based interventions include removal of exotic vegetation and weeds, native revegetation (with bioengineering where possible), battering, stock management and rock fillets. Water based interventions considered the placement of buoys to reduce nearshore boat traffic.

**Recommendation:** WRL recommend a combination of land and water based management interventions for this stretch. Stock management, in combination with the removal of exotic vegetation, battering to create multi-level terraces with a back-slope of 1H:3V and native revegetation (planting of sedges, shrubs and trees) of the upper bank and verge should be used to stabilise the riverbank in the riparian zone across the entire stretch. Investigate the potential for rock fillets in conjunction with toe armouring to encourage phragmites growth. In addition, buoys should be placed at the mid-river width from the shore in this stretch while revegetation is established.

**Justification:** Stock management is required to prevent ongoing riverbank destabilisation and damage caused by stock access. Rock fillets are recommended to provide riverbank stabilisation and to protect native regeneration. Note that buoys are not satisfactory as a stand-alone management option for this stretch.

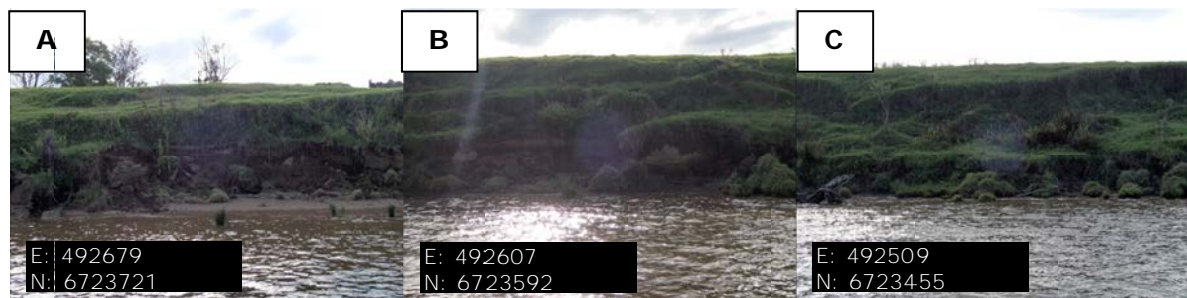
**Site Description:** The site is located on the right bank of the Clarence River downstream of the Big River Holiday Park and Ski Lodge in Grafton. The site is located on an inside-bank and is exposed to moderate fetch lengths from north-east/south-west directions. The site was poorly vegetated in the wave zone and on the upper bank at the time of the inspection. The site contained limited native vegetation and no verge cover. The bank height was greater than three (3) metres with a near-vertical upper bank slope. Significant erosion, slumping and undercutting across the entire stretch was observed at the time of the inspection.

**Management Assessment:** Site-specific land and water based management options were assessed to reduce riverbank erosion. Land based interventions include removal of exotic vegetation and weeds, native revegetation (with bioengineering where possible), battering, stock management and rock fillets. Water based interventions considered the placement of buoys to reduce nearshore boat traffic.

**Recommendation:** WRL recommend a combination of land and water based management interventions for this stretch. Stock management, in combination with the removal of exotic vegetation, battering to create terraces with a back-slope of 1H:3V and native revegetation (planting of sedges, shrubs and trees) of the upper bank and verge should be used to stabilise the riverbank in the riparian zone across the entire stretch. Investigate the potential for rock fillets in conjunction with toe armouring to encourage Phragmites growth. In addition, buoys should be placed at the mid-river width from the shore in this stretch while revegetation is established.

**Justification:** Stock management is required to prevent ongoing riverbank destabilisation and damage caused by stock access. Rock fillets are recommended as this stretch is on an inside-bank providing favourable flow and sedimentation conditions and the wave zone slope is 1H:7V. Note that buoys are not satisfactory as a stand-alone management option for this stretch.

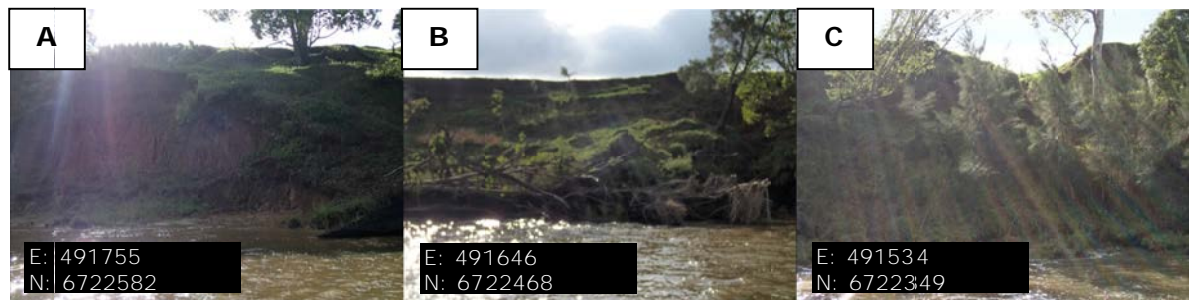
**Site Description:** The site is located on the right bank of a straight section of the Clarence River opposite from Crowther Island. The site is located on a straight section of the river and is exposed to moderate fetch lengths from south/south-east directions. The site was poorly vegetated in the wave zone and on the upper bank, with the exception of transect 'B' which contained trees and tree roots, at the time of the inspection. The site contained limited native vegetation and no verge cover. The bank height was greater than three (3) metres with a near-vertical upper bank slope. Significant erosion and slumping across all three transects, and vegetation undercutting at transect 'C', was observed at the time of the inspection.

**Management Assessment:** Site-specific land and water based management options were assessed to reduce riverbank erosion. Land based interventions include removal of exotic vegetation and weeds, native revegetation (with bioengineering where possible), battering, renourishment and stock management. Water based interventions considered the placement of buoys to reduce nearshore boat traffic.

**Recommendation:** WRL recommend a combination of land and water based management interventions for this stretch. Stock management, in combination with the removal of exotic vegetation, battering to create terraces with a back-slope of 1H:3V and native revegetation (planting of sedges, shrubs and trees) of the upper bank and verge should be used to stabilise the riverbank in the riparian zone across the entire stretch. Cut riverbank material should be used for toe renourishment to protect revegetation works. In addition, buoys should be placed at the mid-river width from the shore in this stretch while revegetation is established.

**Justification:** Stock management is required to prevent ongoing riverbank destabilisation and damage caused by stock access. Buoys, revegetation and renourishment will establish local native vegetation to stabilise riverbank sediments by generating a network of roots and partially absorbing wave attack. Note that buoys are not satisfactory as a stand-alone management option for this stretch.

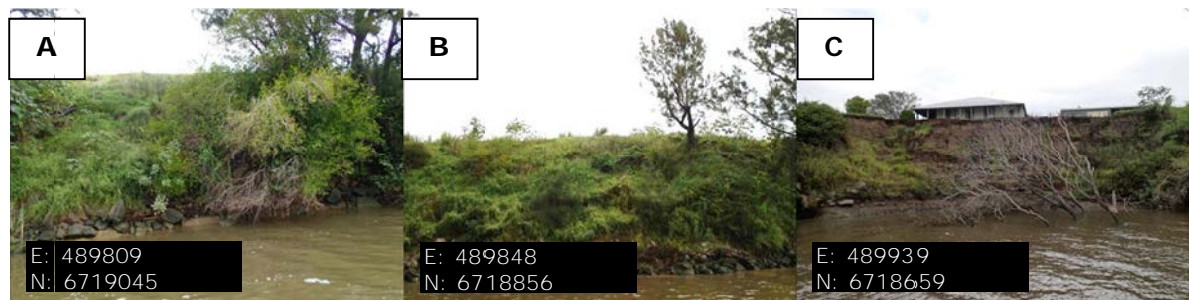
**Site Description:** The site is located on the right bank of the Clarence River opposite from Carrs Peninsula. The site is located on an outside-bank and is exposed to moderate fetch lengths from north/south-west directions. The site was protected by a rock revetment in the wave zone and well vegetated on the upper bank at the time of the inspection. The site contained limited native vegetation and no verge cover. The bank height was greater than three (3) metres with a near vertical upper bank slope. Catastrophic erosion due at transect 'C' was observed at the time of the inspection.

**Management Assessment:** Site-specific land and water based management options were assessed to reduce riverbank erosion. Land based interventions include removal of exotic vegetation and weeds, native revegetation (with bioengineering where possible), renourishment, armoring and stock management. Water based interventions considered the placement of buoys to reduce nearshore boat traffic.

**Recommendation:** WRL recommend a combination of land and water based management interventions for this stretch. Stock management, in combination with the removal of exotic vegetation, and native revegetation (planting of sedges, shrubs and trees) of the upper bank and verge should be used to stabilise the riverbank in the riparian zone across the entire stretch. Cut riverbank material should be used for toe renourishment to protect revegetation works. Repair rock revetment across entire stretch. Investigate potential for battering to create terraces with a back-slope of 1H:3V at transect 'C'. Full engineering design of rehabilitation works is required. In addition, buoys should be placed at mid-river in this stretch.

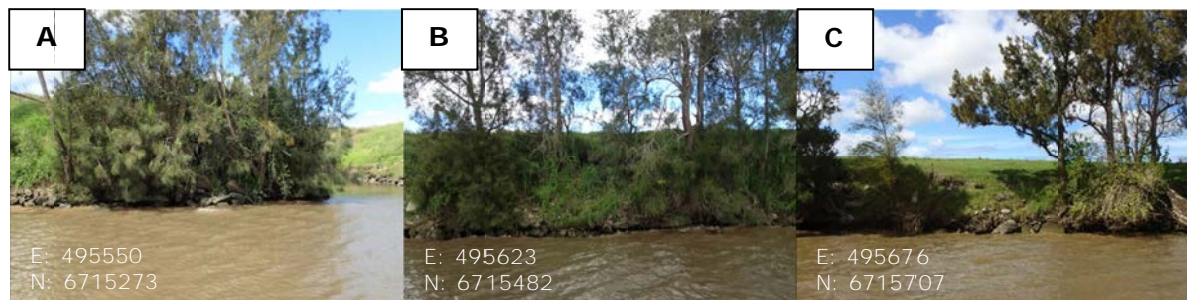
**Site Description:** The site is located on the right bank of the Clarence River downstream of the Grafton bridge. The site is located on an outside-bank and is exposed to moderate fetch lengths from north-west/south-west directions. The site is protected by a rock revetment in the wave zone and was relatively well vegetated on the upper bank at the time of the inspection. The site contained limited native understorey regeneration and no verge cover. The bank height was greater than three (3) metres with a near-vertical upper bank slope. Significant erosion at transect 'A' and transect 'C', and vegetation undercutting at transect 'B' and transect 'C', was observed at the time of the inspection.

**Management Assessment:** Site-specific land and water based management options were assessed to reduce riverbank erosion. Land based interventions include removal of exotic vegetation and weeds, native revegetation (with bioengineering where possible), armouring and stock management. Water based interventions considered the placement of buoys to reduce nearshore boat traffic.

**Recommendation:** WRL recommend a combination of land and water based management interventions for this stretch. Stock management, in combination with the removal of exotic vegetation, and native revegetation (planting of sedges, shrubs and trees) of the upper bank and verge should be used to stabilise the riverbank in the riparian zone across the entire stretch. Repair existing rock revetment. In addition, buoys should be placed at the mid-river width from the shore in this stretch while revegetation is established.

**Justification:** Stock management is required to prevent ongoing riverbank destabilisation and damage caused by stock access. Revegetation will establish local native vegetation to stabilise riverbank sediments while the rock revetment will provide toe protection from wave attack. Note that buoys are not satisfactory as a stand-alone management option for this stretch.

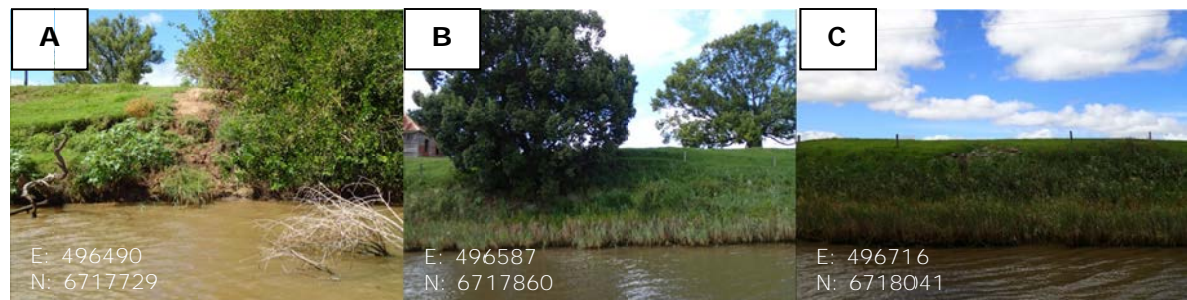
**Site Description:** The site is located on the right bank of the Clarence River downstream of the Grafton bridge, opposite from the northern end of Elizabeth Island. The site is located on an inside-bank and is exposed to moderate fetch lengths from north/south-west directions. The site was well vegetated in the wave zone and on the upper bank at the time of the inspection. Note that adjacent sites are protected in the wave zone by a rock revetment. The site contained limited native understorey regeneration and no verge cover. The bank height was greater than three (3) metres with a near-vertical upper bank slope. Significant erosion and undercutting at transect 'A' was observed at the time of the inspection.

**Recommendation:** WRL recommend a combination of land and water based management interventions for this stretch. Stock management, in combination with the removal of exotic vegetation, and native revegetation (planting of sedges, shrubs and trees) of the upper bank and verge should be used to stabilise the riverbank in the riparian zone across the entire stretch. Repair existing rock revetment. In addition, buoys should be placed at the mid-river width from the shore in this stretch while revegetation is established.

**Justification:** Stock management is required to prevent ongoing riverbank destabilisation and damage caused by stock access. Revegetation will establish local native vegetation to stabilise riverbank sediments while the rock revetment will provide toe protection from wave attack. Note that buoys are not satisfactory as a stand-alone management option for this stretch.

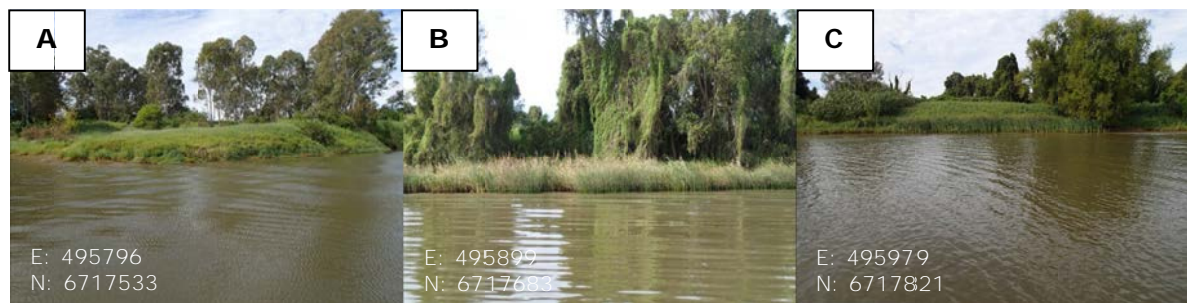
**Site Description:** The site is located on the right bank of Elizabeth Island on the Clarence River. The site is exposed to moderate fetch lengths from west/south-west directions. The site was poorly vegetated in the wave zone but relatively well vegetated on the upper bank at the time of the inspection. The site contained limited native vegetation and limited to no verge cover. The bank height was greater than three (3) metres with an upper bank slope of 1H:3V. Erosion and vegetation undercutting at transect 'A' was observed at the time of the inspection.

**Recommendation:** WRL recommend a combination of land and water based management interventions for this stretch. Planting of native trees in combination with the removal of exotic vegetation should be used to stabilise the riverbank on the island across the entire stretch. In addition, buoys should be placed at the mid-river width from the shore in this stretch while revegetation is established.

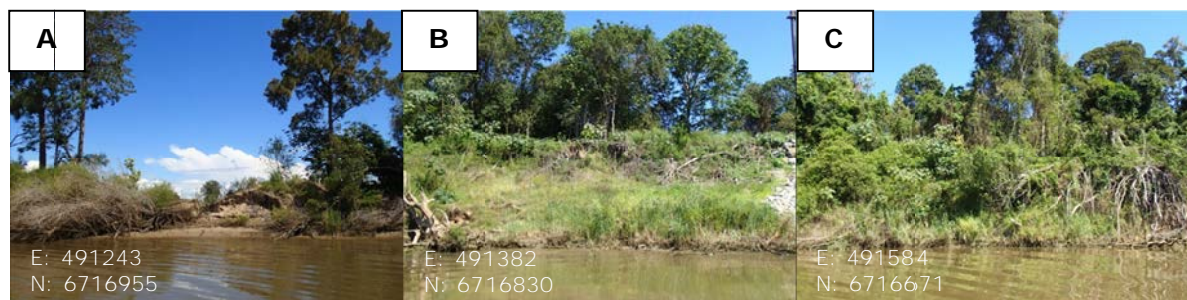
**Site Description:** The site is located on the right bank of Susan Island on the Clarence River. The site is located on a straight section of the river and is exposed to moderate fetch lengths from north/north-east directions. The site was poorly vegetated in the wave zone and on the upper bank at the time of the inspection. The site contained limited native vegetation and sufficient verge cover. The bank height was greater than three (3) metres with a near vertical upper bank slope. Significant erosion at transect 'A' and transect 'B', with slumping at transect 'B' and vegetation undercutting at transect 'C', was observed at the time of the inspection.

**Recommendation:** WRL recommend a combination of land and water based management interventions for this stretch. The removal of exotic vegetation, in combination with native revegetation (planting of sedges, shrubs and trees) of the upper bank and verge and renourishment should be used to stabilise the riverbank in the riparian zone at each transect. Investigate the potential to extend existing armoring upstream of transect 'B' to provide rock protection at transect 'A'. In addition, buoys should be placed at mid-river in this stretch while revegetation is established.

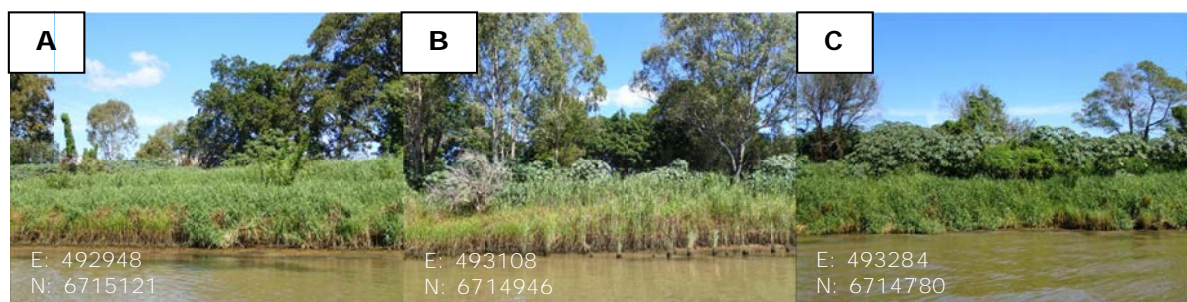
**Site Description:** The site is located on the right bank at the southern point of Susan Island on the Clarence River. The site is located on a straight section of the river and is exposed to moderate fetch lengths from north-east/south-east directions. The site was generally well vegetated in the wave zone and on the upper bank at the time of the inspection. The site contained limited native vegetation and sufficient verge cover. The bank height ranged between 1 – 3 metres with a 1H:3V bank slope. No erosion, slumping or undercutting was observed at the time of the inspection.

**Recommendation:** WRL recommend a managed retreat (or 'do-nothing' option) for this stretch. Note that the site was shown to be prograding at the time of the inspection.
