2015 Riverbank Vulnerability Assessment using a Decision Support System: Seaham Weir Pool and Lower Williams River

WRL Technical Report 2015/02
May 2016

By W C Glamore, I R Coghlan and J E Ruprecht

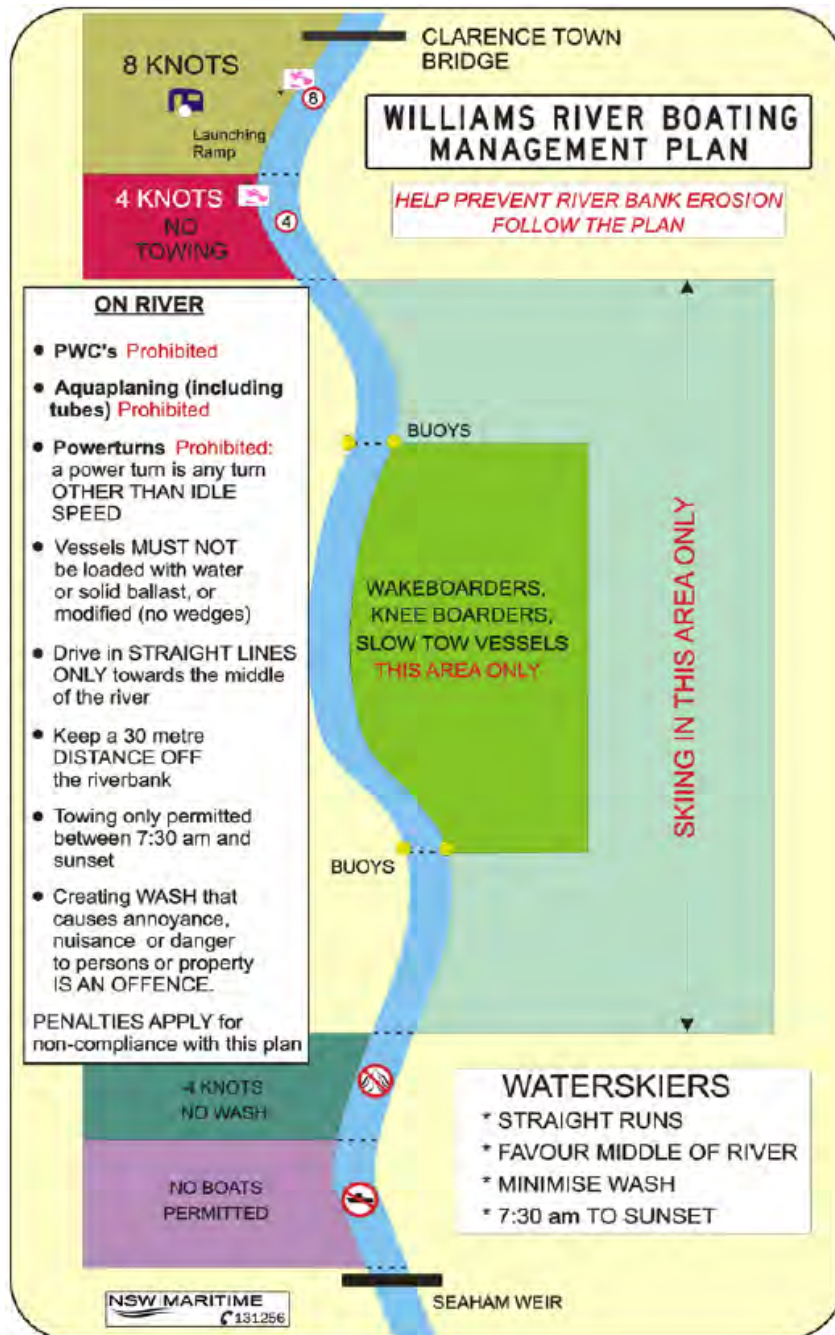
Figure 2-1: Upper Williams River (Seaham Weir Pool) Boating Traffic Management Plan (NSW RMS, n.d.)

The Upper Williams River Boating Traffic Management Plan (NSW RMS, n.d.) sets out existing boating restrictions between the Seaham Weir (Stretch 1) and the upstream limit of navigation on the Williams River (Stretch 49) (Figure 2-1). Each zone within the Seaham Weir Pool has been aligned with the corresponding DSS sites (see Section 4.2) in Table 2-1 and reproduced in Figure 2-2.

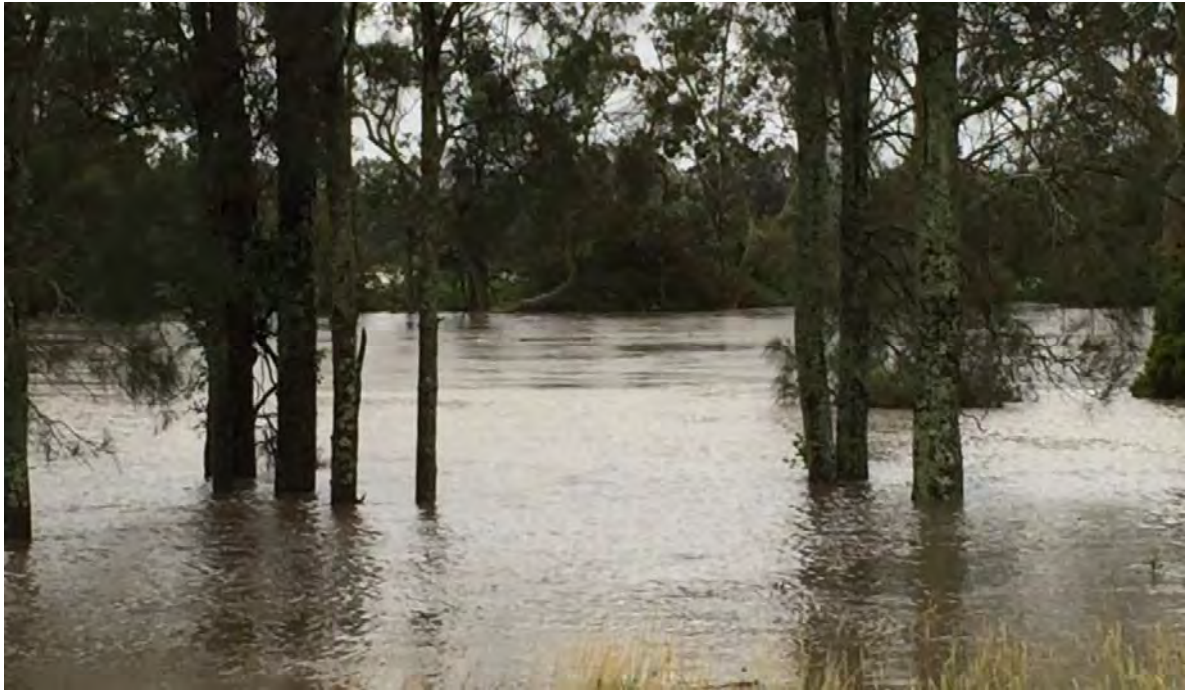
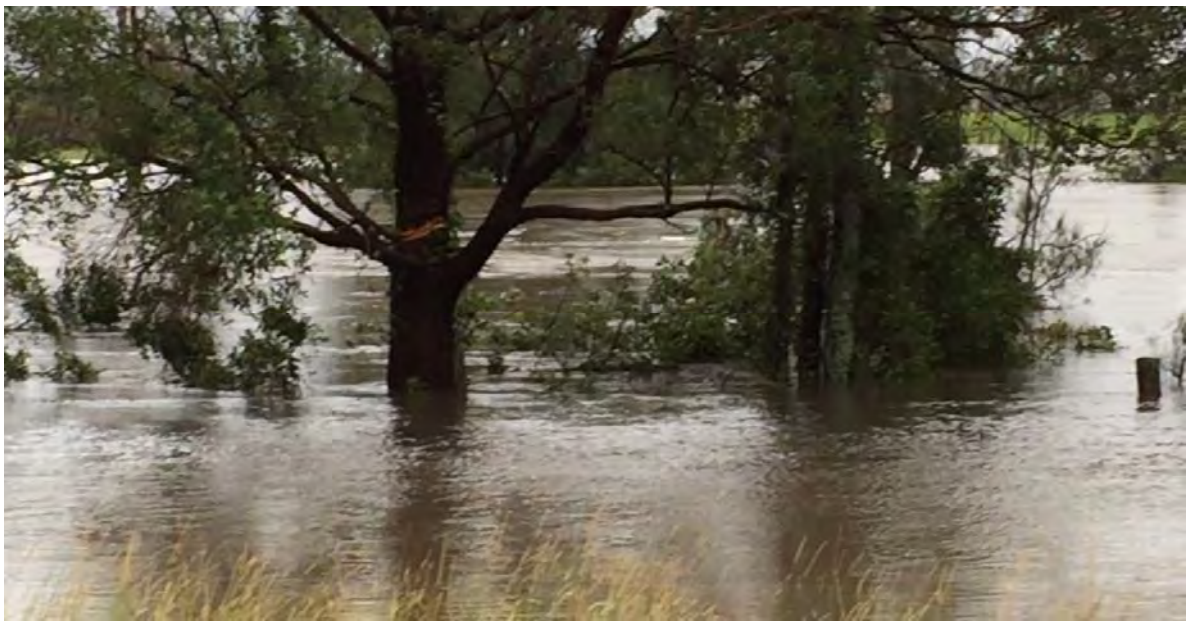
Figure 2-7: Images of April 2015 Flood on Seaham Weir Pool (Source: Mr John Spearpoint, 2015)

During the flood period from 20 April to 5 May 2015, flooding on the Williams River ranged in classification from minor to major, as provided in Table 2-3. In the Upper Hunter Region, the Williams River at Dungog experienced major flooding reaching a peak water level of 8.68 m AHD at 10:30 AM on 21 April 2015, and the rainfall at Dungog recorded a peak intensity of 180 mm/h, which is an annual exceedance probability (AEP) of less than 1%. In the Lower Hunter Region, the Williams River at Glen Martin (alternatively, Mill Dam Falls) also experienced major flooding with a recorded peak water level of 12.13 m AHD. The BOM flood classification at Raymond Terrace was minor, with peak water levels reaching 3.06 m AHD. Observed water levels on the Williams River at Mill Dam Falls, Seaham Weir (downstream) and Raymond Terrace from 20 April to 5 May 2015 are provided in Figure 2-5. Figure 2-6 displays a wind rose from Williamstown Station for the month of April where the majority of the winds blew from the south, with a maximum wind gust of 113 km/h recorded on 21 April 2015. Images captured from the flood on Seaham Weir Pool are provided in Figure 2-7.

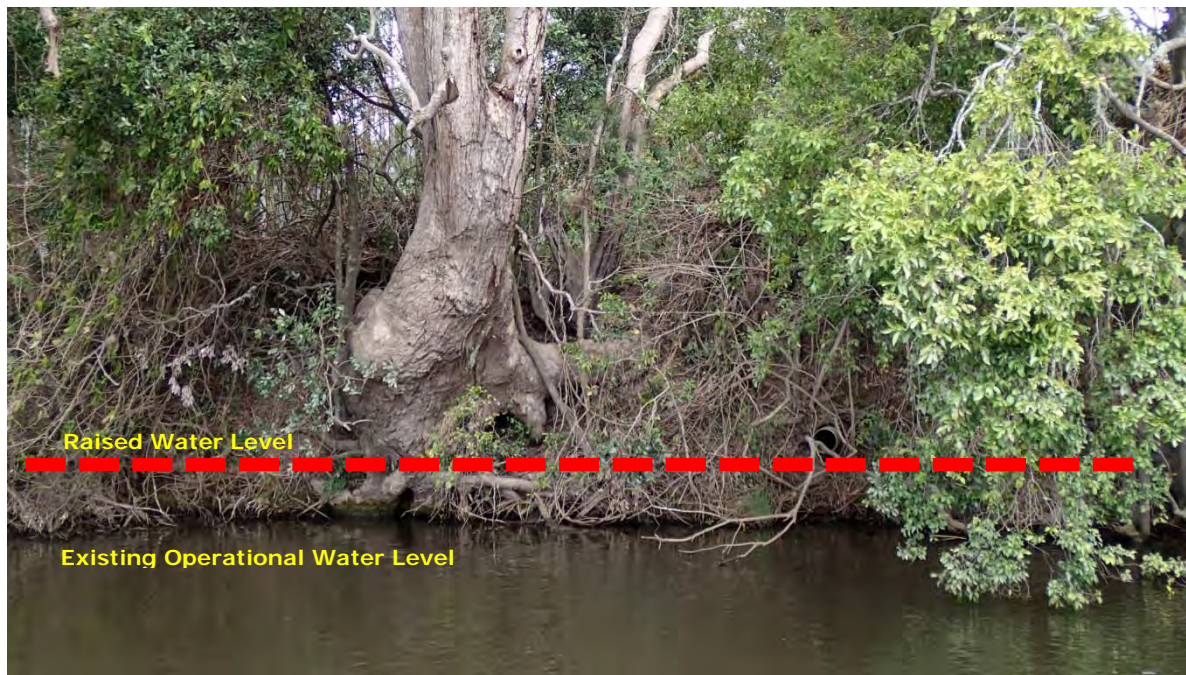
Results of a raised operational water level assessment for the Seaham Weir Pool are provided in Appendix M. A comparison between the existing and raised operational water level assessments highlighted minimal difference between the number of occurrences for each erosion potential category. Note it was acknowledged that the response of riverbank vegetation to an ongoing raised operational water level is unknown and may result in the long-term root migration up the riverbank. On this basis, altering the Seaham Weir Pool operational water level to mitigate erosion is not recommended.

Figure 5-3: Comparison Between Existing vs Raised Operational Water Levels for Seaham Weir Pool at Site R03C

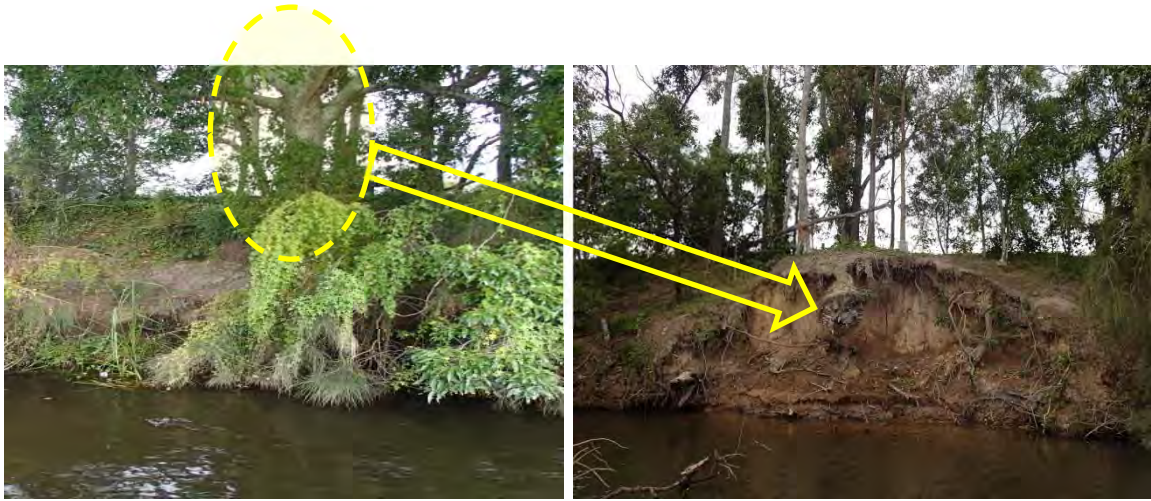
Figure 5-4: Comparison of March 2015 (Pre-Flood) and August 2015 (Post-Flood) at Site L11A

The April 2015 flood event (discussed in Section 2.4) caused significant changes to the erosion potential of the riverbanks along the Seaham Weir Pool study area. Figure 5-4 provides an example where significant undercutting has led to riverbank failure at Site L11A following the flood event. Table 5-2 and Figure 5-5 provide the distribution of erosion potential categories for the existing operational water level on the Seaham Weir Pool based on the August 2015 assessment. A comparison between the March 2015 (pre-flood) and August 2015 (post-flood) DSS assessments indicated that flooding has directly increased the number of sites identified as erosive in the study area. Considering only transects within the Seaham Weir Pool (Stretches 1-45), the number of sites in the 'Moderately Erosive' or 'Highly Erosive' categories increased from 157 occurrences before the April 2015 flood to 191 occurrences after the flood, a 13% increase in erosive sites. These changes corresponded to an equivalent reduction in the number of sites identified as resistant to erosion in the March 2015 assessment.

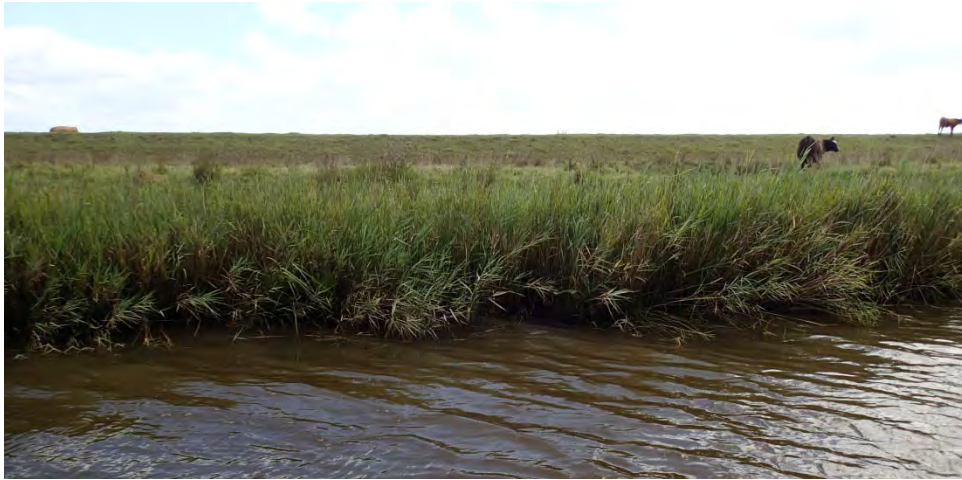
Figure 5-9: Cleared Floodplain and Cattle Access at Stretch R66 on the Lower Williams River (March 2015)

The DSS assessment of the Seaham Weir Pool and Lower Williams River found that sites with low resistance to erosion were influenced by a range of factors. Many reaches are laterally unconfined by alluvial floodplains on one (1) or both sides. These floodplains were typically observed to be laterally unconfined farmlands cleared of native riparian vegetation (Figure 5-9). At many sites there was also obvious uncontrolled stock access to the riverbanks (Figure 5-10 and Figure 5-11). In fact, during the 2015 field assessments stock access was observed at approximately 25% of all sites on the Seaham Weir Pool and approximately 40% of all sites on the Lower Williams River. The combination of these factors increases the risk of bank destabilisation including erosion, slumping and undercutting (Figure 5-12).

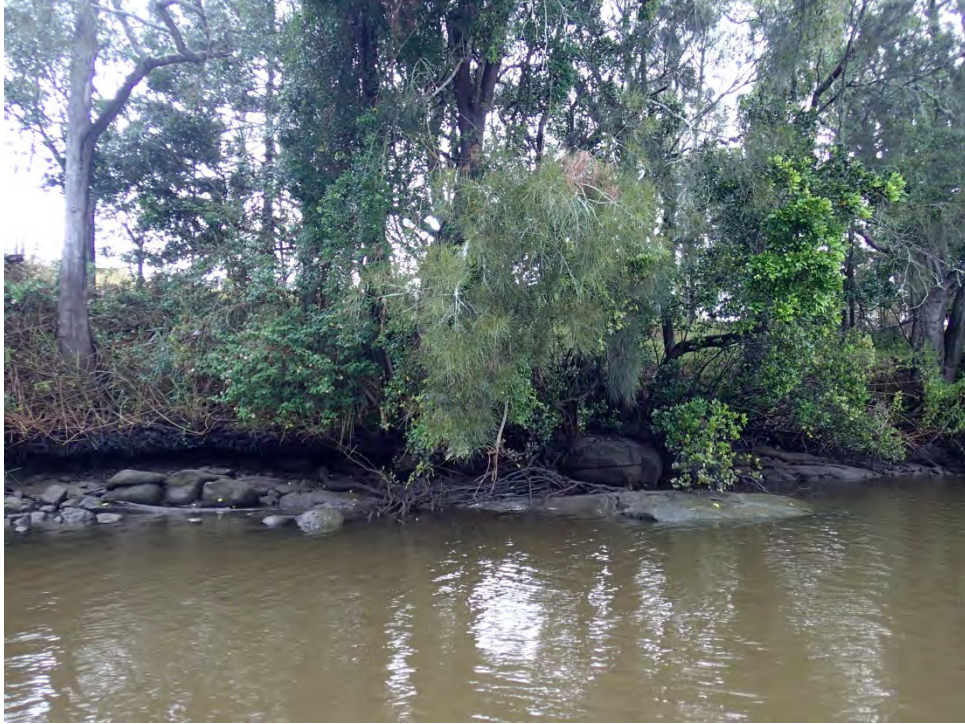
Figure 5-13: Natural Rock Armouring (Also Note Undercutting) at Stretch R75 on the Lower Williams River (March 2015)

Armouring of the riverbank is a major influencing factor in the assessment of riverbank erosion potential. Very few reaches of the study area are naturally armoured by large rock ledges or cliffs (Figure 5-13), while other reaches have been artificially armoured (Figure 5-14 and Figure

5-15). This armouring, whether it is natural or artificial, generally provides 'Highly Resistant' erosion potential ratings.

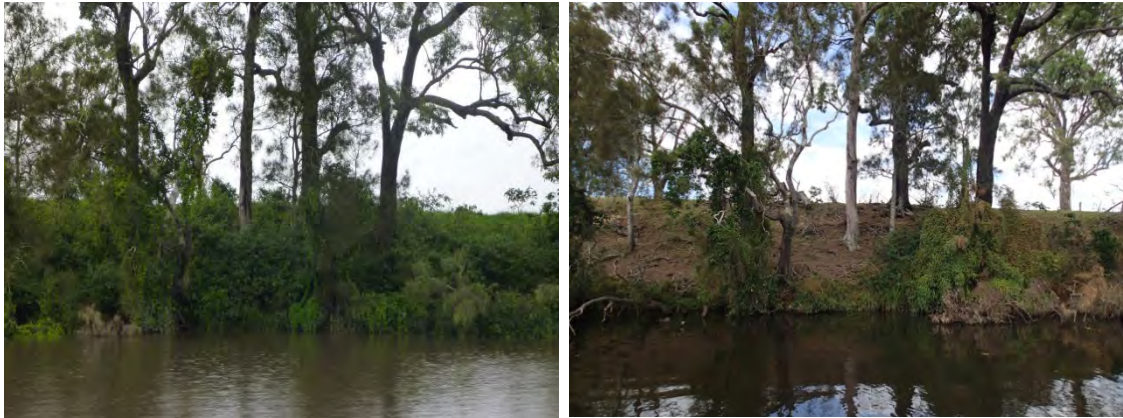
Figure 6-1: Riverbank Conditions Worsened at R04C From 'Mildly Resistant' in 2012 (Left) to 'Highly Erosive' in March 2015 (Right)

Table 6-3 provides a direct comparison between the March 2015 field assessment of the Seaham Weir Pool (Table 6-2) and the adjusted 2012 baseline (Table 6-1). It was evident that riverbank erosion conditions across the study area had generally deteriorated over the assessment period. An example of this is shown in Figure 6-1 where riverbank conditions have significantly worsened at R04C from ‘Mildly Resistant’ in 2012 (left) to ‘Highly Erosive’ in 2015 (right). The DSS results showed an overall 7% increase in ‘Highly Erosive’ sites, with the majority of the sites located in the wakeboarding section of the Seaham Weir Pool, and an overall decrease in ‘Moderately Erosive’ and ‘Mildly Resistant’ sites (by 7% and 4%, respectively). However, it was also evident during the March 2015 field assessment that the riverbank conditions at several

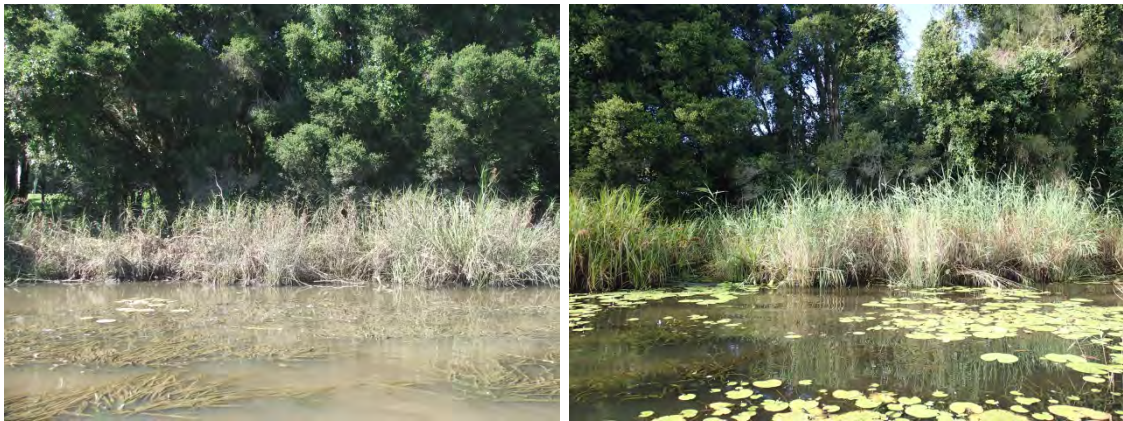
Figure 6-2: Riverbank Conditions Unchanged at L22B From 'Highly Resistant' in 2012 (Left) to 'Highly Resistant' in March 2015 (Right)

sites across the study area were unchanged (Figure 6-2) or had improved (Figure 6-3) since the inaugural 2012 field assessment.

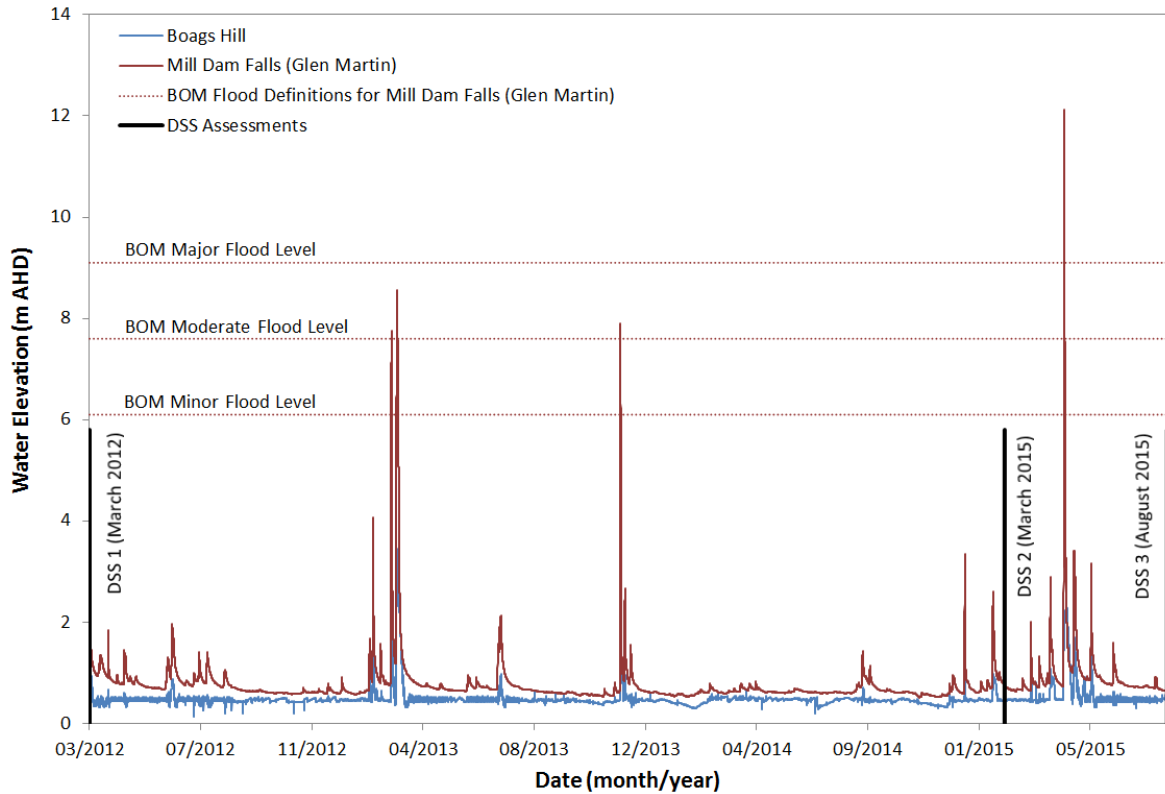
Figure 6-4: Water Levels on the Seaham Weir Pool between 2012 and 2015 DSS Assessments

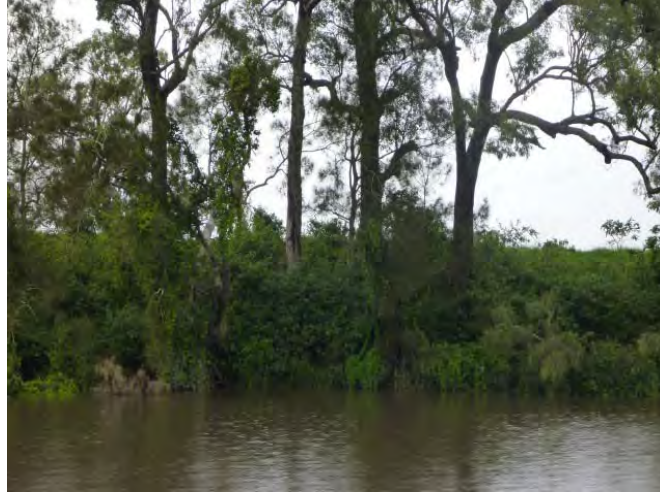
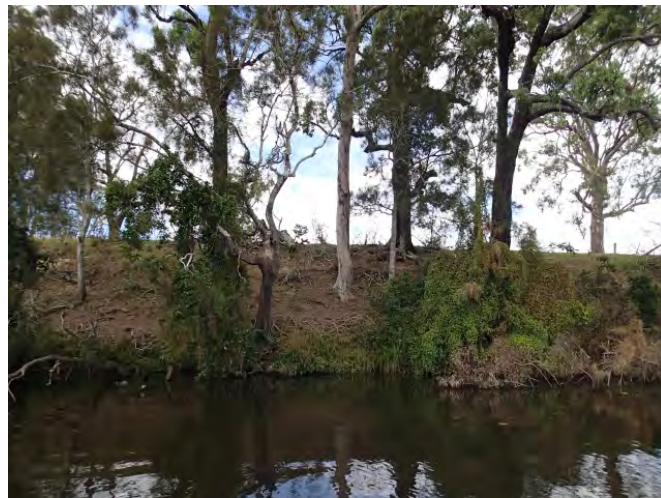
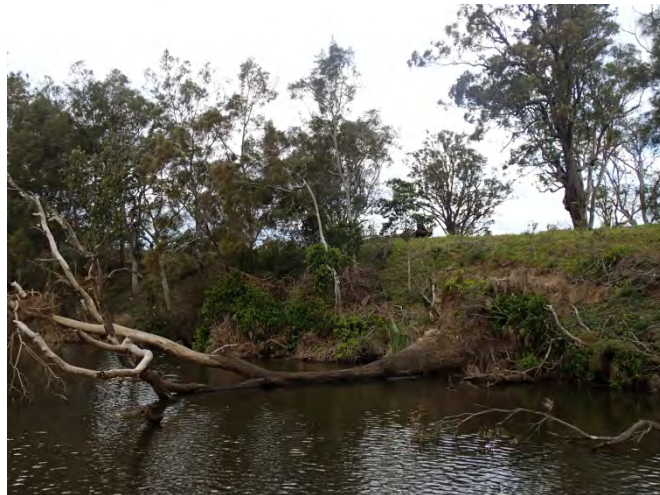
Figure 6-5: Riverbank Conditions Worsened at R04C From 'Mildly Resistant' in 2012 (Top) to 'Highly Erosive' in March 2015 (Middle), and 'Highly Erosive' in August 2015 (Bottom)

Table 6-5 shows that the number of stretches identified as 'Moderately Erosive' or 'Highly Erosive' has increased from 55 occurrences in March 2015 (pre-flood) to 69 occurrences in August 2015 (post-flood), a 16% increase in erosive sites. Furthermore there was a 7% increase in the number of stretches assigned a 'Manage' recommendation. These changes also corresponded to an equivalent reduction in the number of sites identified as resistant to erosion in the March 2015 assessment. No sites in the study area improved between the March 2015 assessment and the August 2015 assessment, except for Stretch R22. Overall, the riverbank conditions are significantly worse compared to the 2012 assessment (Figure 6-8). Due to the

relatively short timeframe between assessments, and the limited boat activity over winter, the increased erosive state of the riverbanks was considered to be a direct result of the flooding that occurred in April 2015. It is worth noting that while the erosion appears to be directly linked to the floods, the vulnerability of the riverbank to erode was likely due to a range of pre-existing factors, as measured in the DSS analysis.

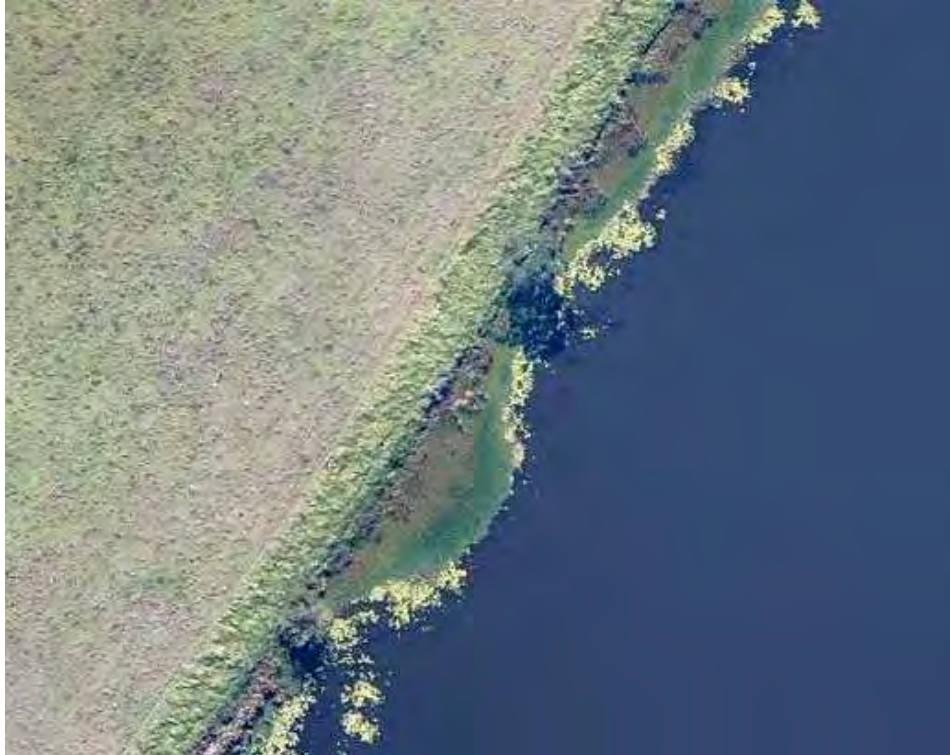
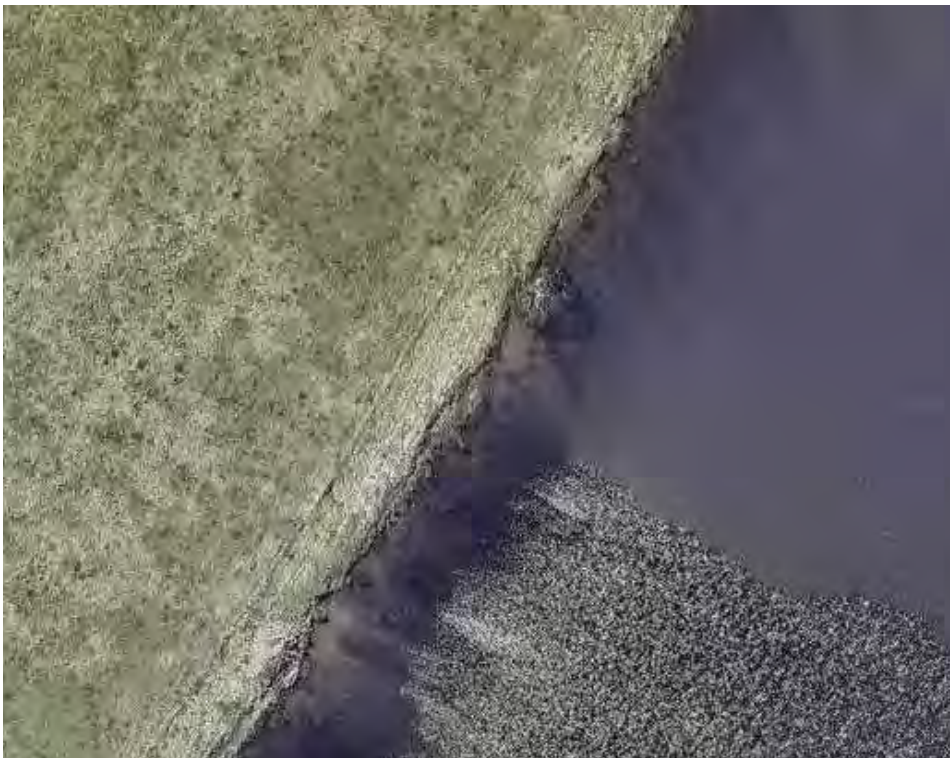
Figure 6-6: Example Loss of Sub-Aquatic Vegetation and Tree Uprooting from April 2015 Flood Event at Stretch R24 - 9 August 2014 (Top) 4 October 2015 (Bottom) (Source: NearMap)

- Loss of sub-aquatic vegetation, reeds, and phragmites in the wave zone (Figure 6-6);
- Reduction in upper riverbank ground-cover vegetation, including exotic weeds and vines;
- Riverbank erosion and slumping; and
- Tree up-rooting.

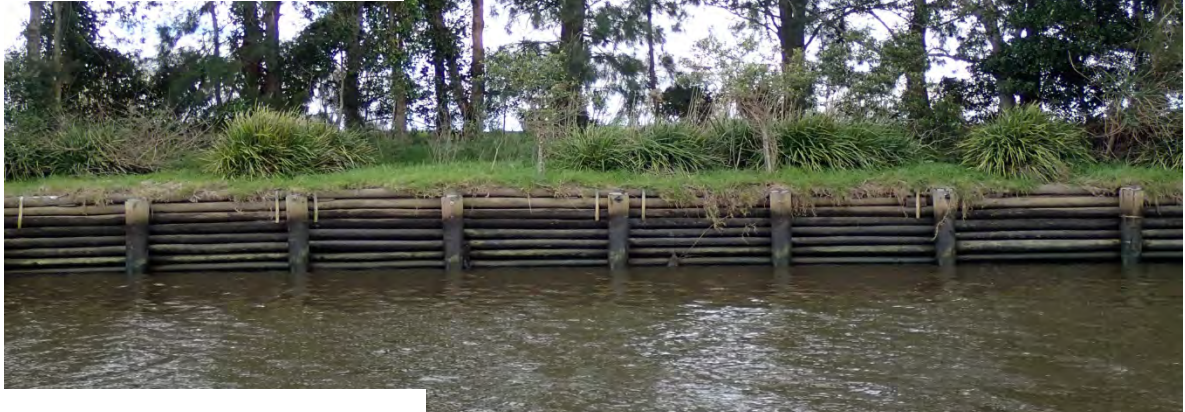
Upper Bank Cover: <10%
 Upper Bank Slope: Near Vertical
 Bank Height: >3 m
 Bank Sediment Type: Armour

Valley Setting: Completely Armoured
 Verge Cover: >60%

Erosion Above Wave Zone: Absent
 Slumping: Absent
 Undercutting: Absent
 Stock Access: Absent

Dominant Wave Zone Cover Type:
 Mid Tide: (<10%) Rock
 High Tide: (<10%) Rock

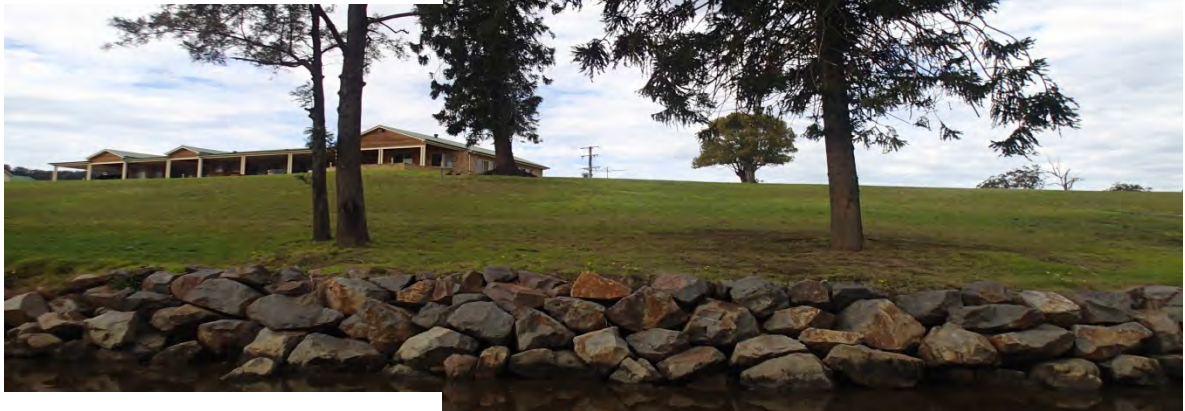
Upper Bank Cover: <10%
 Upper Bank Slope: ~1:3
 Bank Height: 1-3 m
 Bank Sediment Type: Rock

Valley Setting: Completely Armoured
 Verge Cover: <10%

Erosion Above Wave Zone: Absent
 Slumping: Absent
 Undercutting: Absent
 Stock Access: Absent

Dominant Wave Zone Cover Type:
 Mid Tide: (<10%) Rocks
 High Tide: (<10%) Rocks

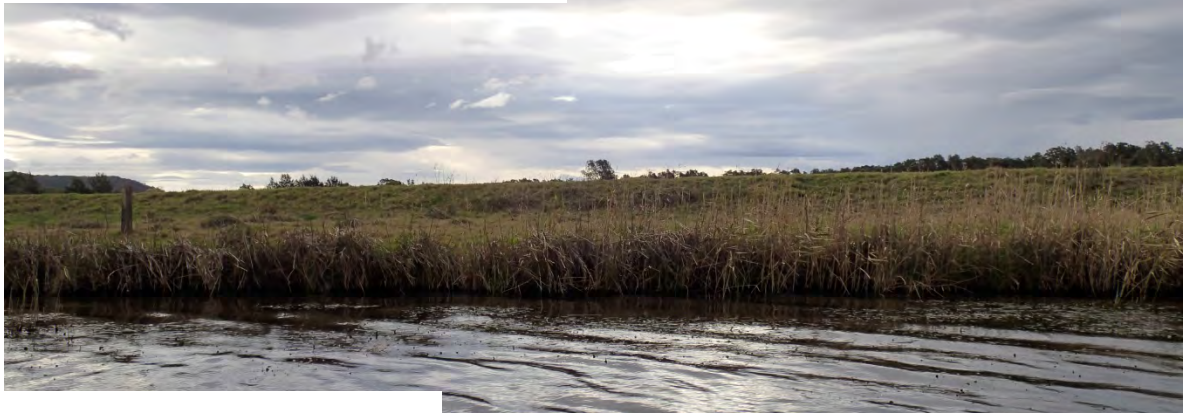
Upper Bank Cover: >60%
Upper Bank Slope: <1:7
Bank Height: 1-3 m
Bank Sediment Type: Complex (Sand and Clay)

Valley Setting: Laterally Unconfined
Verge Cover: <10%

Erosion Above Wave Zone: Absent
Slumping: Absent
Undercutting: Absent
Stock Access: Present

Dominant Wave Zone Cover Type:
Mid Tide: (>60%) Reeds
High Tide: (>60%) Reeds

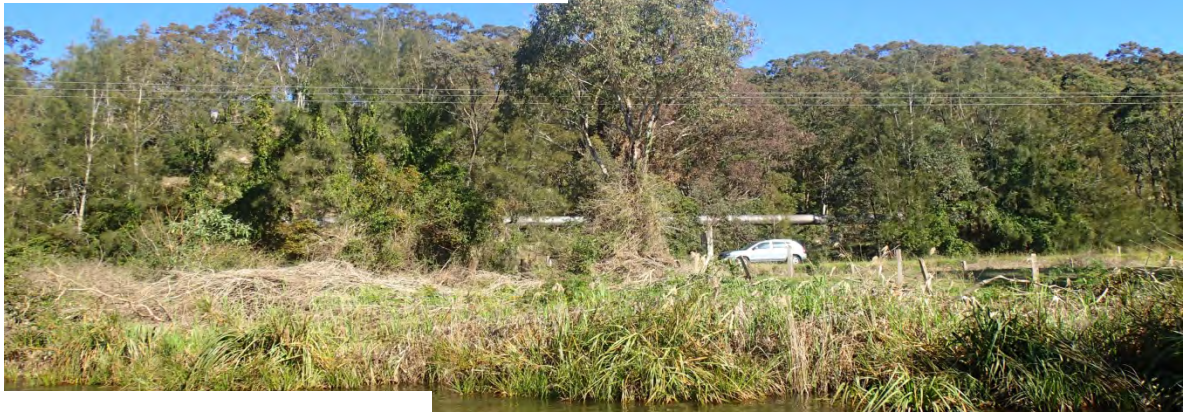
Upper Bank Cover: >60%
Upper Bank Slope: ~1:5
Bank Height: 1-3 m
Bank Sediment Type: Complex (Sand and Clay)

Valley Setting: Laterally Unconfined
Verge Cover: <10%

Erosion Above Wave Zone: Absent
Slumping: Absent
Undercutting: Absent
Stock Access: Absent

Dominant Wave Zone Cover Type:
Mid Tide: (>60%) Reeds
High Tide: (>60%) Reeds

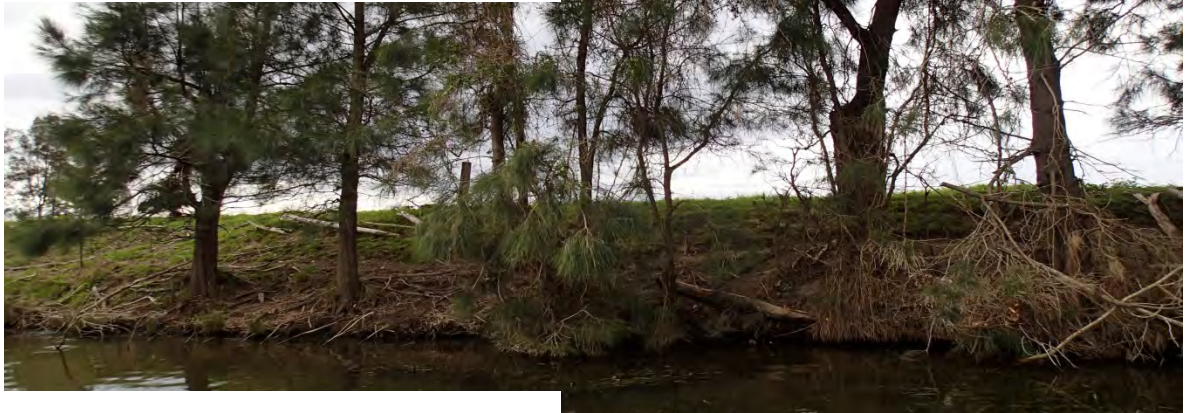
Upper Bank Cover: 31-60%
Upper Bank Slope: ~1:3
Bank Height: 1-3 m
Bank Sediment Type: Complex (Sand and Clay)

Valley Setting: Laterally Unconfined
Verge Cover: <10%

Erosion Above Wave Zone: : >30% of Banks
Slumping: Absent
Undercutting: Absent
Stock Access: Absent

Dominant Wave Zone Cover Type:
Mid Tide: : (<10%) Bare (<1:7 Slope)
High Tide: (>60%) Trees/ Tree Roots

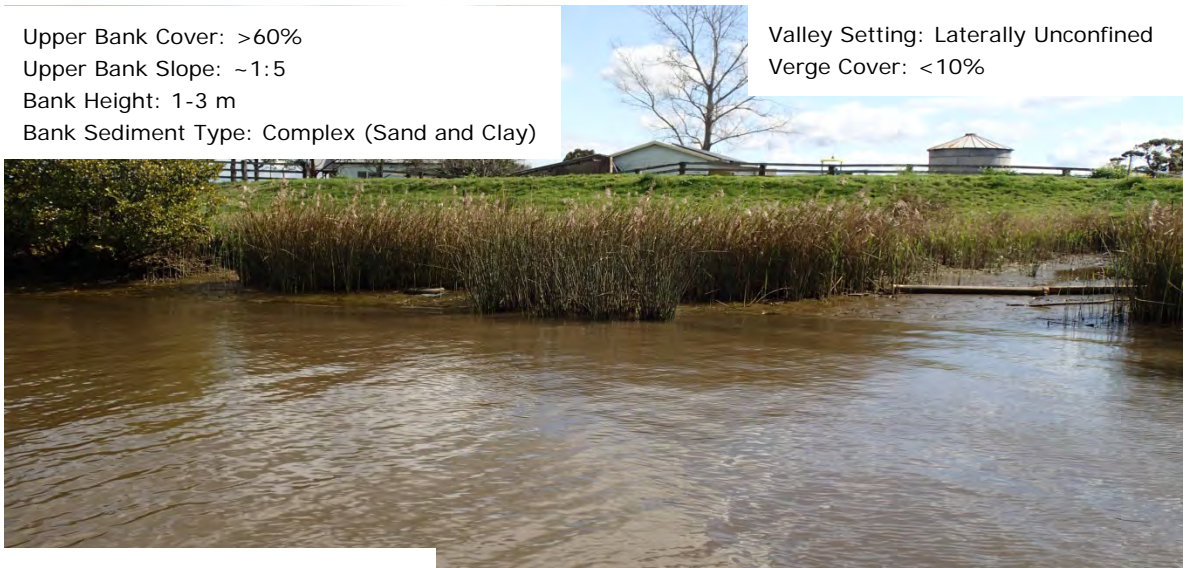
Upper Bank Cover: >60%
Upper Bank Slope: ~1:5
Bank Height: 1-3 m
Bank Sediment Type: Complex (Sand and Clay)

Valley Setting: Laterally Unconfined
Verge Cover: <10%

Erosion Above Wave Zone: Absent
Slumping: Absent
Undercutting: Absent
Stock Access: Absent

Dominant Wave Zone Cover Type:
Mid Tide: (<10%) Bare (1:3 – 1:6 Slope)
High Tide: (31-60%) Reeds

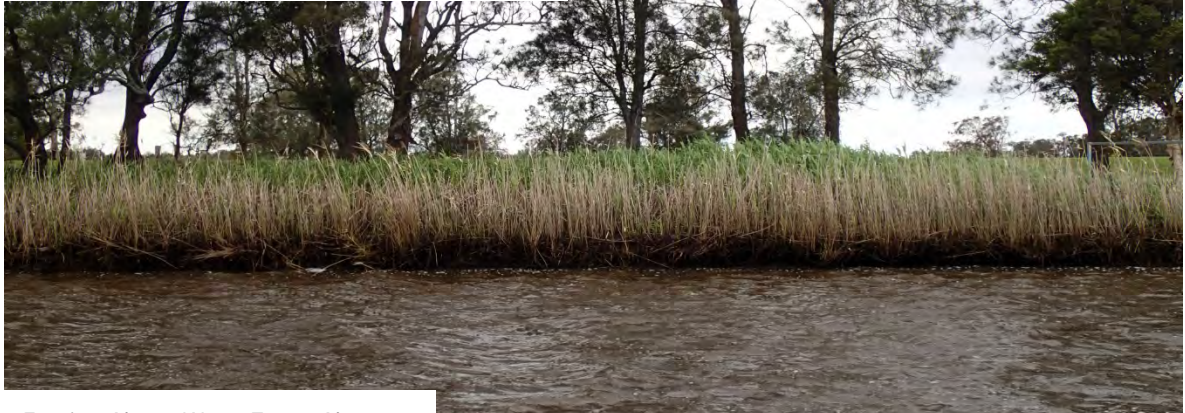
Valley Setting: Laterally Unconfined
Verge Cover: 31-60%

Erosion Above Wave Zone: Absent
Slumping: Absent
Undercutting: >30% Banks
Stock Access: Absent

Dominant Wave Zone Cover Type:
Mid Tide: (<10%) Bare (Vertical)
High Tide: (>60%) Reeds

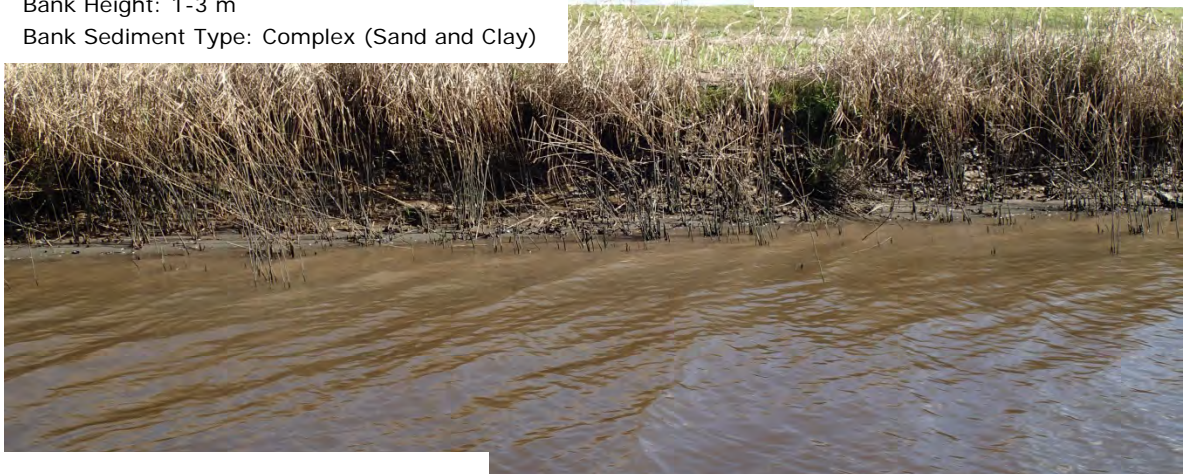
Valley Setting: Partially Armoured
Verge Cover: <10%

Erosion Above Wave Zone: >30% Banks
Slumping: Absent
Undercutting: Absent
Stock Access: Present

Dominant Wave Zone Cover Type:
Mid Tide: (<10%) Bare (Vertical)
High Tide: (10-30%) Reeds

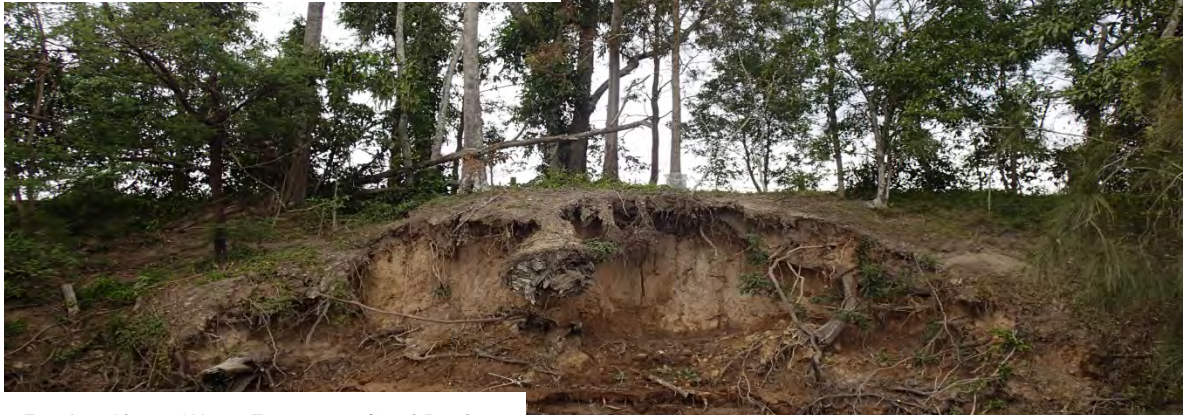
Upper Bank Cover: >60%
Upper Bank Slope: Near Vertical
Bank Height: >3 m
Bank Sediment Type: Complex (Sand and Clay)

Valley Setting: Laterally Unconfined
Verge Cover: 31-60%

Erosion Above Wave Zone: >30% of Banks
Slumping: Absent
Undercutting: Absent
Stock Access: Present

Dominant Wave Zone Cover Type:
Mid Tide: (<10%) Bare (Vertical)
High Tide: (<10%) Bare (Vertical)

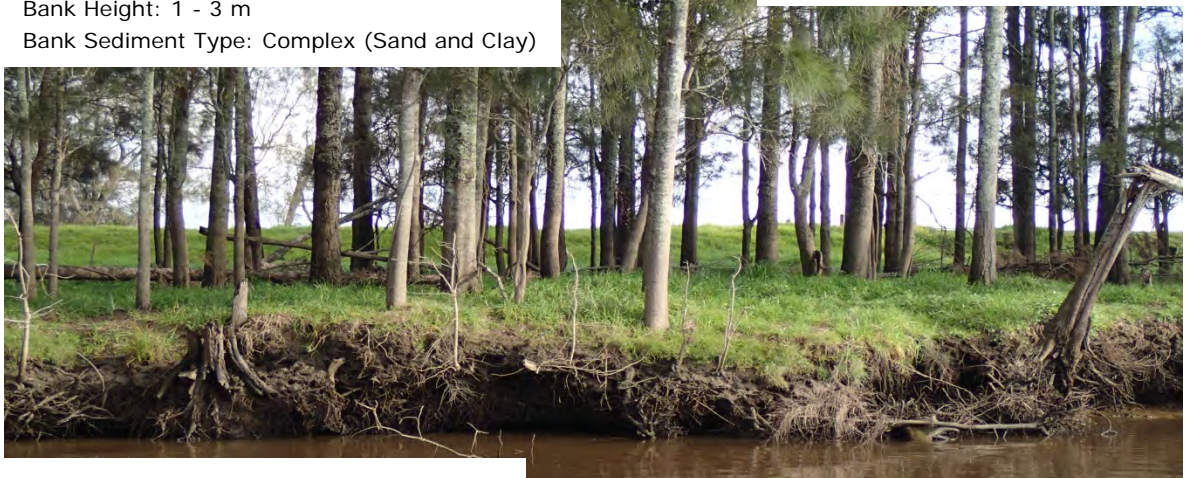
Upper Bank Cover: <10%
Upper Bank Slope: Near Vertical
Bank Height: 1 - 3 m
Bank Sediment Type: Complex (Sand and Clay)

Valley Setting: Laterally Unconfined
Verge Cover: >60%

Erosion Above Wave Zone: >30% of Banks
Slumping: Absent
Undercutting: >30% of Banks
Stock Access: Present

Dominant Wave Zone Cover Type:
Mid Tide: (<10%) Bare (Vertical Slope)
High Tide: (>60%) Trees/Tree Roots

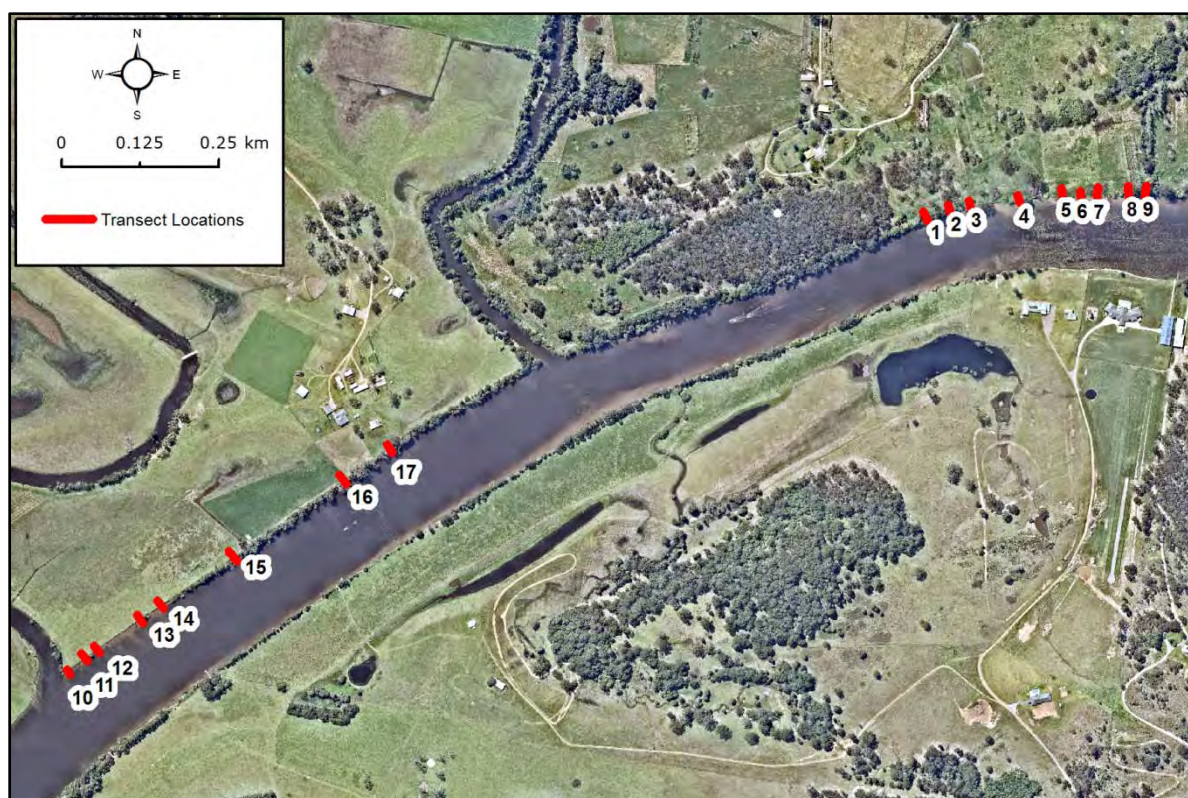
Figure R-1: Riverbank Monitoring Locations

All profiles are located on the right bank of the Seaham Weir Pool (Figure R-1). Sites 1-9 cover a distance of approximately 400 m directly opposite a rock armoured section on the left bank. Sites 10-17 are located further downstream and cover a distance of approximately 700 m between two creek confluences.

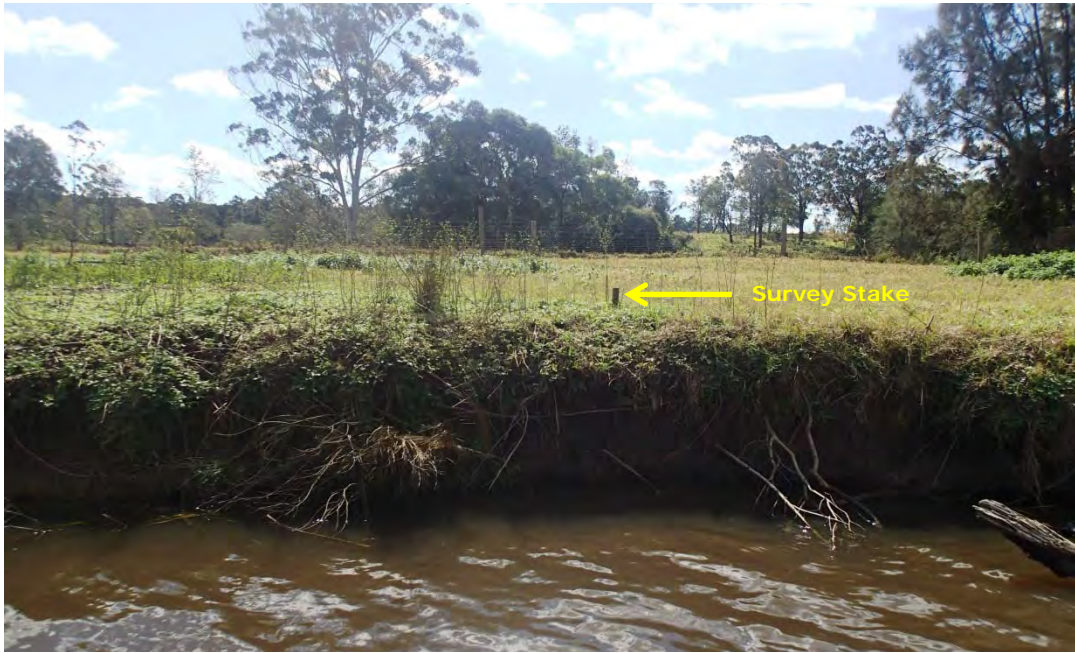
Figure R-2 : DLCS Monitoring Site 4 (August 2015)

Photos of a selection of the monitoring sites (including the survey stakes at the top of the riverbank) taken by WRL staff in August 2015 are provided in Figure R-2 (Site 4), Figure R-3 (Site 7), Figure R-4 (Site 8) and Figure R-5 (Site 9).
