## 3D Physical Modelling of Coffs Harbour Northern Breakwater Upgrade

WRL Technical Report 2015/05  
May 2015

Water Research Laboratory  
UNSW Australia  
School of Civil and Environmental Engineering

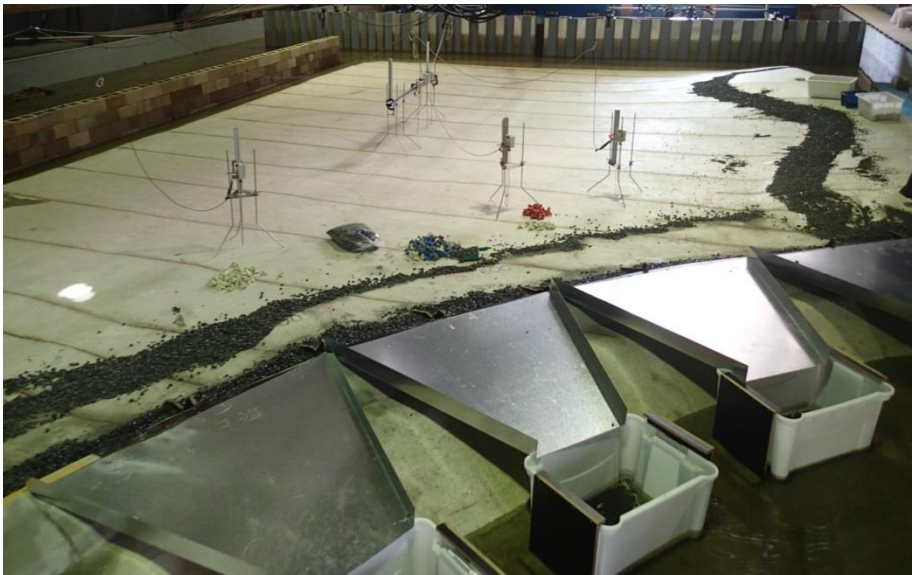
**Figure 4.2: Bathymetry Construction (2/2)**

**b) Overview of Existing Breakwater Core and of Muttonbird Island Shoreline with Increased Roughness**

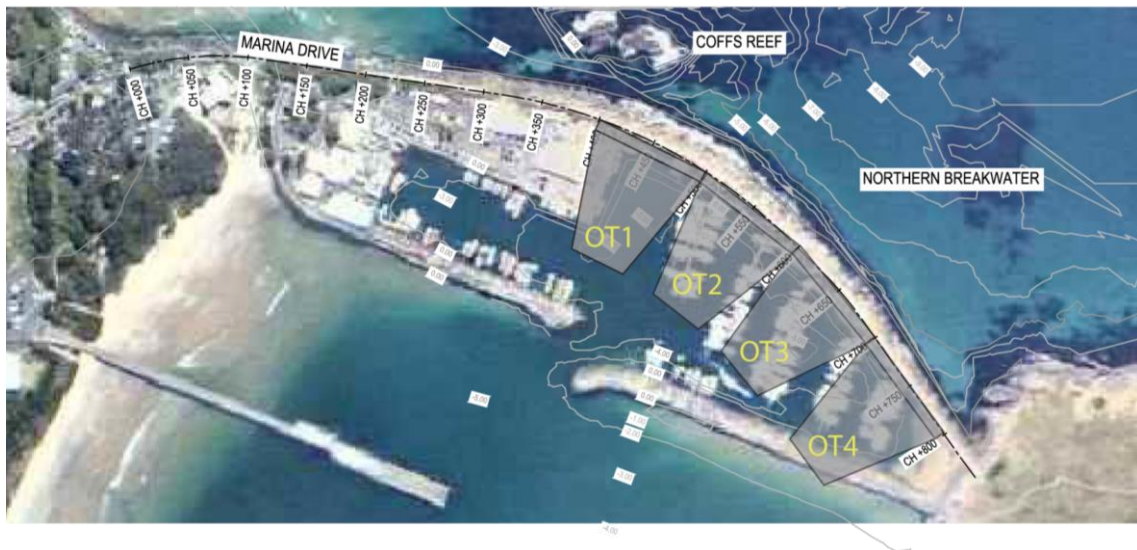
**Figure 4.7: Overtopping Measurement Locations**

Average overtopping rates were measured using four (4) volumetric catch trays installed leeward of the breakwater crest, so that the total volume of overtopping water was captured and then averaged over the test duration. The 400 m long modelled section of the northern breakwater was therefore divided in four distinct 100 m long sections over which individual average overtopping rates were measured during testing. This allowed for more detailed understanding of the overtopping patterns and differences along the breakwater. The four overtopping catch trays were mounted flush with the crest of the breakwater such that it captured all overtopping flows, as shown on Figure 4.7.

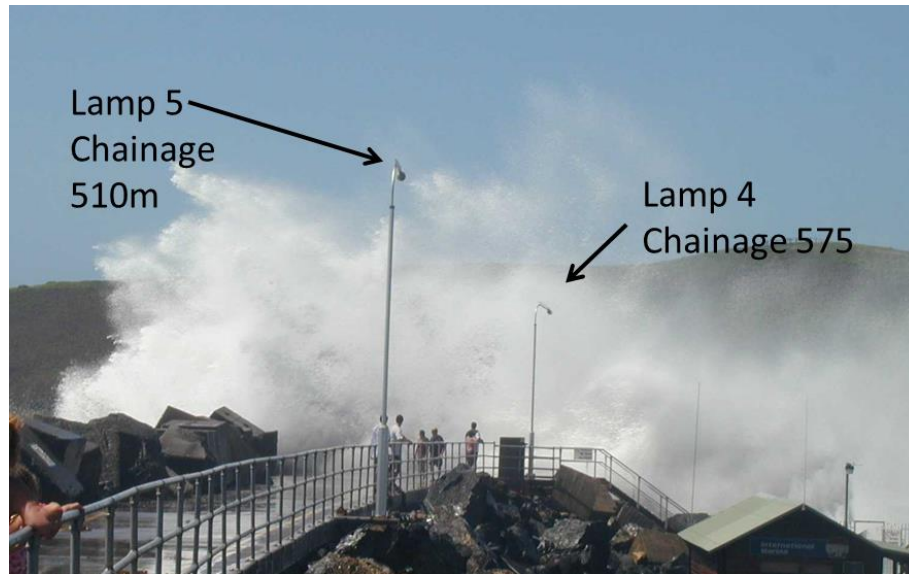
**Figure 6.2: Observed Wave Overtopping Conditions during the 2004 Event**

**a) Overtopping Spray from Ch. 600 m to Ch. 700 m**

**b) Example of Vertical Overtopping Spray around Ch. 550 m**

qualitative comparison with the overtopping processes observed in the model. Further analysis of these pictures (Figure 6.2) showed that most of the overtopping consisted of large spray (white water) over the breakwater crest between chainage 500 m and 700 m, which can be seen to have reached heights of up to 6 m.

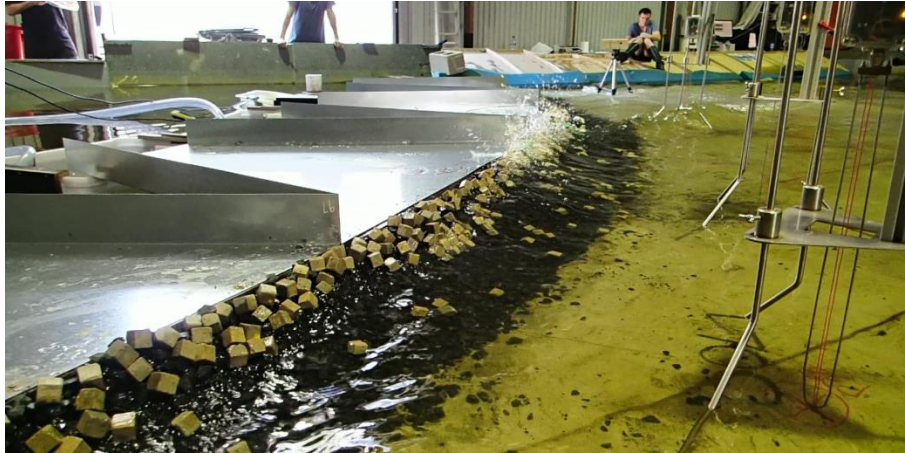
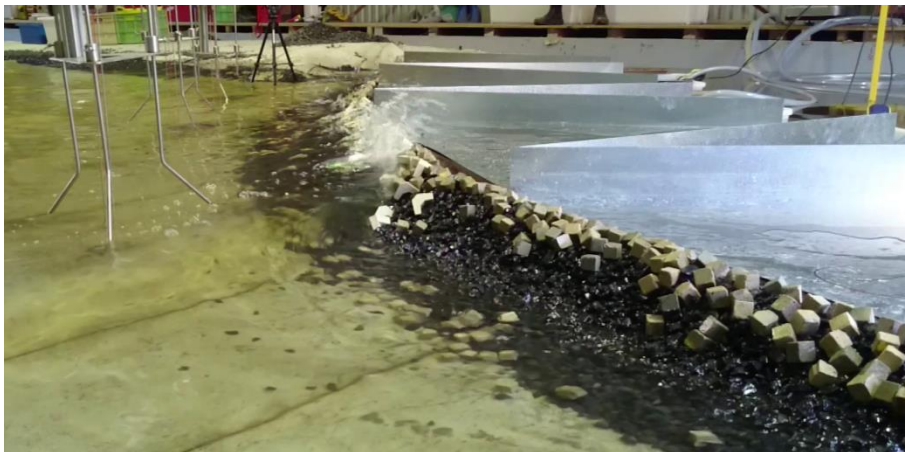
**Figure 6.3: Observed Wave Overtopping Conditions for the 2004 Event Model Test**

The peak wave/water level conditions for the March 2004 storm event were reproduced in the physical model, with observations of the overtopping recorded. Observed overtopping in the model mainly consisted in vertical spray over the crest across overtopping trays OT 2 (ch. 500 m – ch. 600 m) and OT 3 (ch. 600 m – ch. 700 m). On a very limited number of instances (less than 10 occurrences over a 2 hour prototype scale test duration), large breaking waves were observed to result in a small amounts of green water being projected in the overtopping catch trays, predominantly around ch. 600 m. Very limited overtopping of the structure could be

observed across catch trays OT 1 (ch. 400 m – ch. 500 m) and OT 4 (ch. 700 m – ch. 800 m), and consisted only of vertical spray, due to the absence of wind in the modelling.

**a) Overtopping Spray from Ch. 575 m to Ch. 625 m**

**b) Example of Overtopping around Ch. 550 m**

The qualitative overtopping observations in the physical model test were considered to be relatively consistent with the photographs taken of the real world breakwater during the storm event. The quantitative results of overtopping assessment for the 2004 historical event are illustrated in Table 6.2. Based on the published tolerable rates (USACE, 2006; EurOtop, 2007), the measured average overtopping rates during this test would be classified as a potential hazard to pedestrians but not to the structure, which is also considered to be consistent with the level of overtopping observed at the site during the storm event.

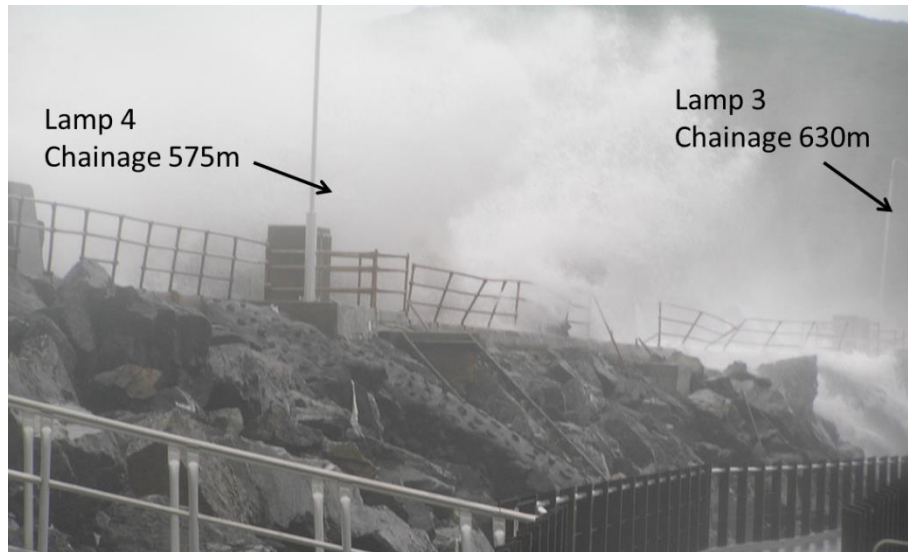
Figure 6.4: Observed Wave Overtopping Conditions for the 2009 Event

**a) Overtopping Spray from Ch. 575 m to Ch. 700 m**

b) Example of Green-Water Overtopping around Ch. 600 m

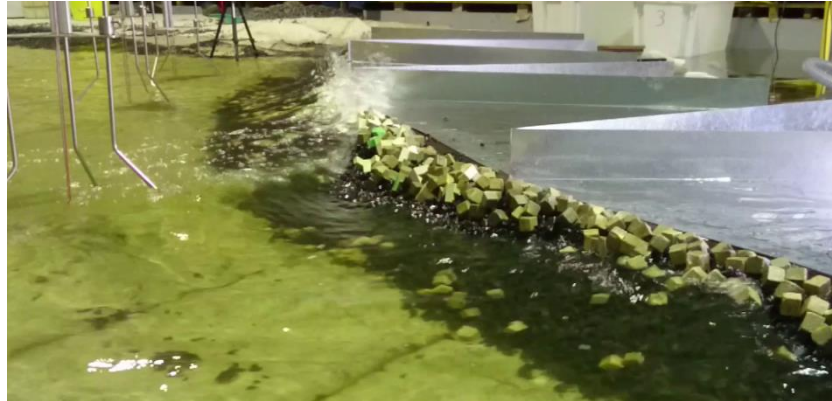
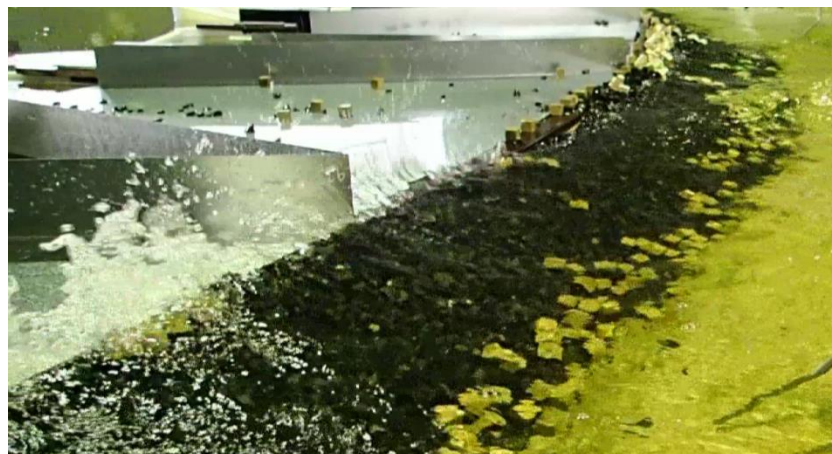
**Figure 6.7: Observed Wave Overtopping Conditions for the 2009 Event Model Test**

**a) Simultaneous Green-Water Overtopping from Ch. 550 m to Ch. 600 m**

**c) Overtopping Sequence from Ch. 650 m to Ch. 750 m with Displaced Concrete Cubes**

Approximately 12 concrete cubes as well as secondary armour rocks were observed to be displaced by overtopping wave bores and carried over the crest of the breakwater. It can be seen from the overtopping assessment results provided in Table 6.3 that the breakwater was significantly overtopped throughout the duration of the test. The central and southern sections (i.e. ch. 500 m to ch. 800 m) were subject to average overtopping rates that largely exceeded what would be classified as a hazard to pedestrians (>10 L/s/m), with the section around ch. 650 m reaching values typically associated with potential structural damage to the structure itself and sinking yachts located in the lee of the breakwater.

As expected, the observed overtopping during model testing was significantly larger and more frequent than observed for the 2004 test event. As an indication, the breakwater crest along

overtopping catch tray OT 2 (ch. 500 m – ch. 600 m) was overtopped nearly 200 times while OT 4 (ch. 700 m – ch. 800 m) was overtopped more than 50 times during the two hour (prototype scale) duration of the test. Overtopping in the model could mostly be characterised as green-water, with several stretches of breakwater crest submerged simultaneously (about 100 m stretches).

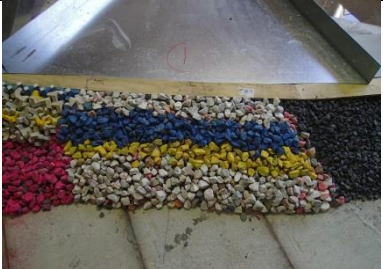
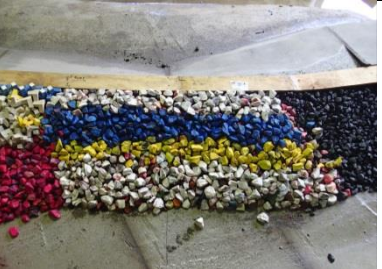
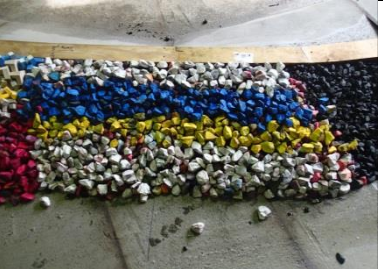
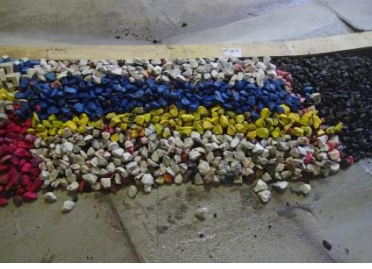
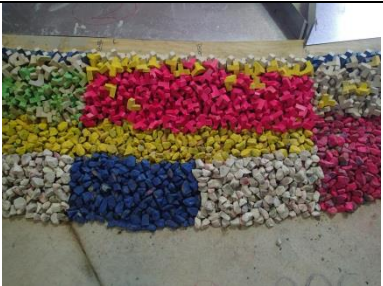
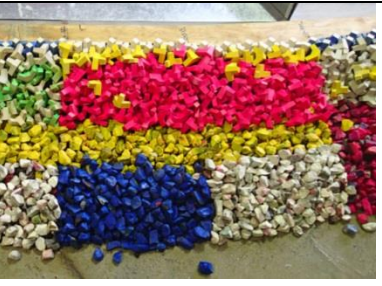
Figure 7.3: Upgrade 8a Cumulative Damage Assessment (1/3)

Chainage (m)	"As-Built"	After 10 year ARI HAT	After 100 year ARI HAT SLR	After 100 year ARI MSL
425-475

A brief summary of the nature and extent of the observed damage during each of the consecutive armour stability tests is presented in Sections 7.2.2 to 7.2.4. The cumulative damage to the primary armour, crest containment units and rock toe berm is presented in Table 7.1 for each armour stability test. Photographs of the model “as built” and after each tests are presented in Figure 7.3, Figure 7.4 and Figure 7.5. 2D laser profiles of the model breakwater “as built” and after each test are presented in Appendix A in order to provide additional information on the evolution of the rock berm.

For the 10 year ARI event with a 1.2 m AHD water level (HAT), only small persistent rocking motions for less than 2% of the 12 t Hanbars on seaward slope were observed. A total of four 12 t Hanbar units were observed to be displaced and move down the front face onto the rock berm, amounting for 0.4% of the total number of 12 t units. No rocking or displacement of the modified 20 t Hanbars located near the crest was observed throughout the test. There was also negligible damage to the 5-8 tonne rock berm, with the majority of the displaced rocks coming from the upper part of the front slope.

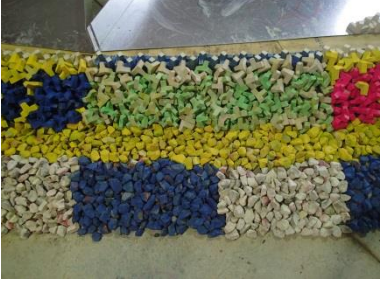
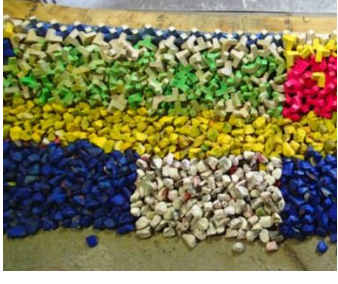
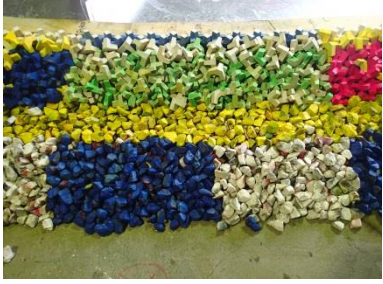
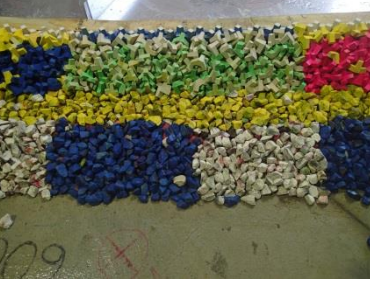
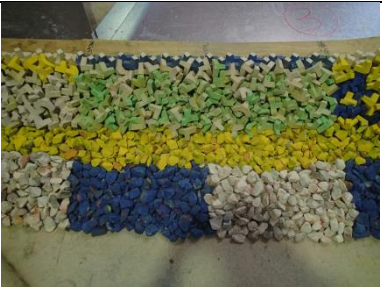
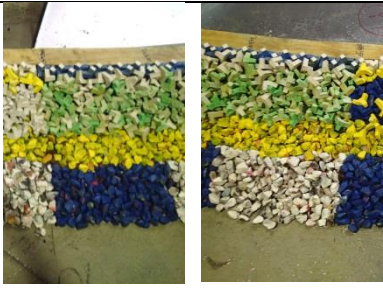
Figure 7.4: Upgrade 8a Cumulative Damage Assessment (2/3)

Chainage (m)	"As-Built"	After 10 year ARI HAT	After 100 year ARI HAT SLR	After 100 year ARI MSL
550-600

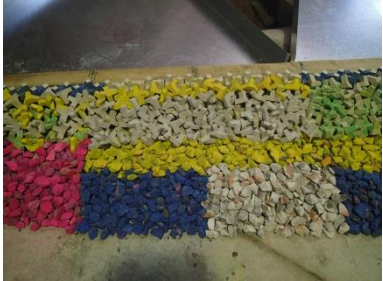
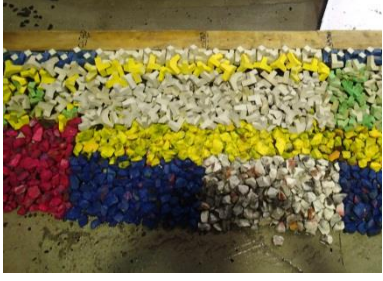
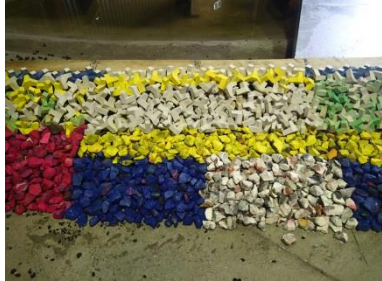
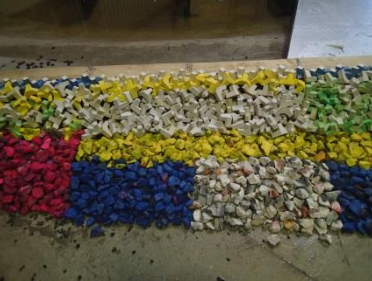
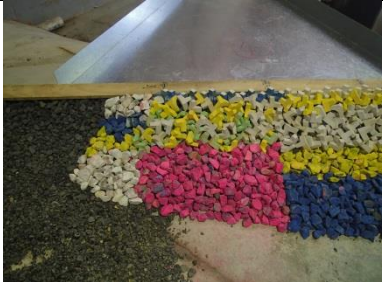
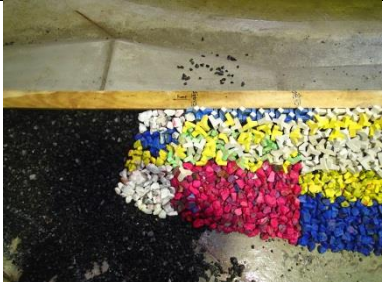
Figure 7.5: Upgrade 8a Cumulative Damage Assessment (3/3)

Chainage (m)	"As-Built"	After 10 year ARI HAT	After 100 year ARI HAT SLR	After 100 year ARI MSL
700-750

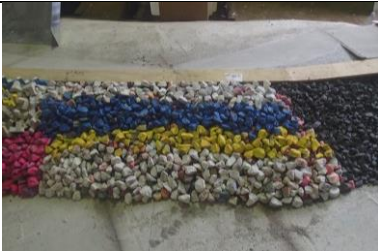
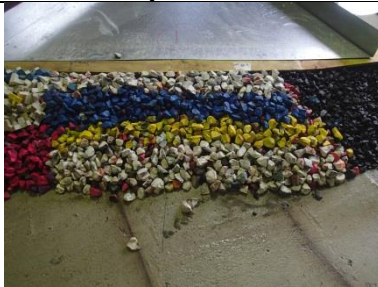
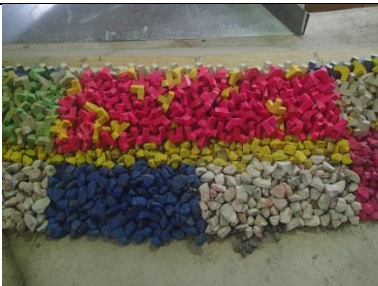
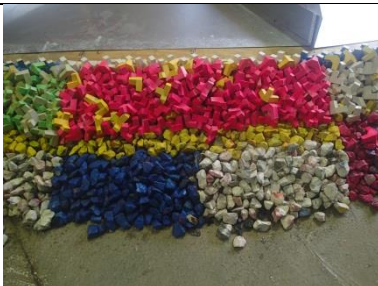
Figure 7.7: Upgrade 8b Cumulative Damage Assessment (1/3)

Chainage (m)	"As-built"	After 10 year ARI HAT	After 100 year ARI HAT SLR
425-475

A brief summary of the nature and extent of the observed damage during each of the consecutive armour stability tests is presented in Sections 7.3.2 and 7.3.3. The cumulative damage to the primary armour, crest containment units and reduced rock toe berm is presented in Table 7.2 for each armour stability test. Photographs of the model “as built” and after each test are presented in Figure 7.7, Figure 7.8 and Figure 7.9. 2D laser profiles of the model “as built” and after each test are presented in Appendix B in order to provide additional information on the evolution of the rock berm.

For the 10 year ARI event with a 1.2 m AHD water level (HAT), only small persistent rocking motions for 1% of the 12 t Hanbars on seaward slope were observed. A total of six 12 t Hanbar units were observed to be displaced and moved down the front face onto the rock berm. This is more than the four 12 t Hanbar units displaced for Option 8a and amounts to 0.6% of the total number of 12 t Hanbar units. No rocking or displacement of the modified 20 t Hanbars located near the crest could be observed throughout the test. While damage to the reduced 5-8 tonne rock berm could still be considered negligible, waves were observed to be more frequently breaking directly on the two lower rows of 12 t Hanbar units. Damage to the rock berm was observed to occur more readily, and was thought to be the result of more of a sucking action of the waves breaking on the rock armour over the flat part of the berm, compared to Option 8.

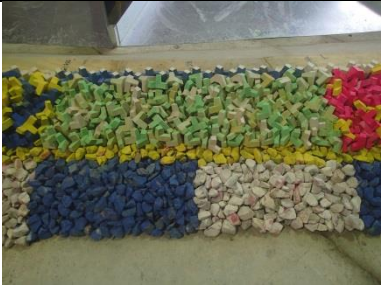
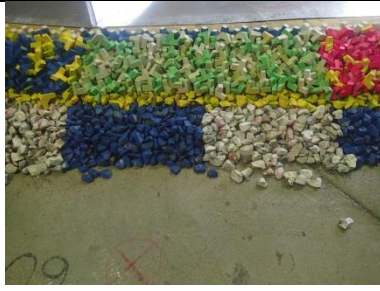
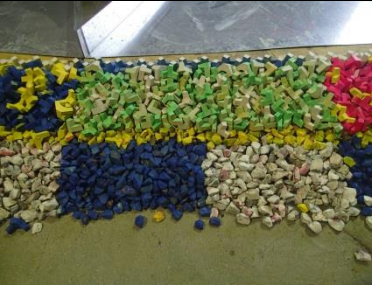
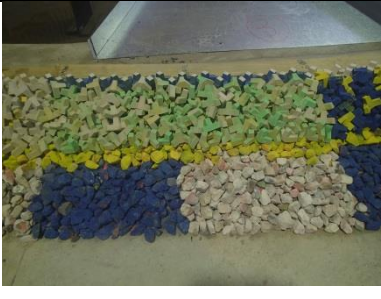
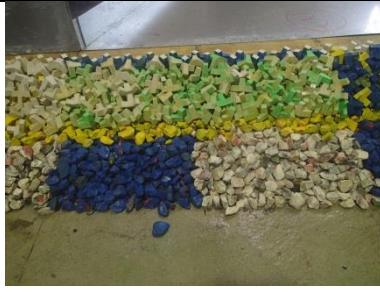
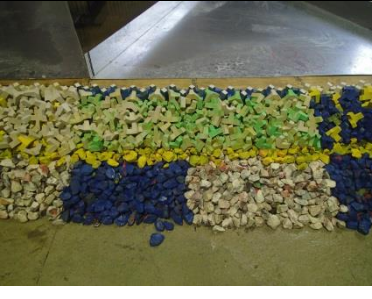
**Figure 7.8: Upgrade 8b Cumulative Damage Assessment (2/3)**

Chainage (m)	"As-built"	After 10 year ARI HAT	After 100 year ARI HAT SLR
550-600

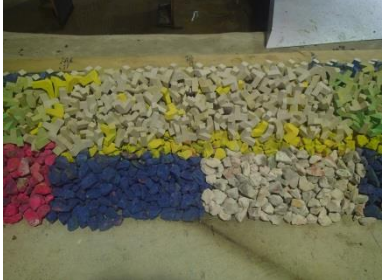
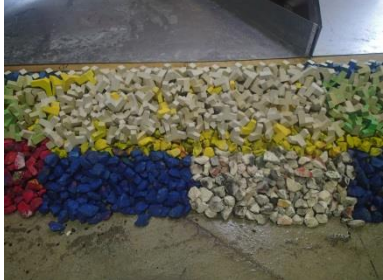
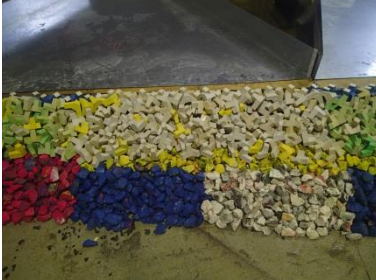
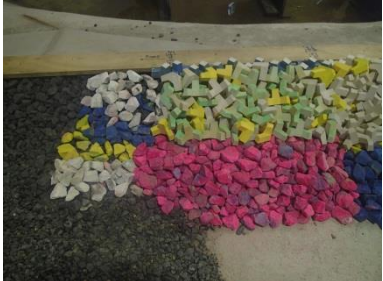
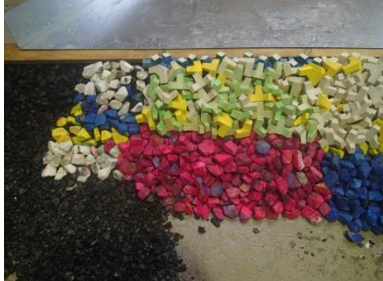
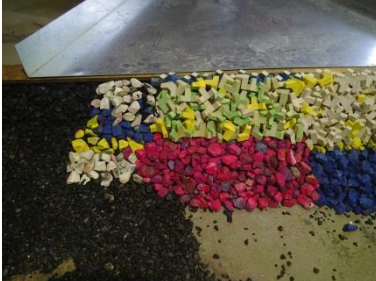
**Figure 7.9: Upgrade 8b Cumulative Damage Assessment (3/3)**

Chainage (m)	"As-built"	After 10 year ARI HAT	After 100 year ARI HAT SLR
700-750
