Woodberry Swamp Hydrologic Study

WRL Technical Report 2016/03

November 2016

By D S Rayner, W C Glamore and J E Ruprecht

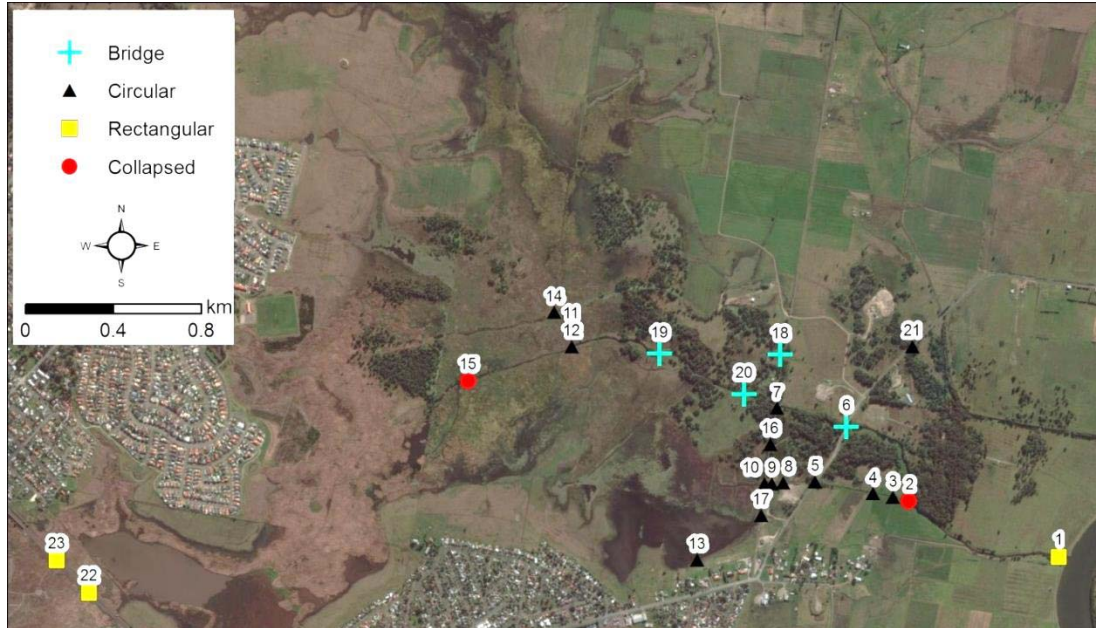
Figure 3.2: Key structure location and type (Background image: ESRI)

Table 3.1: Key hydraulic structures

Channel geometry and hydraulic control structures (Figure 3.1, Figure 3.2 and Table 3.1) were used to represent the 1-D channel network. Where channel survey data was unavailable, geometry was interpolated or extrapolated from the nearest survey data.

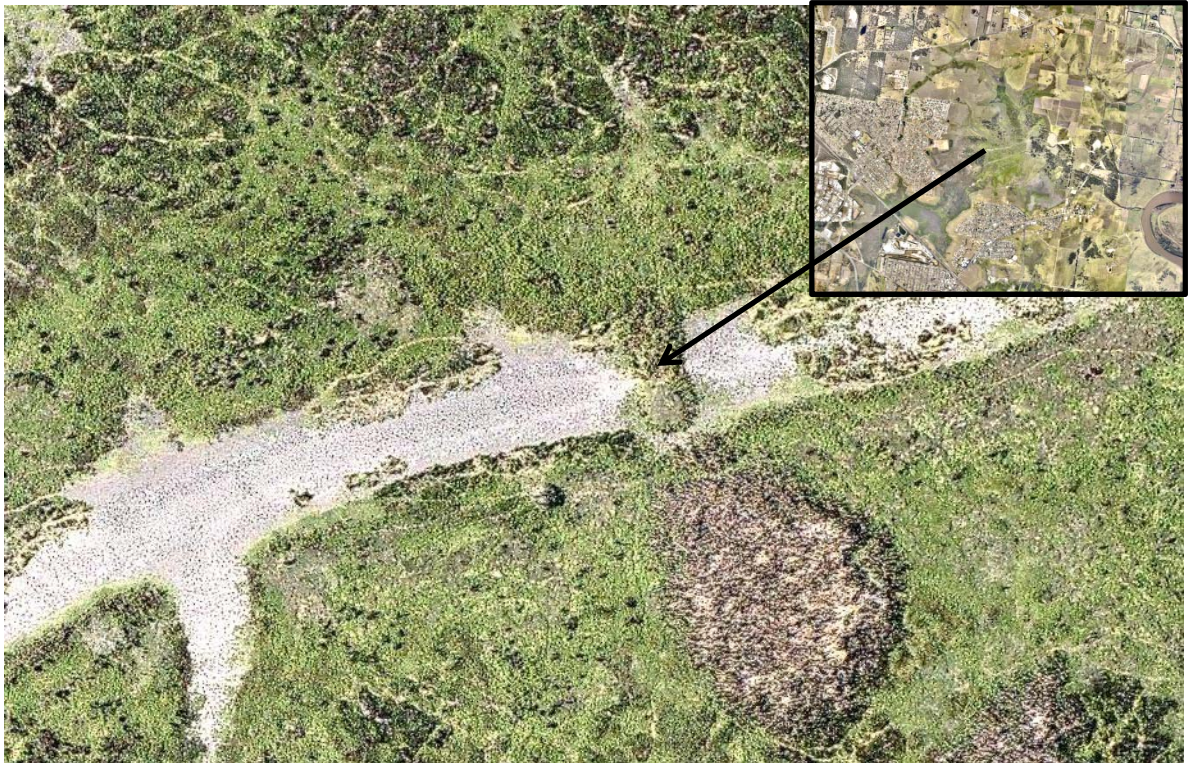
Figure 3.5: Collapsed culvert in the middle of the floodplain (Background image: Near Map)

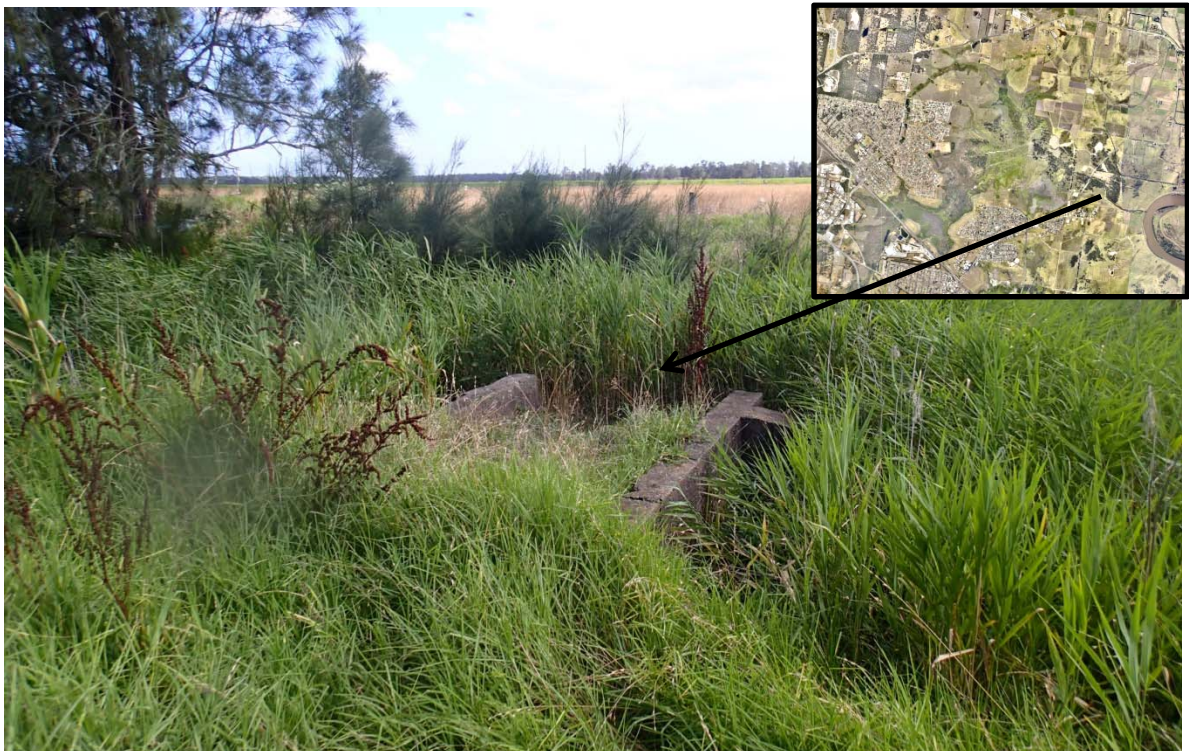
Figure 3.6: Collapsed culvert on side drainage channel, downstream of Woodberry Road

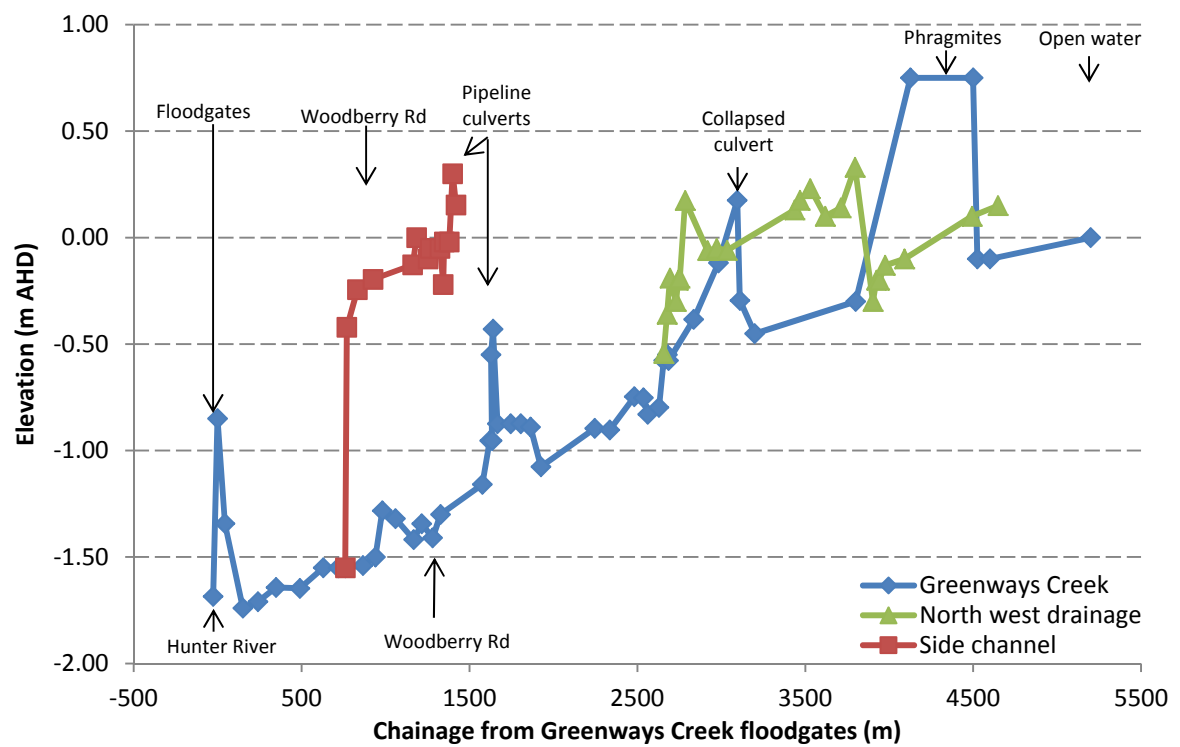
Figure 3.8: Long-section of drainage channel thalweg (minimum elevation) with distance from floodgates at Hunter River

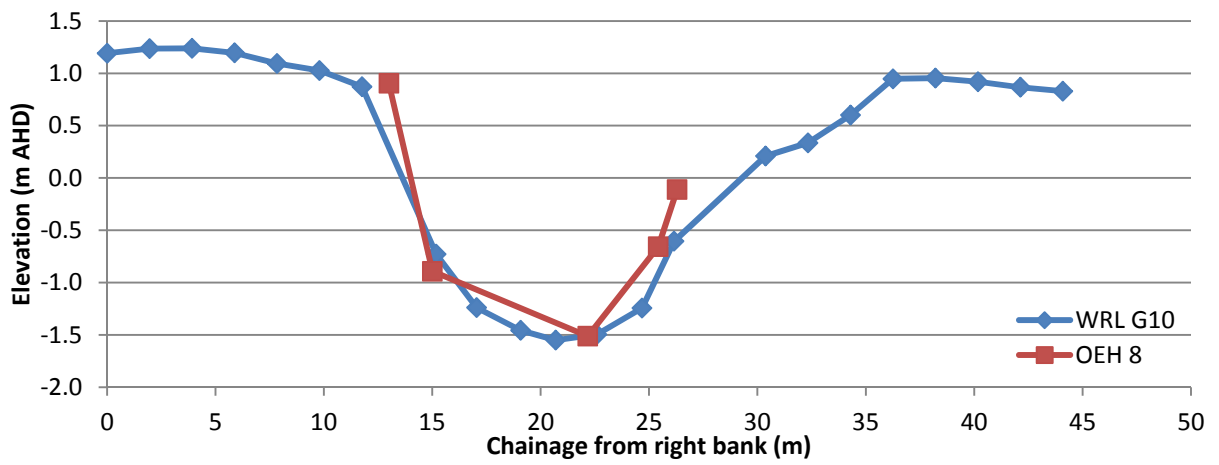
Figure 3.11: Example comparison of Greenways Creek - cross-section G10

The cross-section profiles vary slightly due to changes in vegetation and sedimentation, however the general shape and overall invert indicate that infilling from sedimentation is not an issue within lower reaches of Greenways Creek. It is likely that during flood events some sediment from catchment runoff is stored on the floodplain and in the floodplain drainage network. The remainder is likely discharged into the Hunter River.

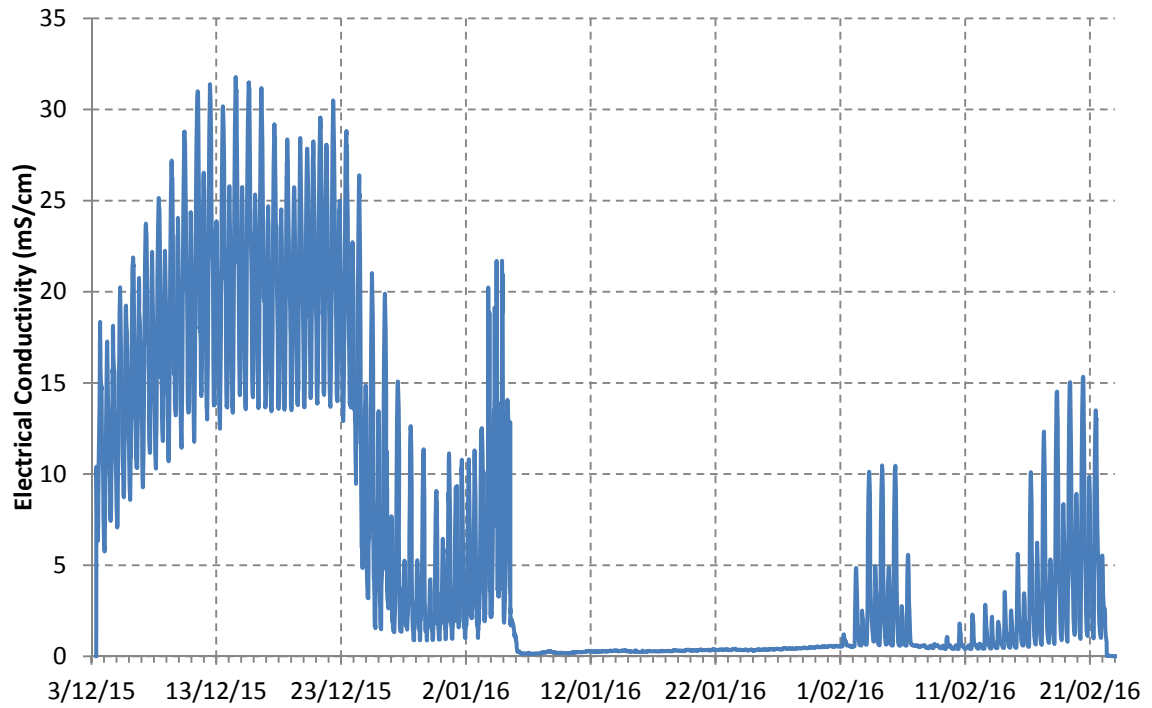
Figure 3.16: Hunter River (Location 1) electrical conductivity (ocean EC ~ 55 mS/cm)

Water levels in the main Hunter River (logger Location 1) were observed to peak after water levels in the upstream areas of Woodberry Swamp peaked (logger Location 4). Peak river levels did not exceed the elevation of the levee bank adjacent to the Greenways Creek floodgates. Hunter River water levels were observed to return to regular tidal levels by 14th January. Salinity in the river was also observed to be flushed from the receiving water due to the rainfall event (Figure 3.16). Salinity was not observed to return until February.

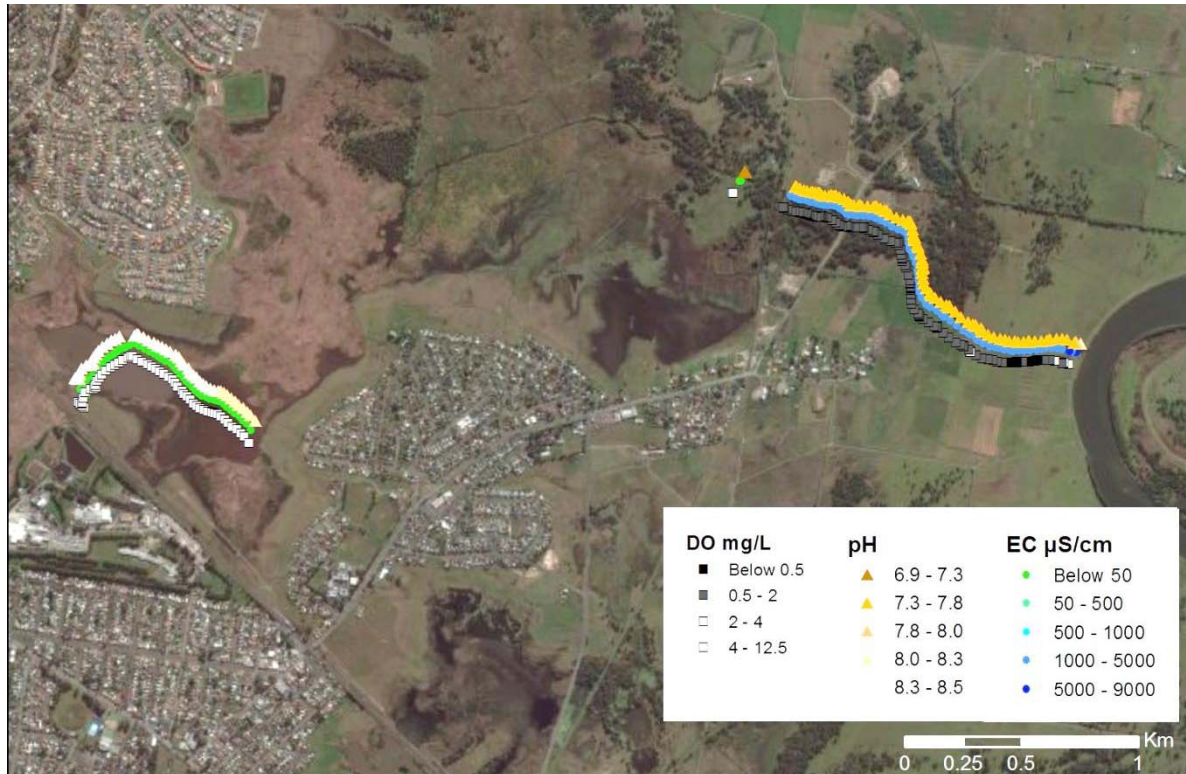
Figure 3.18: Water quality during field investigation (3rd Dec 2015) (Background image: ESRI)

Water quality during the field investigation for this study on 3rd December 2015 was measured using a YSI EXO2 multi-parameter water quality sonde (Figure 3.18). Acidity was observed to be near neutral pH. Electrical conductivity (i.e. salinity) was generally fresh, with higher conductivity measured near the floodgates. Dissolved oxygen (DO) was measured to be low at the downstream extent of Greenways Creek with DO concentrations below 2 mg/L, the concentration at which water becomes hypoxic to fish. DO concentrations in the open water backswamp areas were measured to be higher. Regular flushing of Greenways Creek would result in improved water quality including higher dissolved oxygen concentration, and connectively to the wider Hunter River estuary would benefit fisheries.

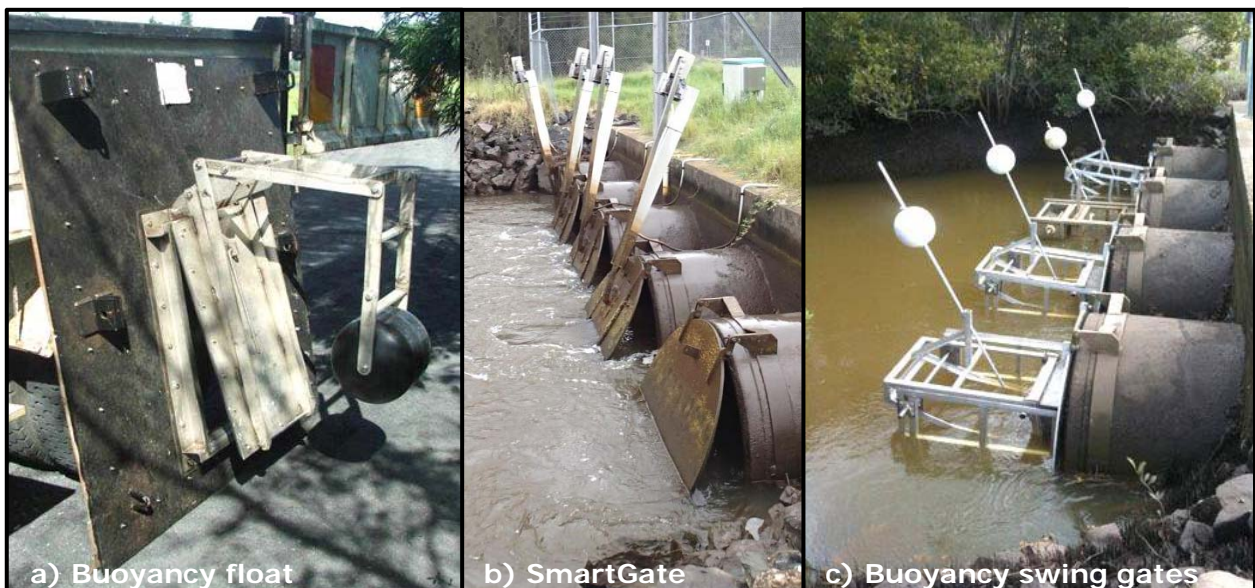
Figure 8.1: Different modified auto-tidal floodgate designs

A key concern with re-introducing tidal flushing is the potential impact on existing land use practices. The floodgates at Greenways Creek were initially constructed to limit tidal intrusion into the low-lying areas of Woodberry Swamp. Subsequently, any tidal flushing regime must consider existing land use practices. Flushing is achieved by modification of the steel floodgate with a hole cut in the middle. A hinged flap is installed to close the orifice and limit flushing at a specified elevation to protect upstream assets. A number of common modified floodgate designs are shown in Figure 8.1.

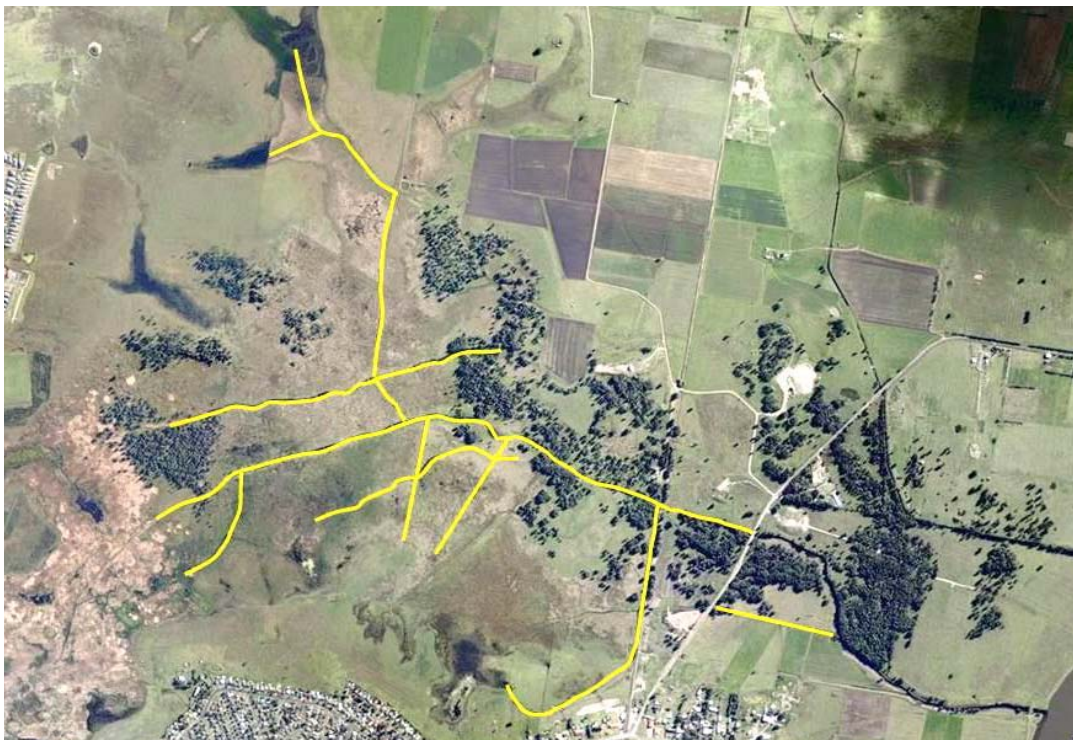
Figure 8.2: Identified drainage channels with significant in-drain vegetation

Based on an excavator cost of approximately \$3,500 per 500 m, mechanical cleaning of the drains presented in Figure 8.2 would cost approximately \$60,000. Note that excavation of sediment for channel deepening or widening would increase costs and require further assessment and approval. Weed treatment of the excavated sediments may also be required. A cost-benefit analysis of the resources required, considered against the benefits to affected landholders from increased drainage, is recommended prior to implementing this option.

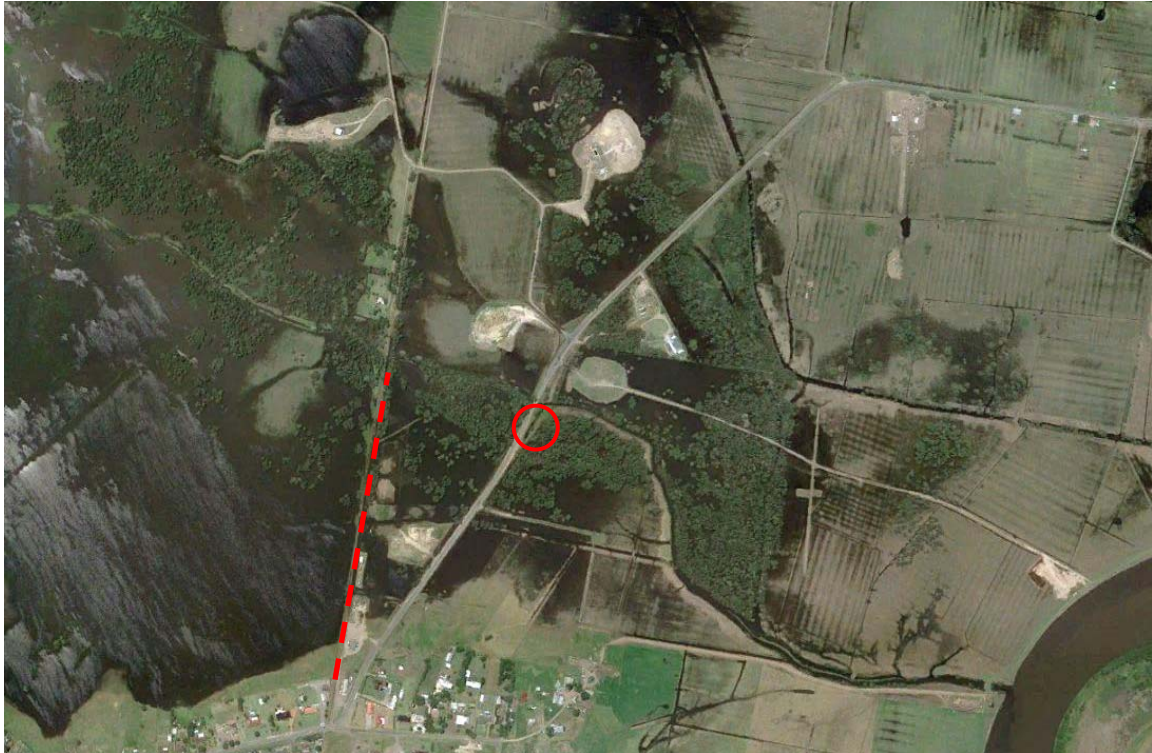
Figure 8.4: Removed section of pipeline, and modified Woodberry Road cross-section for numerical model scenario (Background image: Google Earth)

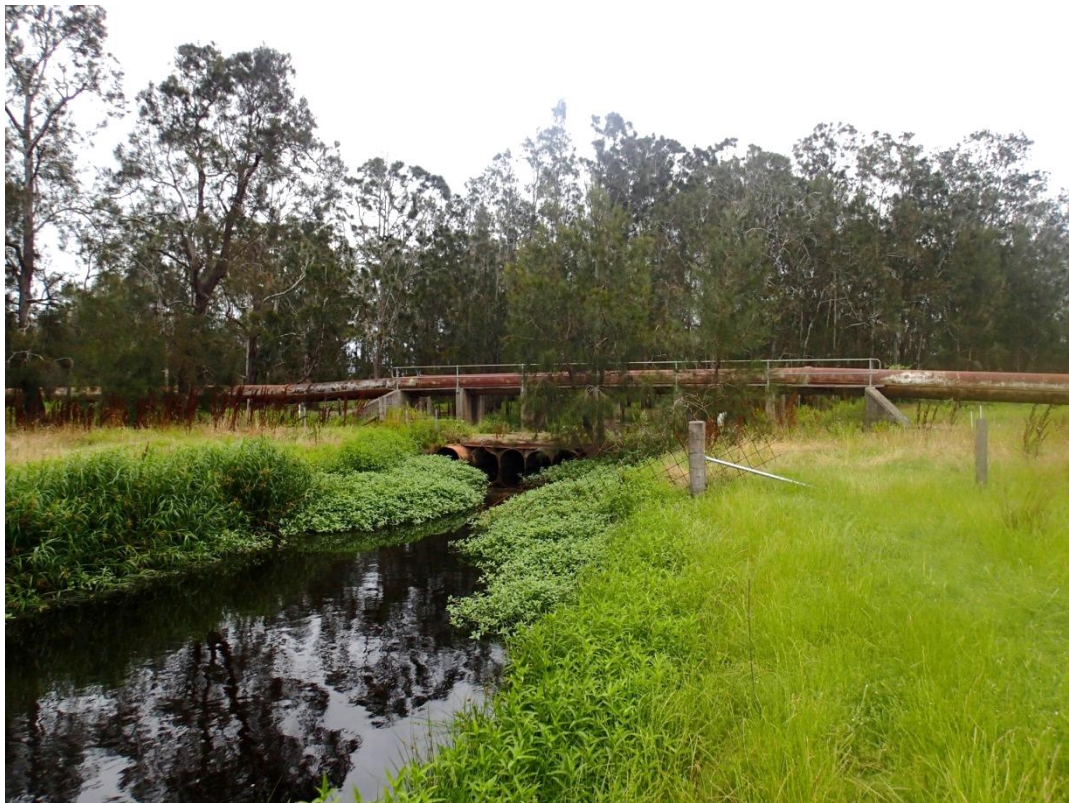
Figure D.6: P5 – HWC pipeline at Greenways Creek

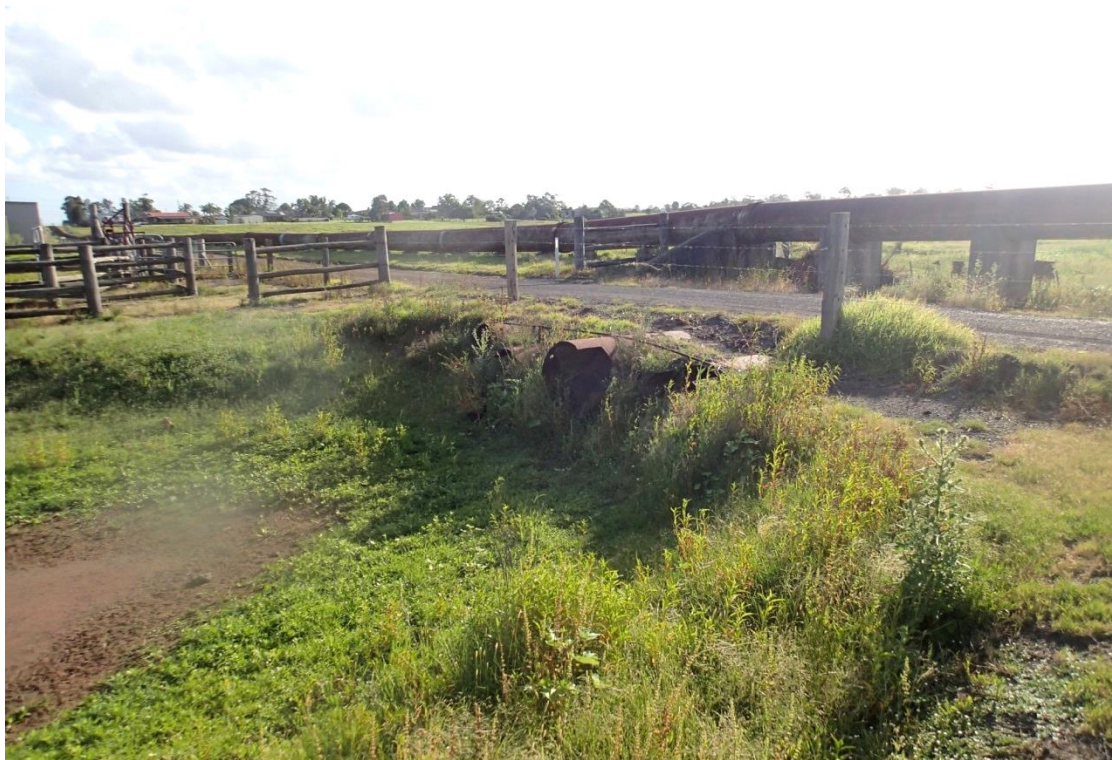
Figure D.8: P7 – Culverts under HWC pipeline access road

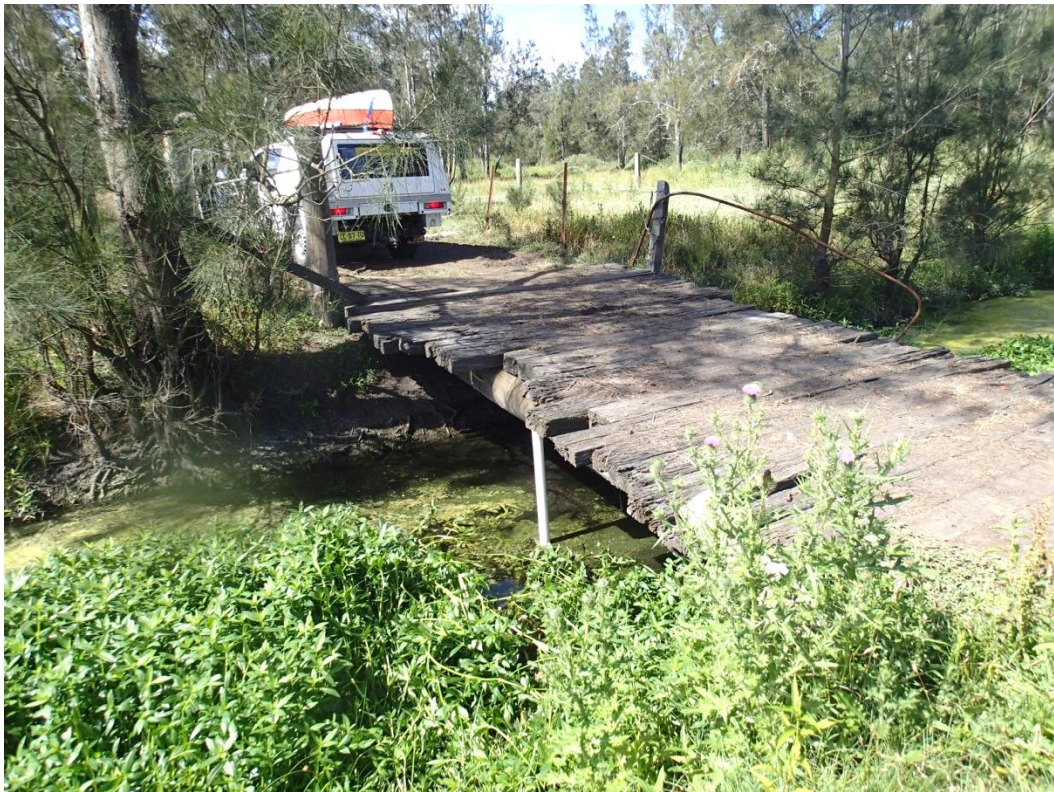
Figure D.12: P11 – Water level logger installation on wooden bridge at Greenways Creek
