UAV Surveying of Wyong Coastline – November 2015

WRL Technical Report 2016/04
March 2016

By C D Drummond and J G Cullen

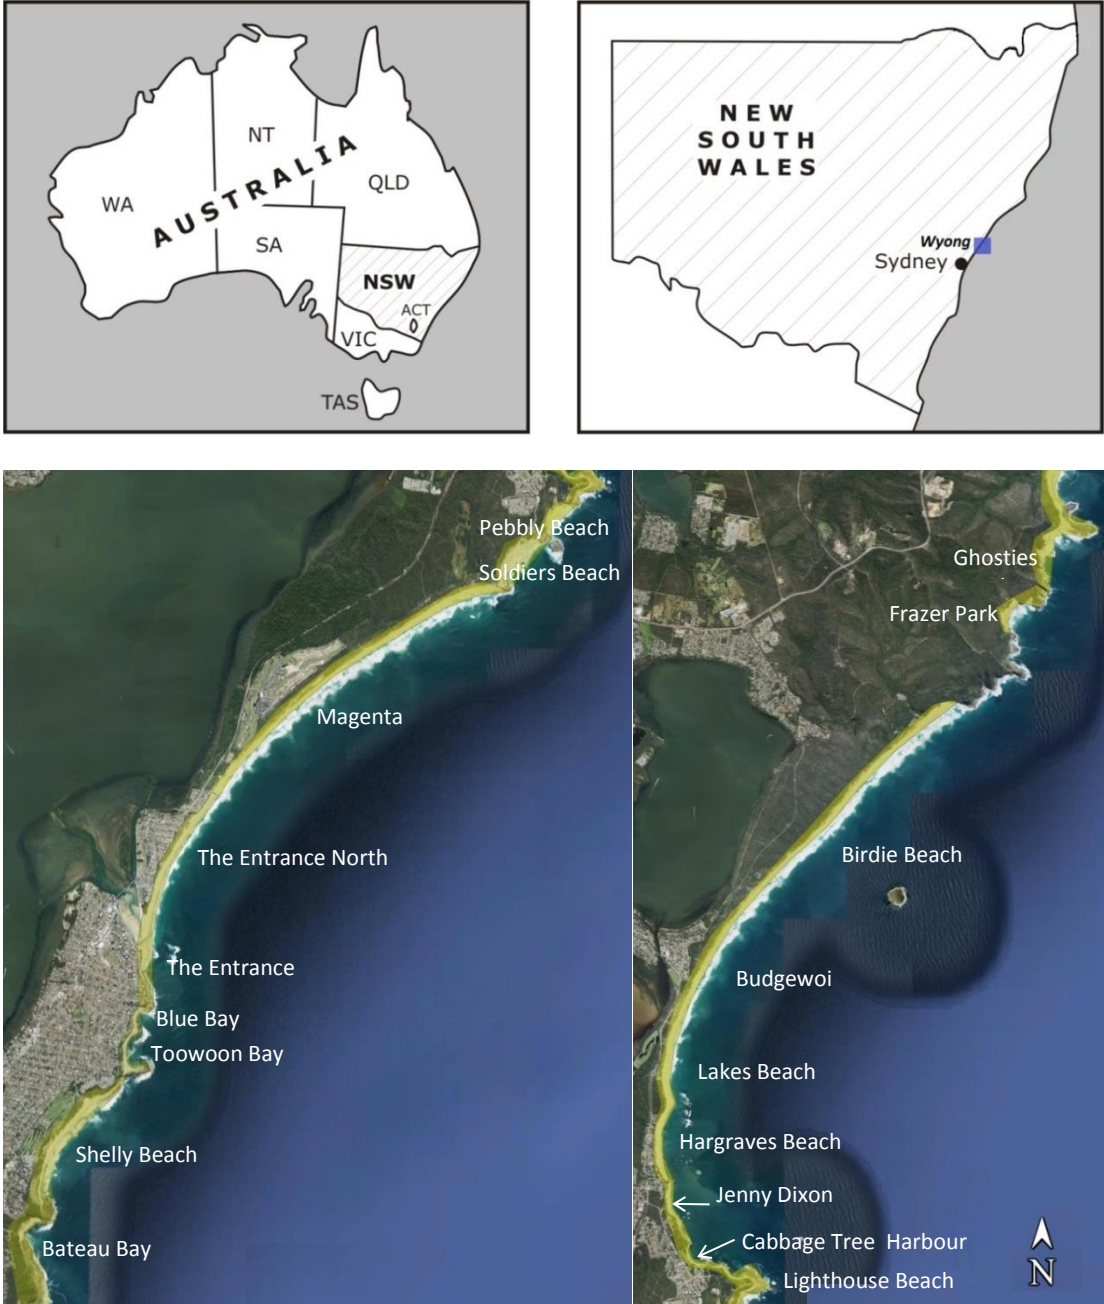
Figure 1: Site Location and UAV survey coverage highlighted in yellow

WRL completed UAV surveys of the vast majority of the Wyong Shire Council coastline with total coverage of beach area from Bateau Bay to Ghosties Beach. The survey excluded a 2 km section of remote cliff areas between Birdie Beach and Frazier Park that was inaccessible due to site restrictions (Figure 1).

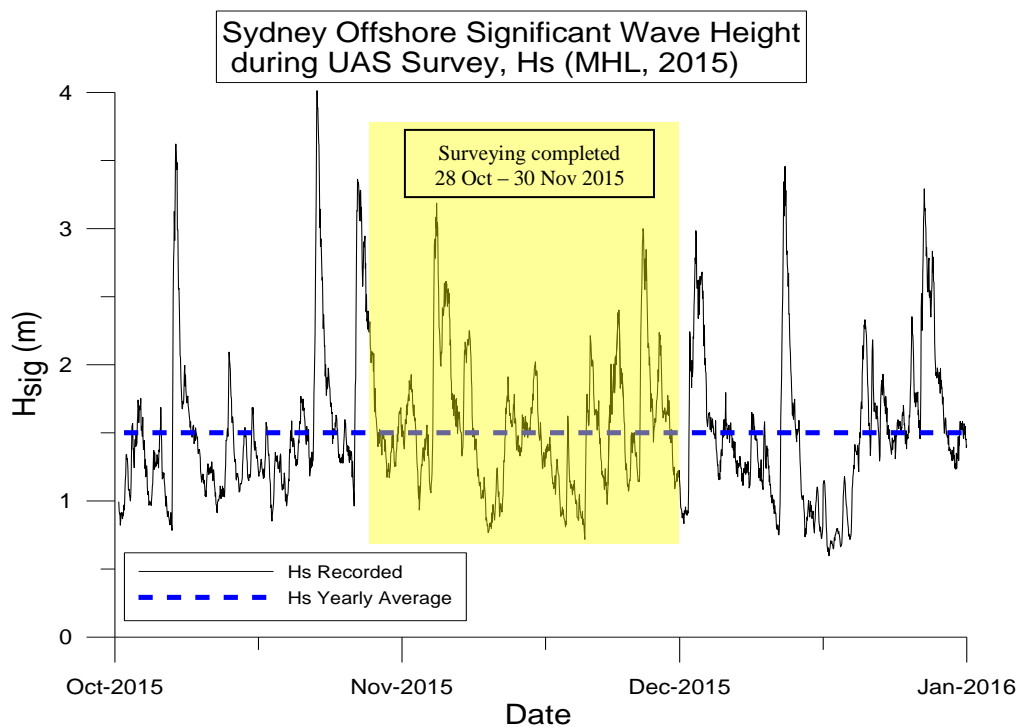
Figure 2: Sydney offshore significant wave height over the survey period (source: MHL, 2015)

The Wyong coastline experiences average significant wave heights of 1.5 m from the south-south-east superimposed on a highly variable wind wave climate (Shand et al., 2010). Due to this prevailing wave direction, the southern extents of beaches in this region usually have some degree of protection from storm erosion with exposure increasing to the north of each embayment. There were three notable wave events surrounding the survey campaign with a significant wave height exceeding 3 m. These occurred on 27th October from a south direction immediately prior to the commencement of surveys, 4th November from the east and 27th November from the south-south-east (Figure 2) both of which were during the survey period.

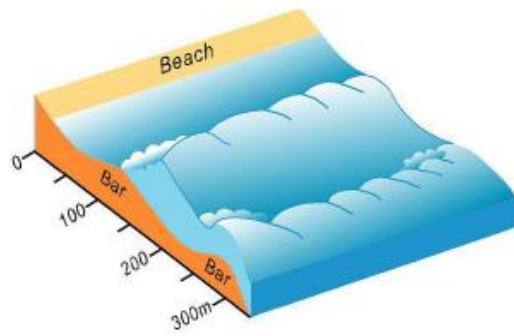
Figure 3: Wave Dominated Beach Types (after Short, 2007)

Classification of wave dominated coastlines are provided by Short (2007) which includes six beach types that are defined based on wave energy and sediment conditions (Figure 3). The coastal analysis provided in Section 4 includes classification of each beach into these beach states at the time of surveying. Beach type or 'state' refers to the prevailing nature of beach, including waves and currents, and the width and shape of the surf zone, including bars and troughs (Short 2007). At one end of the continuum are *Reflective Beaches*, where wave energy is largely reflected at the shoreline. These beaches are characterised by low wave energy and a steep, reflective shoreline. At the other

end of the continuum are *Dissipative Beaches* where wave energy is dissipated over a large surf zone. These beaches lie at the higher end of the beach energy spectrum and are found on open coasts with long wave periods and large waves. There are four *Intermediate* beach states that lie between reflective and dissipative beaches, with the majority of beaches in the Wyong Shire region falling into one of these categories. These are *longshore bar – trough* (LBT), *rhythmic bar and beach* (RBB), *transverse bar and rip* (TBR), and *low tide terrace* (LTT), and are detailed in Figure 3. Beaches naturally change between beach states in response to changes in the incident wave energy.

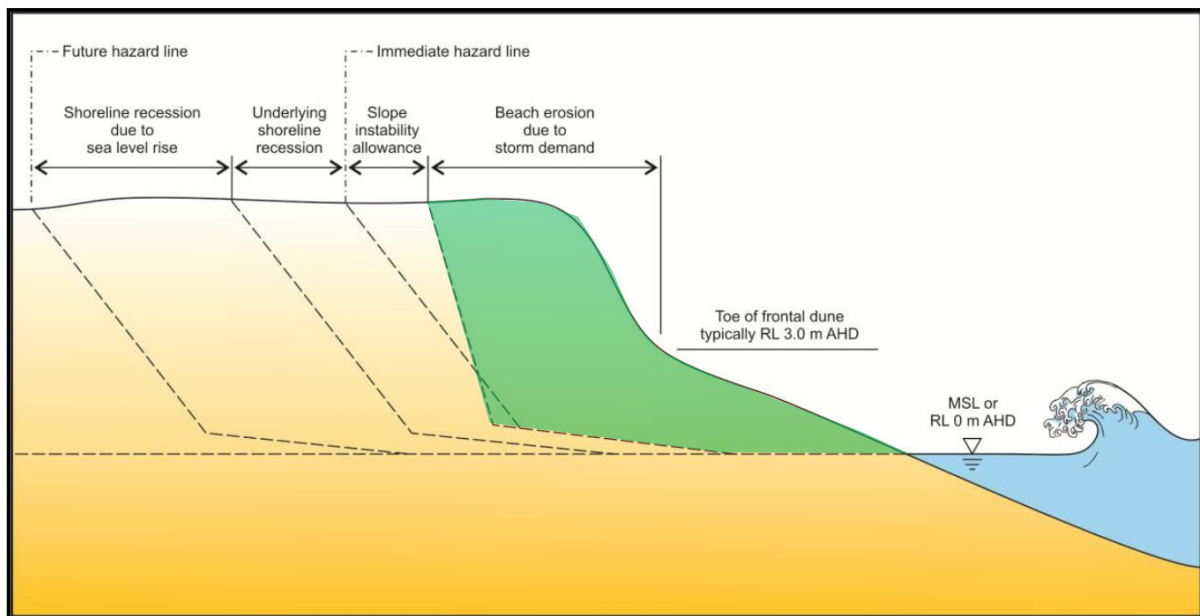
Figure 4: Definition of storm demand (zone of wave impact) highlighted in green (adapted from Nielsen et al., 1992)

This report also includes analysis of the volume of available sand buffer above 0 m AHD in the beach profile in front of key public and private assets. This sand buffer is defined in Figure 4 after Nielsen et al. (1992) and can be used to provide information about the level of natural protection that assets would have in an erosive event. A value of 34° was adopted in volume calculations as the safe angle of repose of wet sand for a slumped dune profile. It should be noted that if the volumes of available sand buffer quantified in this report were removed by a storm event then the subject property would be located in a zone of reduced foundation capacity and would require piled foundations to maintain structural stability.

In cases where the UAV derived data did not extend to 0 m AHD due to interference from wave run-up, the slope from 2 m to 3 m AHD was used as a basis for extrapolation to the 0 m AHD contour.

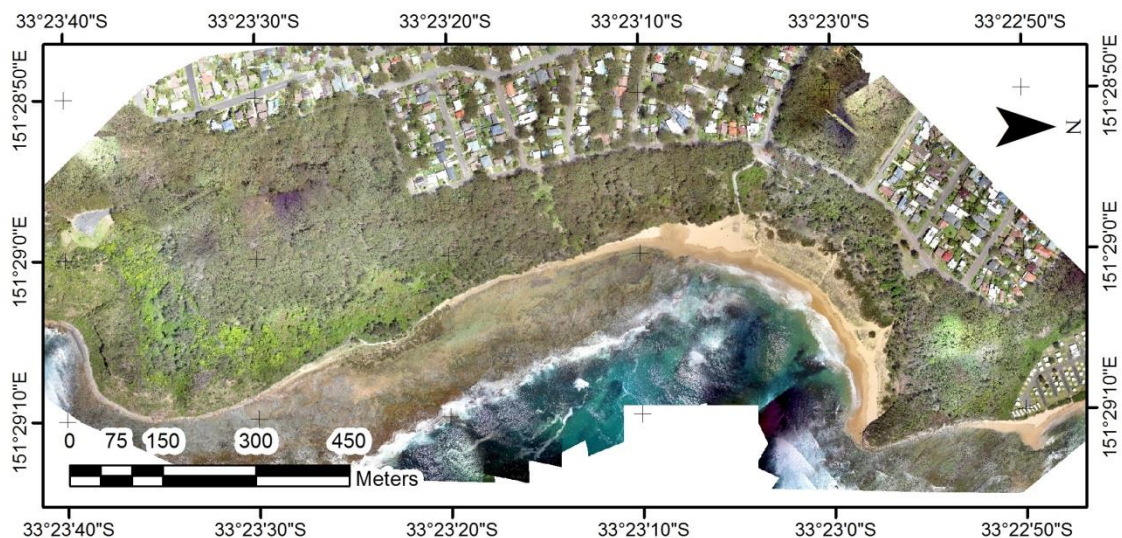
Figure 5: Bateau Bay overview

Bateau Bay is a south-east facing embayed beach, protected by a headland at the north end, an extensive rock platform to the south and offshore reefs in the centre of the bay (Figure 5). At the time of surveying, the beach was in a reflective state with a low gradient representative beach slope of 1 in 50. The rock platform at the base of Crackneck Point had an average height of 1.5 m AHD and an average width of 150 m. The beach was backed by a well vegetated bluff with heights ranging from 3.6 m AHD at the south of the beach to 2.5 m AHD at the north. The bluff was fronted by a stable incipient foredune, moderately vegetated with grass. The closest residential development was located 170 m behind the foredune (measured from the 3 m AHD contour line). Geotechnical stability and erosion from coastal events appeared to be a low risk to public and private infrastructure at this location.

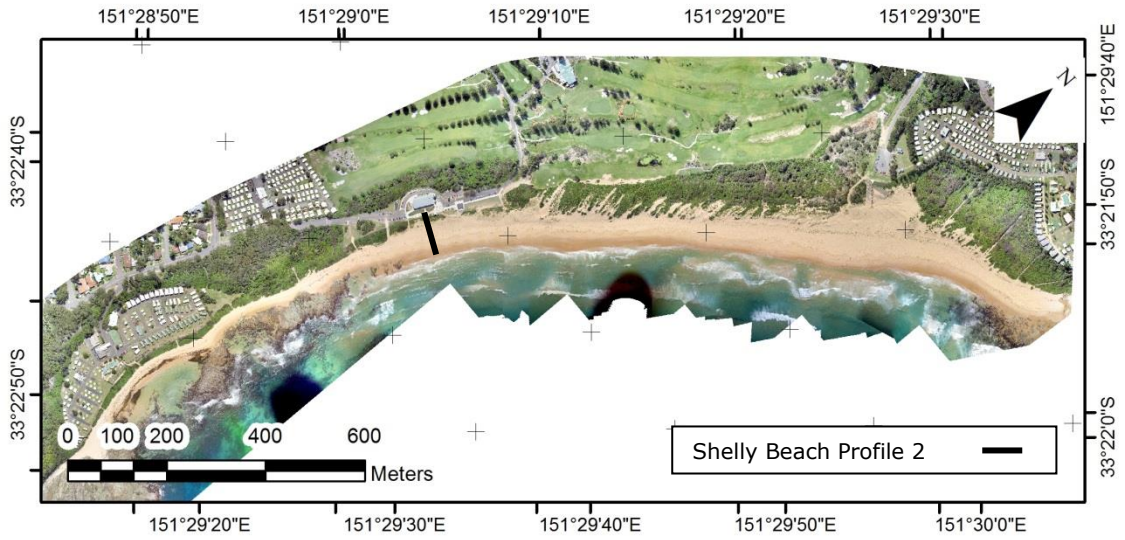
Figure 6: Shelly Beach overview

Shelly Beach is south-east facing beach that has a narrow southern extent that is protected by rock reefs and shelves (Figure 6). The centre and northern end of the beach is wider, with a well vegetated frontal dune present to the north of the Shelly Beach SLSC building and a lightly vegetated incipient foredune. The height of the frontal dune ranges from 3 m AHD to the south, 11 m AHD in the centre of the beach and 16 m AHD to the north. There are rock outcrops at the northern beach, with rock shelves and reefs bounding the far northern extent. At the time of surveying the beach had a representative slope of 1 in 11 and the beach state was rhythmic bar and beach (RBB), with irregular cusps. Blue Lagoon Beach Resort is partially protected by offshore reefs at the southern end of the beach and was 30 m from the 2 m AHD contour at the

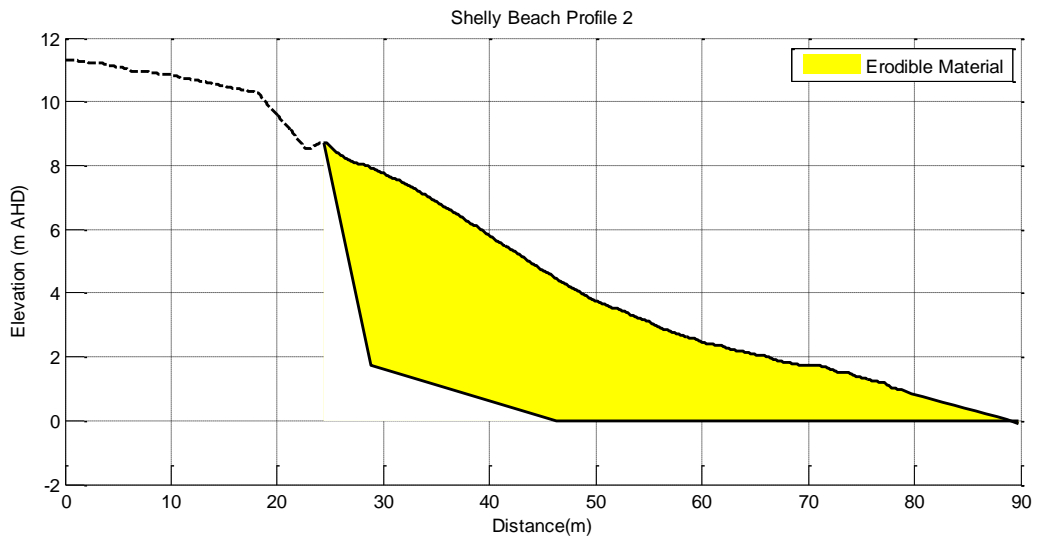
Figure 7: Profile fronting Shelly Beach SLSC (Profile 2) showing volume of available sand buffer in the beach profile above 0 m AHD

time of surveying. The next closest development was located at the northern end of the beach at a distance of 90 m from the 2 m AHD contour. The volume of available sand buffer within the beach profile fronting Shelly Beach SLSC building was equal to 174 m³/m (Figure 7), however after removal of this sediment the SLSC building would be in the zone of reduced foundation capacity. This volume is less than the storm demand of 290 m³/m presented in BMT WBM (2015) as the design storm.

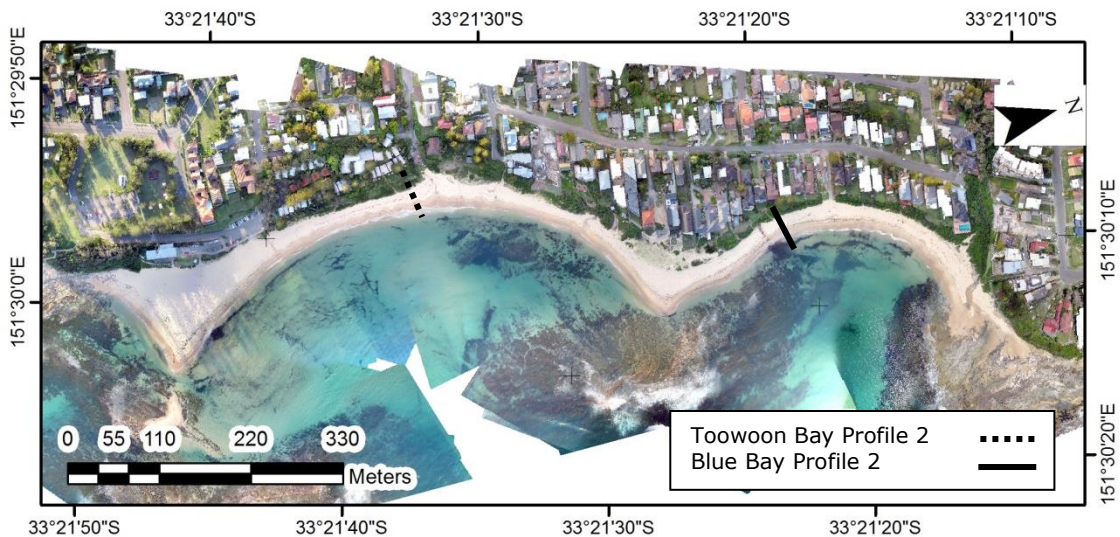
Figure 8: Toowoon Bay and Blue Bay overview

Toowoon Bay is a predominately east facing reflective beach bounded at both extents by tombolos and protected by intertidal rock platforms and rock reefs (Figure 8). The beach is backed by residential development fronted by a narrow and well-vegetated frontal dune. At the time of surveying this dune had heights ranging between 7 m AHD to the south and 5 m AHD in the centre of the beach and a well-vegetated 15 m AHD high bluff at the northern end. The closest development was 33 m from the 2 m AHD contour and is located to the north of the SLSC. There are three small stormwater outlets or creeks and a larger stormwater outlet at the northern end of the beach. Only the larger outlet was observed to have evidence of scour when the site was surveyed. During the survey deployment the beach had a representative slope of 1 in 9.

The tombolo between Blue Bay and Toowoon Bay has an incipient foredune that was moderately vegetated with grass behind a 1 m high scarp. The frontal dune has been developed and has very little vegetation outside of the property bounds.

Blue Bay faces east-southeast and is enclosed by intertidal rock platforms (Figure 8). It is backed by residential development, the closest of which was located 22 m from the 2 m AHD contour during the site survey. Properties were fronted by a number of ad-hoc seawalls constructed out of sandstone blocks or timber retaining walls. During the site visit, there was a narrow and well vegetated dune with heights between 7 m AHD and 12 m AHD, with a lightly vegetated incipient foredune present at the northern end of the beach. Two flowing stormwater outlets were present at the site, located at the northern and southern ends of the beach. The representative beach slope was 1 in 12 and the beach state was in a reflective state in response to low wave energy. The volume of available sand buffer within the beach profile fronting property in the centre of the beach was equal to 103 m³/m (Figure 10). This volume is comparable to the storm demand of 115 m³/m presented in BMT WBM (2015) as the design storm.

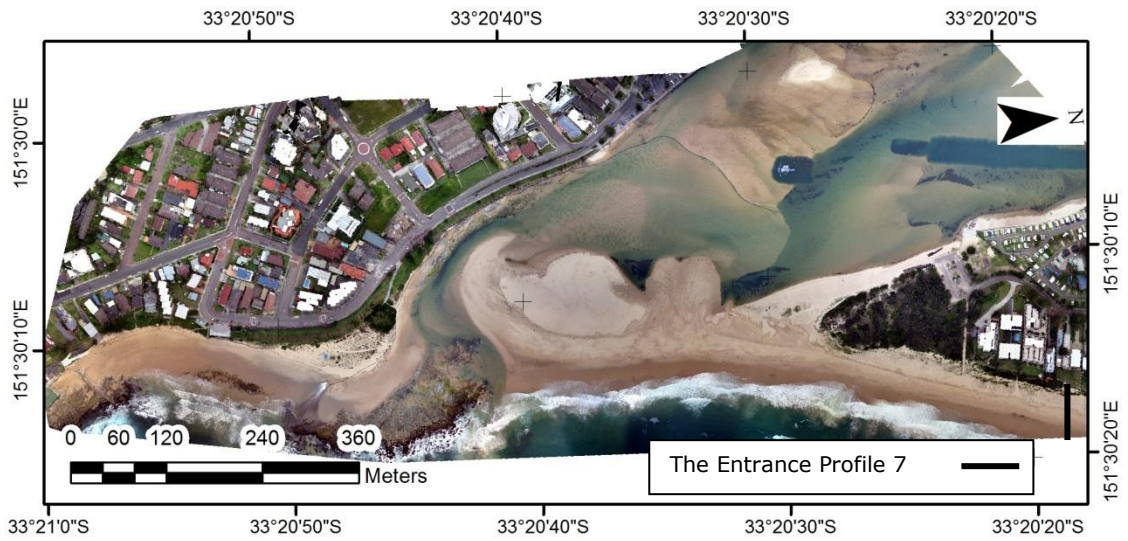
Figure 11: The Entrance overview

The estuary entrance is bounded by rocks to the south and dredging was occurring at the time of surveying (Figure 11). An overwash berm with a height of 2.8 m AHD (Profile 4) was present on the sand spit. To the north of the sand spit and south of properties was a well vegetated dune, 8.5 m high (Profile 6). Property setback from the 2 m AHD contour was 55 m at the southern end of Hutton Rd, 173 m at Bondi Rd and 65 m at the northern end of Curtis Parade.

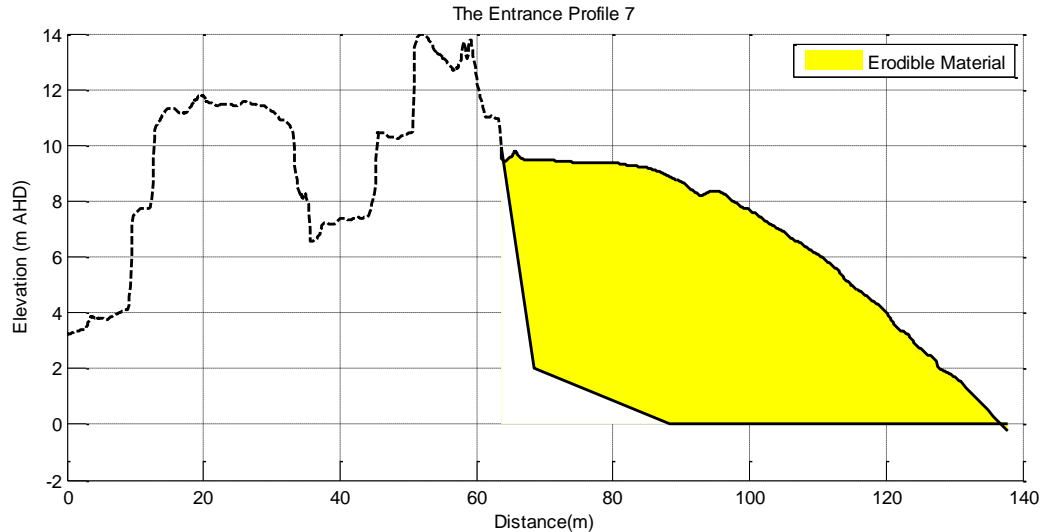
Figure 13: The Entrance profile fronting property at Hargraves St (Profile 7) showing the volume of available sand buffer in the beach profile above 0 m AHD

The volume of available storm demand fronting property at Hutton Rd near Hargraves St (Profile 7) was equal to 410 m³/m (Figure 13), with a beach slope of 1 in 4. This volume is in excess of the storm demand of 170 m³/m presented in BMT WBM (2015).

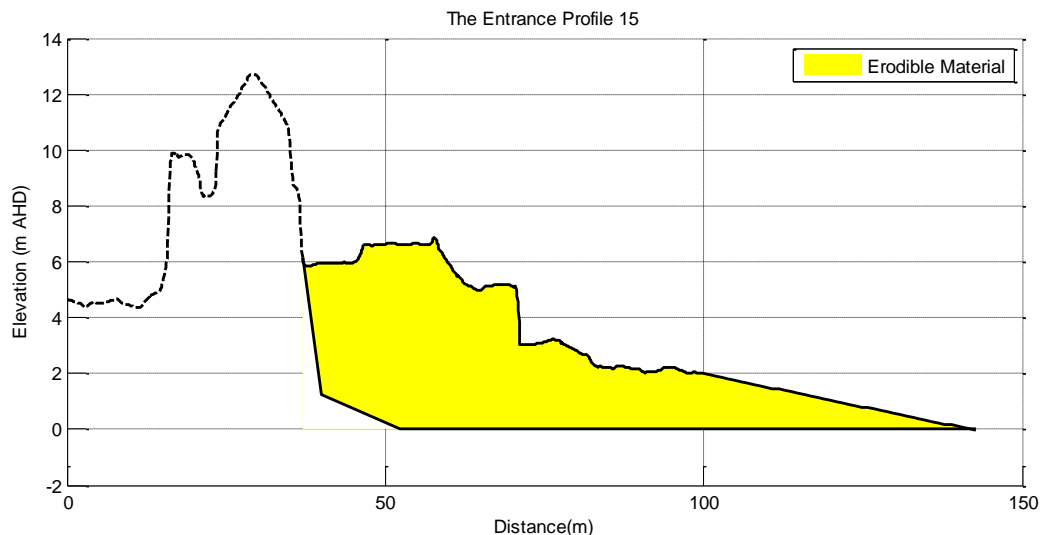
Figure 14: The Entrance North profile fronting property in the centre of Curtis Parade (Profile 15) showing volume of available sand buffer in the beach profile above 0 m AHD

The volume of available storm demand fronting property in the centre of Curtis Parade (Profile 15) was equal to 106 m³/m (Figure 14), with a beach slope of 1 in 21. This volume is less than the storm demand of 170 m³/m presented in BMT WBM (2015).

Any ad hoc seawalls fronting properties along Curtis Parade are unlikely to be structurally sound nor certified by a coastal engineer. The volume of available sand buffer at this location has been calculated up to property footprints as it has been assumed that ad-hoc seawalls at the site would be insufficient to provide satisfactory protection from a large storm event.

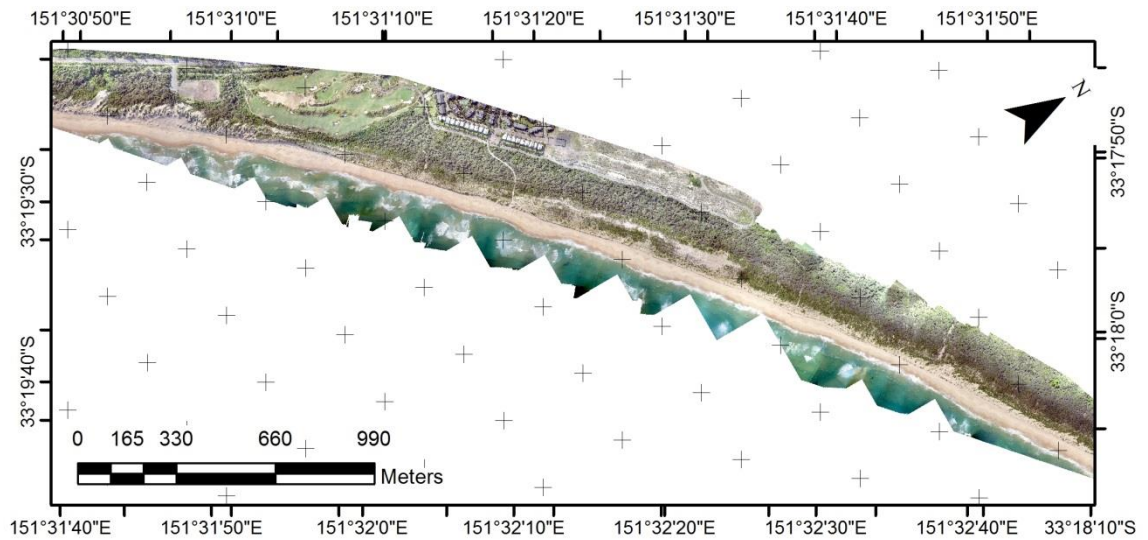
Figure 15: Magenta overview

Magenta Beach is an unprotected south-east facing barrier beach (Figure 15). At the time of surveying the beach had a representative slope of 1 in 11 and the beach state was rhythmic bar and beach (RBB). There was a well vegetated frontal dune with heights ranging from 18 m AHD to the south, 12 m AHD in the centre and 14 m AHD to the north. A lightly vegetated incipient foredune was present in front of the frontal dune. Magenta Shores Resort and Golf Course is located in centre of the beach and was 210 m from the 2 m AHD contour at the time of surveying.

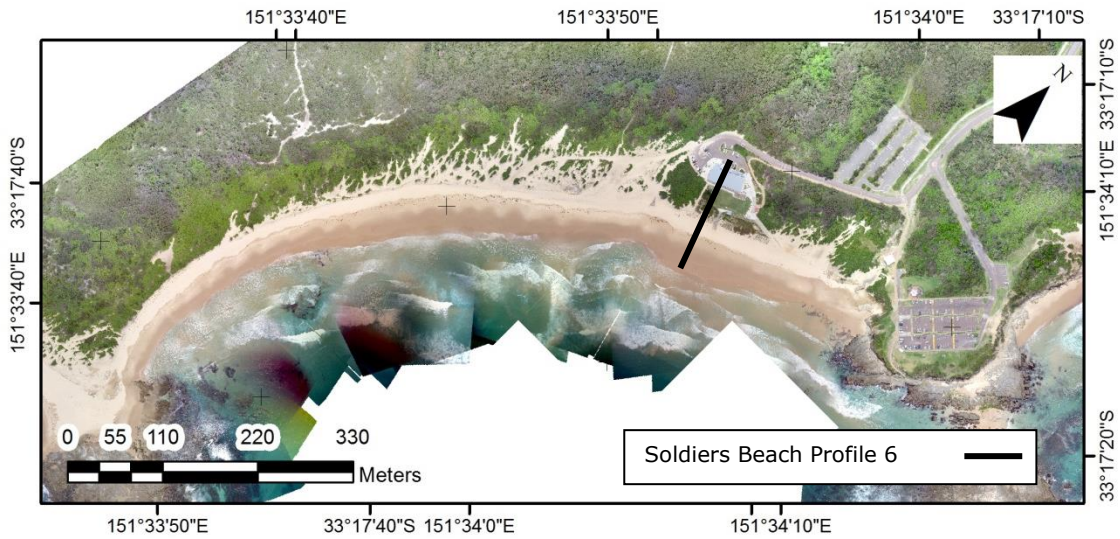
Figure 16: Soldiers Beach overview

Soldiers Beach is south-east facing and is bounded by a headland to the north and a tombolo to the south (Figure 16). At the time of surveying, the beach had a representative slope of 1 in 9 and the beach state was transverse bar and rip (TBR), with cusps. There was a high frontal dune with heights ranging from 25 m AHD to the south, 17 m AHD in the centre of the beach and 8 m AHD at the north. The dunes at the south and north of the beach were well vegetated, with vegetation becoming more sparse at the centre of the beach where a 4WD access track runs south from Soldiers Beach SLSC. Outcrops of rock were present at the north of the beach and in the dunes 150 m south of the SLSC. The volume of available sand buffer in the beach profile located in front of Soldiers Beach SLSC was equal to 429 m³/m (Figure 17), which exceeds the design storm erosion volume of 150m³/m presented in BMT WBM (2015).

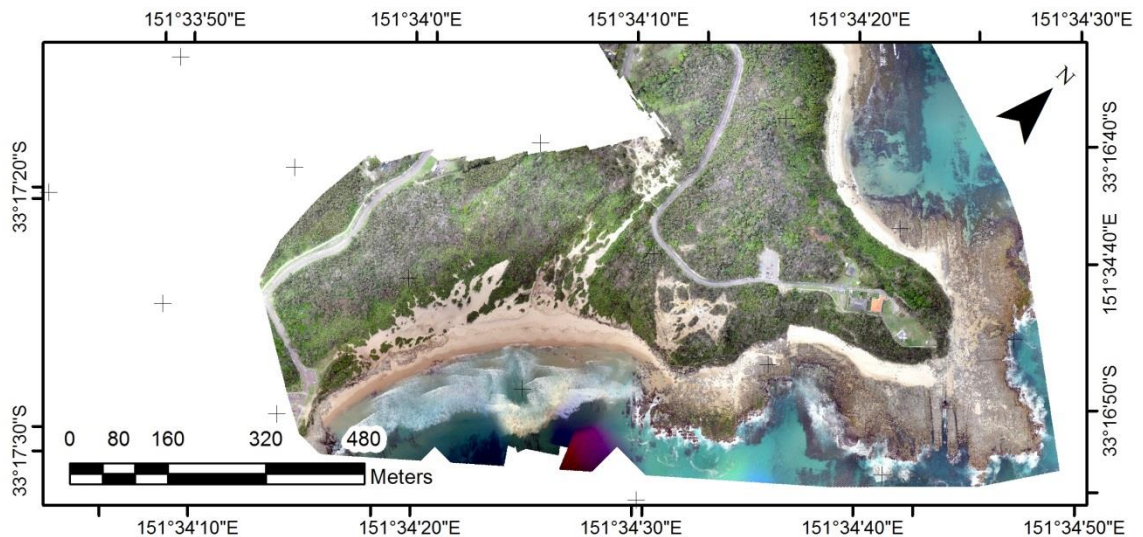
Figure 18: Norah Head overview

Pebbly Beach faces south-east and is undeveloped with the exception of the carpark on Soldiers Point (Figure 18). At the time of the survey the foredune height ranged from 8 m AHD to the south to 13 m AHD to the north and was sparsely vegetated. The hind-dune was predominantly well vegetated with heights ranging between 20 m AHD to the south and 16 m AHD to the north. Cliffs were present to the north over an intertidal rock platform. Rock outcrops were present at the southern end of the beach and in the dune at the centre of the beach. Two channels existed in the centre of the beach on either side of the outcrop, both showing evidence of scour. At the

time of surveying, the representative beach slope was 1 in 16 and the beach state was low tide terrace, with irregular cusps.

Lighthouse beach faces north-east and protected by extensive rock platforms to the east and west (Figure 18). At the time of surveying, there was a narrow, vegetated foredune 8 m AHD in height. The beach representative beach slope was 1 in 9 and the beach state was reflective.

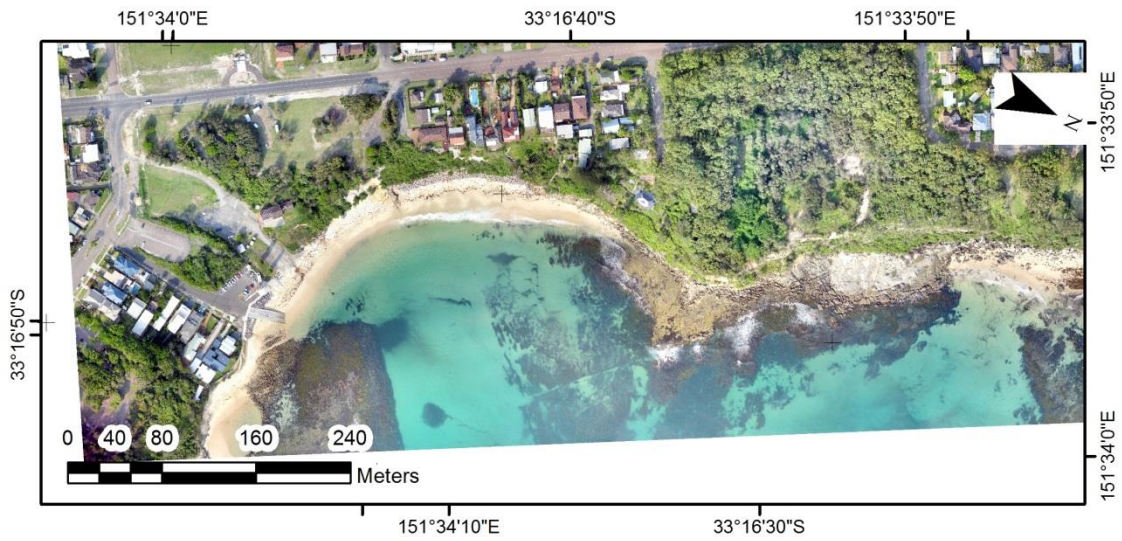
Figure 19: Cabbage Tree Harbour overview

Cabbage Tree Harbour faces north-east and is protected by rock platforms to the north and south (Figure 19). The beach was backed by bluffs at the centre and north with a height of 20 m AHD. At the time of surveying, the beach was narrow with a representative slope of 1 in 6 and the beach state was reflective, with cusps.

The south end of the beach and the top of the bluffs in the centre and north of the beach have been developed with properties located in close proximity to an unstable slope. A predominantly buried seawall fronts property to the south between the rock pool and the boat ramp, with a rock armour and concrete seawall surrounding the boat ramp and in front of the carpark. Rock toe protection is present at the base of the bluff in the centre and north of the beach. The volume of available storm demand is unknown due to the rocky nature of the beach. In the middle of the beach at the southern end of the rock toe protection there was observed to be recent erosion of the clayey bluff caused by a combination of uncontrolled water runoff and human activity.

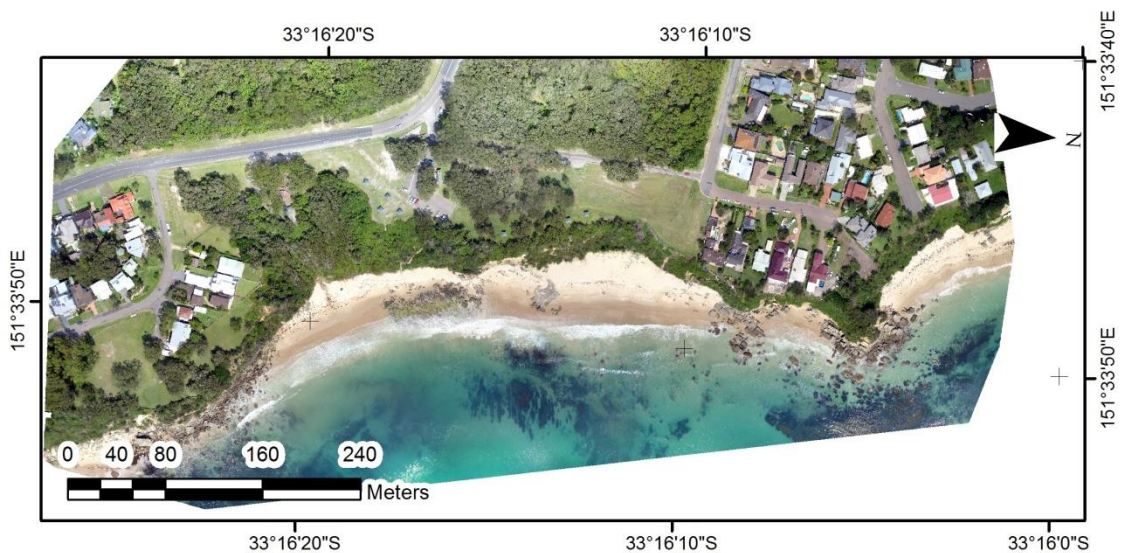
Figure 20: Jenny Dixon Beach overview

Jenny Dixon Beach is a low gradient, east facing beach protected by rock reefs to the north and south (Figure 20). At the time of surveying, the representative beach profile was 1 in 62 and the beach state was reflective. Rock outcropping occurred in the centre and to the north of the beach and the beach was backed by a well vegetated bluff with a height of 20 m AHD. Development was present 40 m from the top of the bluff at the south end of the beach and 4 m from the top of the bluff at the north end.

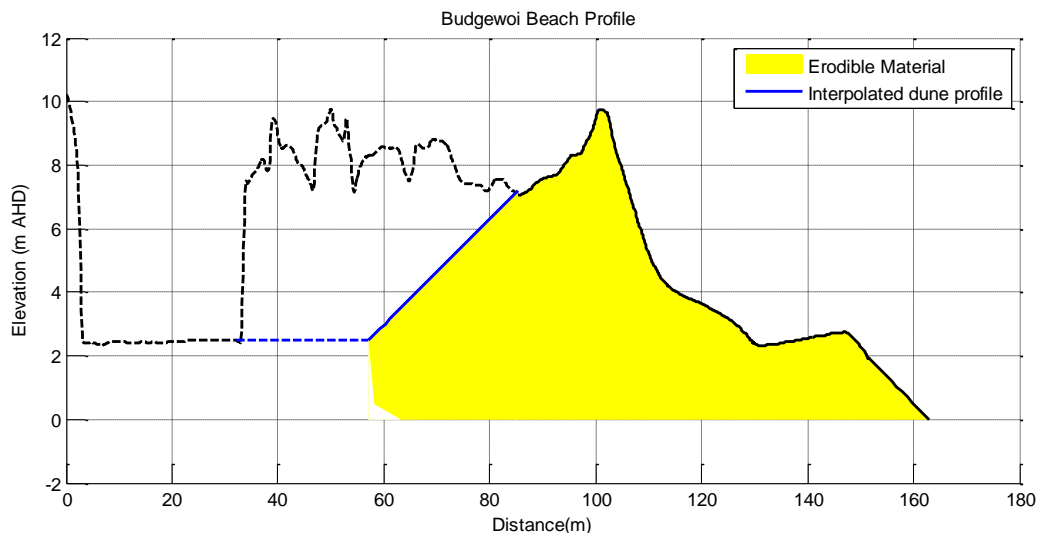
Figure 25: Profile fronting Boomerang St Budgewoi (Lakes Beach Profile 2) showing the volume of available sand buffer in the beach profile above 0 m AHD

Budgewoi Beach had a representative beach slope of 1 in 6 at the time of surveying and the beach state was transverse bar and rip (TBR). Development is minimal along this beach and was located 110 m from the 2 m AHD contour. The dunes were well vegetated in front of and to the north of the development.

The volume of available sand buffer in the beach profile above 0 m AHD and landward of Boomerang Street is equal to 463 m³/m (Figure 25). This volume is in excess of the design storm erosion volume of 250 m³/m presented in BMT WBM (2015).

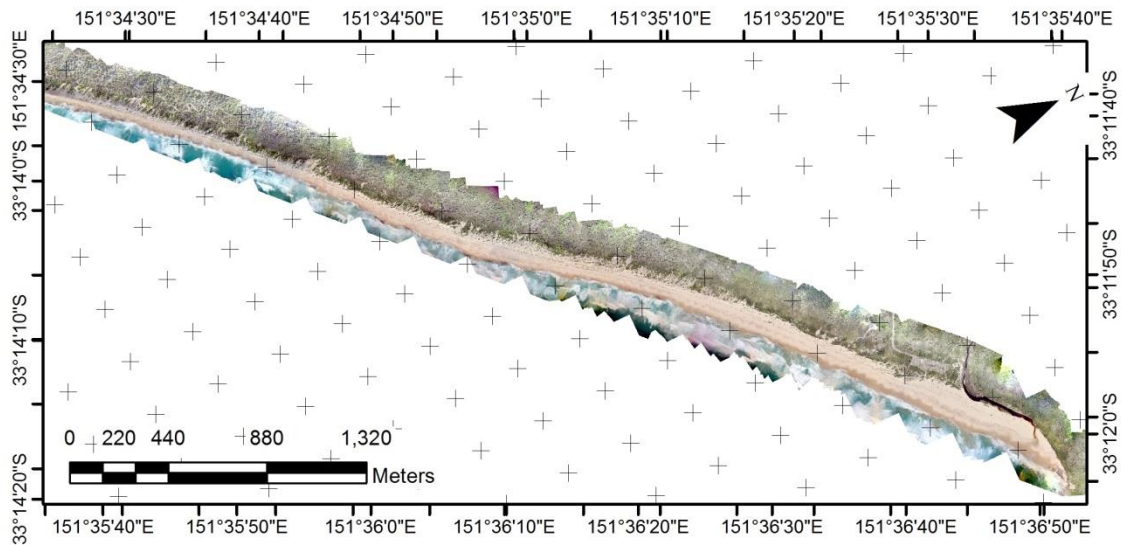
Figure 26: Birdie Beach overview

Birdie beach is a south-east facing barrier beach, undeveloped, with access points at the northern and southern extents (Figure 26). At the time of surveying there was a steep frontal dune along the length of the beach that was well vegetated in most areas. A flowing creek outlet existed at the northern end. When surveyed, the beach state was intermediate and varied from transverse bar and rip (TBR) at the northern end to rhythmic bar and beach (RBB) in the centre and to the south, with well-defined cusps. A salient was present in the wave shadow zone behind Bird Island measuring 1 km in length and a width of 60 m compared to the adjacent average beach width. The representative beach slope was 1 in 51.

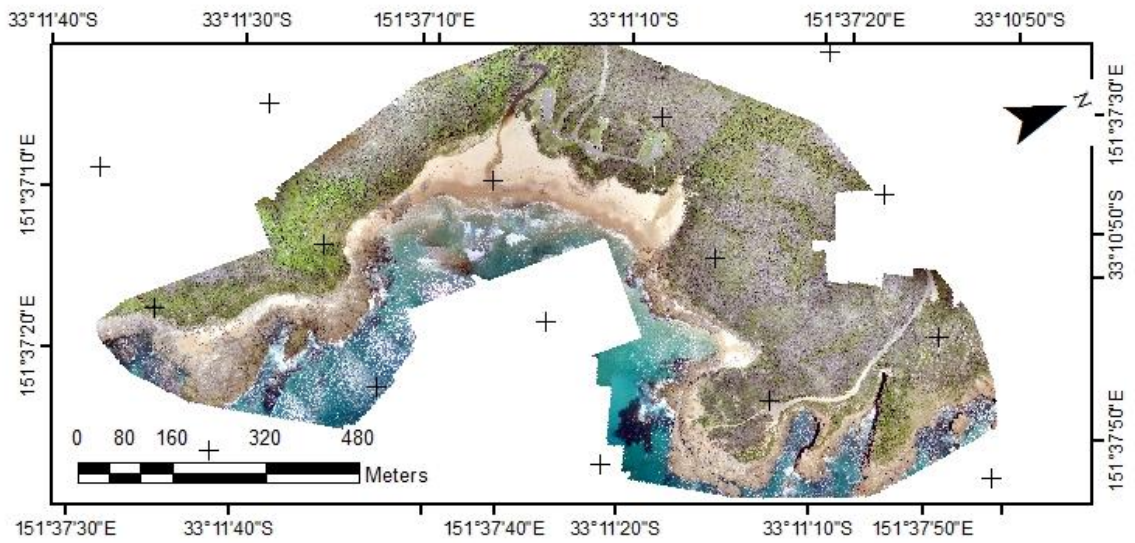
Figure 27: Frazer Park overview

Frazer Park Beach is south-east facing and had a representative slope of 1 in 77 at the time of surveying (Figure 27). The beach is undeveloped aside from three car park areas. There was a flowing creek outlet to the south of the carparks, and another smaller waterway to the north. Rock outcropping occurred at the centre and south end of the beach. When visited, the beach state was transverse bar and rip (TBR).

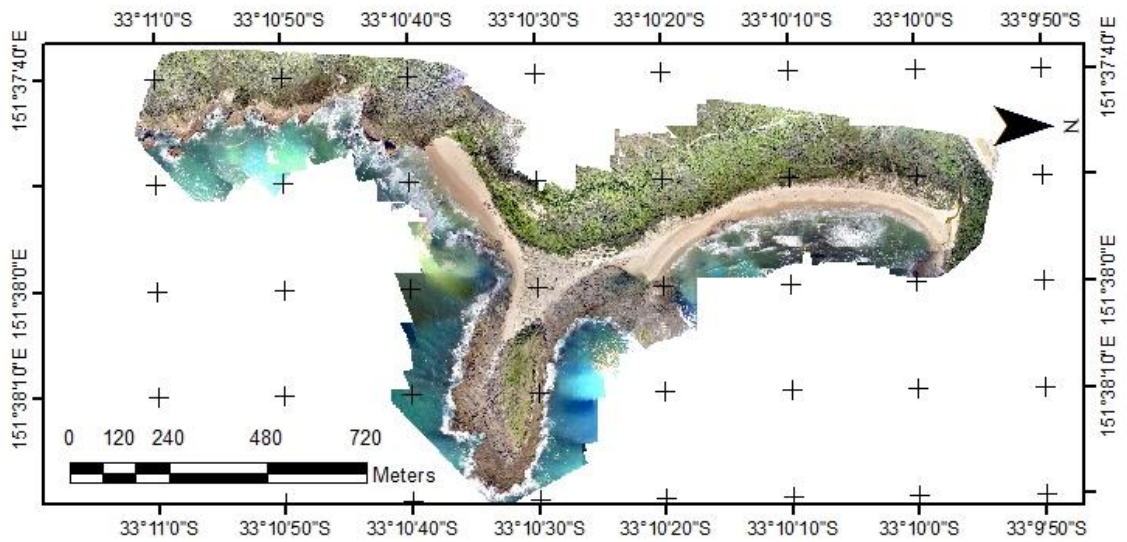
Figure 28: Ghosties Beach overview

The beach is backed by high, steep cliffs and is undeveloped, with the only access via Catherine Hill Bay to the north (Figure 28). The tombolo to Flat Island is lightly vegetated with grass and the island is heavily vegetated. High water level is at the base of the cliff along the majority of the beach. When visited, the beach state was low tide terrace (LTT).

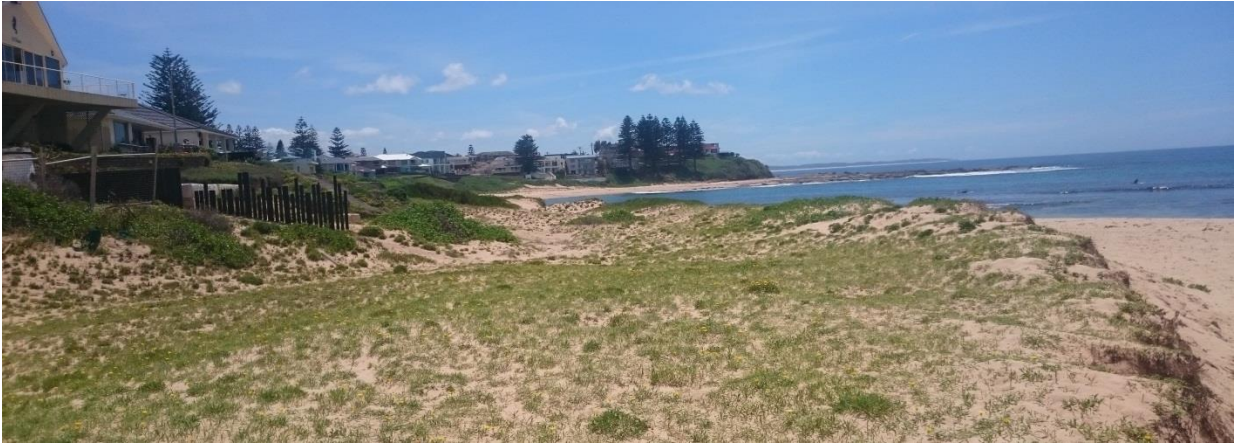
Figure 6: Incipient foredune at the southern extent of Blue Bay (facing north)

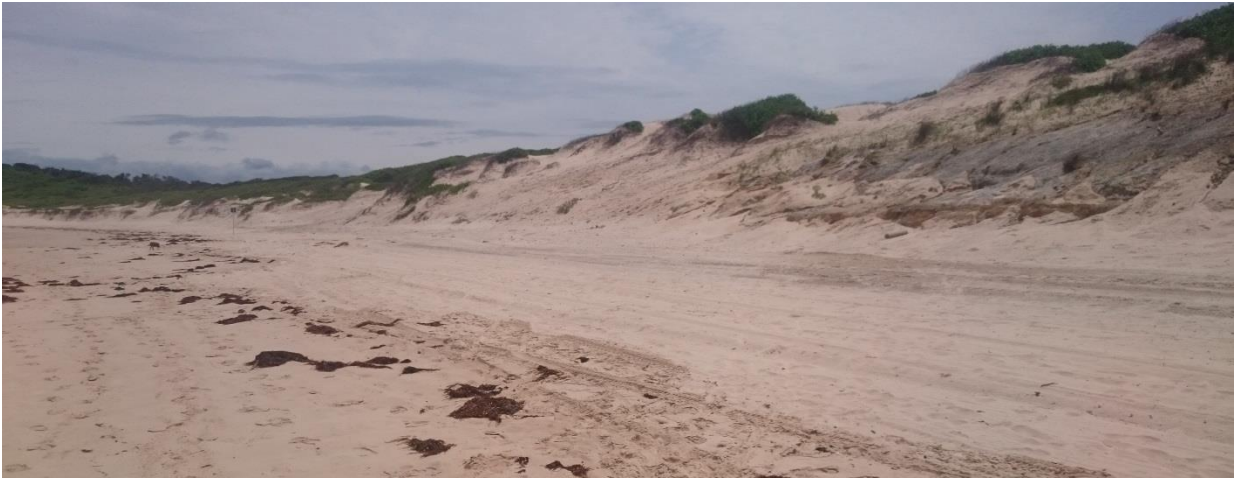
Figure 12: Soldiers Beach facing south. Rock outcropping is visible to the right

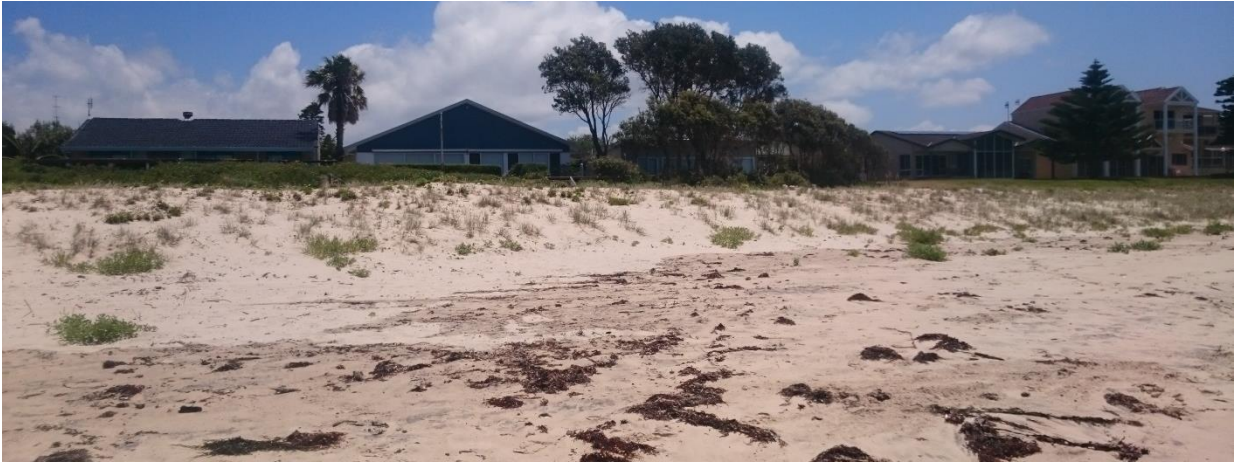
Figure 19: Hargraves Beach incipient foredune fronting residential property
