Water Research Laboratory

UAV Surveying of Wyong Coastline – June 2016

WRL Technical Report 2016/14
July 2016

By C D Drummond and A J Harrison

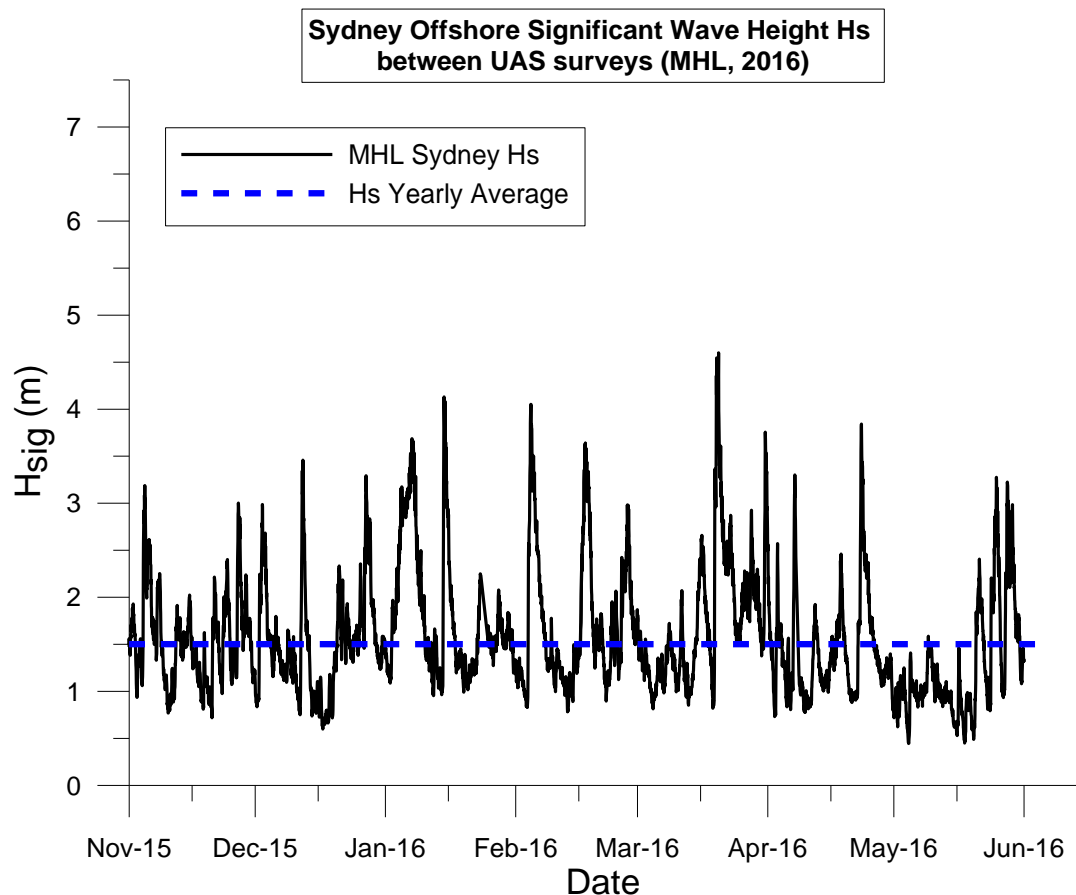
Figure 3-1: Sydney offshore wave height between survey dates

The Wyong coastline experiences an average significant wave height of 1.5 m from the south-south-east superimposed on a highly variable wind wave climate (Shand *et al.*, 2010). Due to this prevailing wave direction, the southern extent of beaches in this region usually have some degree of protection from storm erosion with exposure increasing to the north of each embayment. Figure 3-1 shows the wave heights between November 2015 and the start of June 2016 from the Manly Hydraulics Laboratory (MHL) wave buoy located offshore in 90 m water depth. WRL is awaiting receipt of QA controlled data from MHL of wave heights during the June 2016 ECL storm event, however wave heights reported online from Sydney Port Authority (buoy located offshore of Botany Bay in approximately 92 m water depth showed water heights up to 7 m from an easterly direction in this period).

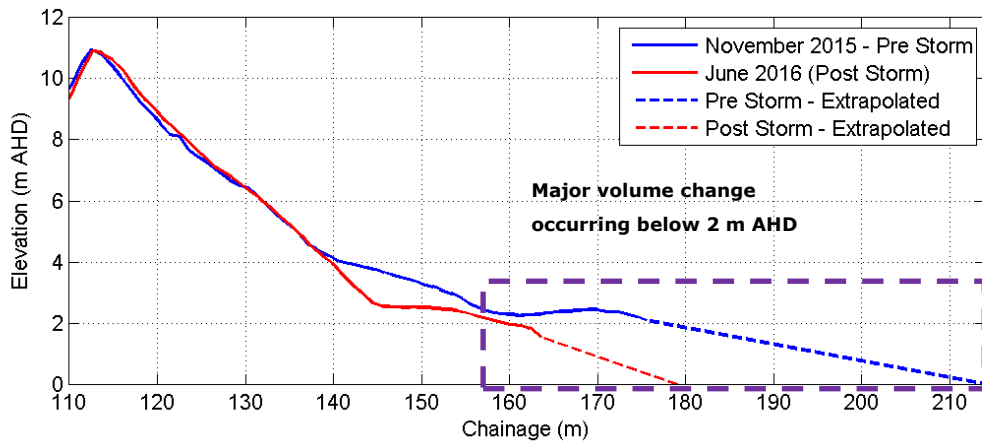
Figure 4-1: Lakes Beach Profile 3 ($\Delta V = -94 \text{ m}^3/\text{m}$)

The erosion intensity map at Lakes Beach (Figure 4-3) indicates that this area lost a significant amount of sand near the scarp along the whole length of the beach. The storm primarily removed sand from the face of the dune. Three (3) of the four (4) profiles showed a relatively consistent volume loss of approximately 30 m³/m, the exception to which is Lakes Beach Profile 3 (Figure 4-1), that had significantly more erosion (94 m³/m). However, most of this eroded volume is accounted by the area below the 2 m AHD contour, where the beach profile had to be extrapolated. There is therefore more uncertainty in this region, and it is possible that at this profile the volume change may be over stated by the analysis.

¹ The majority of erosion at this profile occurred in the extrapolated zone below 2 m AHD (see Figure 4-1).

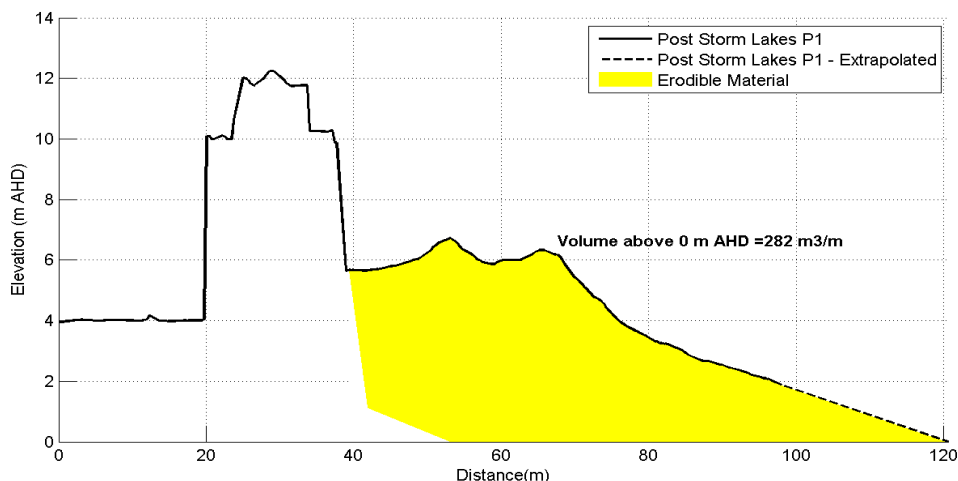
Figure 4-2: Lakes Beach Profile 1 (Lakes Beach SLSC), Post Storm

Figure 4-3 shows the beach response was relatively uniform along Lakes Beach, most likely due to the relatively straight longshore profile. The most significant infrastructure on Lakes Beach is the Surf Life Saving Club at the southern end of the beach (at Profile 1, Figure 4-2). There was a volume loss of 33 m³/m at this location and a beach retreat of approximately 8 m at the 2 m AHD contour between November 2015 and June 2016. It is not considered to have caused threat to the SLSC. In front of the SLSC, there is still a sand buffer of over 280 m³/m, significantly larger than the design storm demand described in BMT WBM (2015) of 150 m³/m.

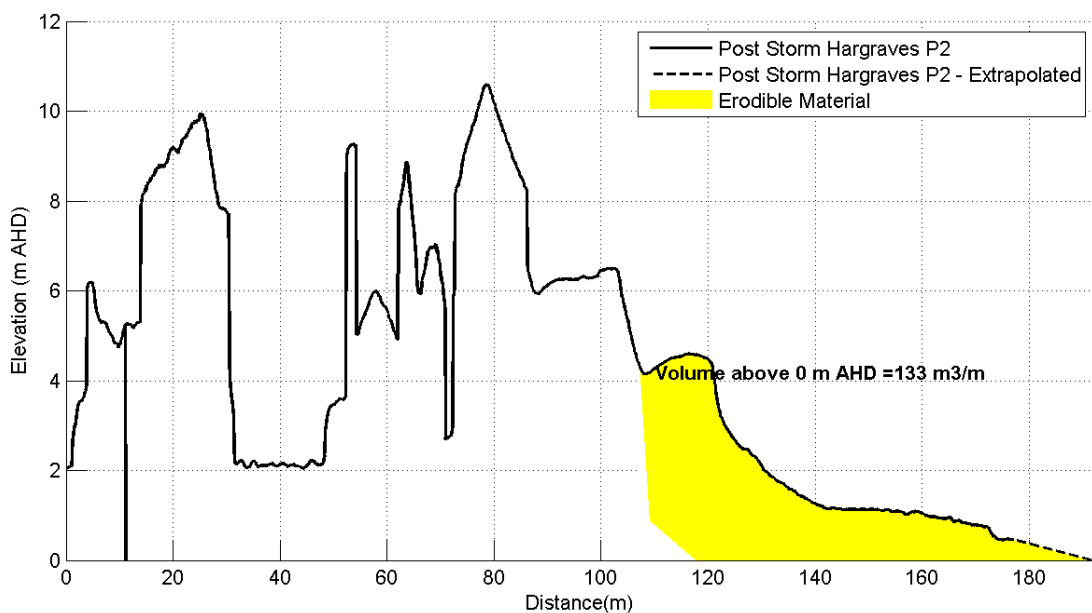
Figure 4-4: Hargraves Beach Profile 2, Post Storm

The central beach shows some significant movement of the scarp. Profile 2 showed a 15 m landward movement of the 2 m AHD contour and shows significant erosion occurring up to 50 m landward of the 0 m AHD contour. Similar beach retreat was observed at Profile 3, although significantly less volume change was observed at this location. This section of Hargraves Beach is densely populated with many residential buildings behind a low vegetated dune. Dramatic loss of beach volume puts these structures at greater risk of coastal inundation and structural damage if another similar storm event occurs before the beach has time to recover. The erosion from the June 2016 storm did not significantly threaten these houses, but did reduce the storm buffer available for subsequent storms. The volume of sand buffer remaining at Hargraves Beach Profile 2 is just over $130 \text{ m}^3/\text{m}$, smaller the design storm erosion of $150 \text{ m}^3/\text{m}$ (BMT WBM, 2015).

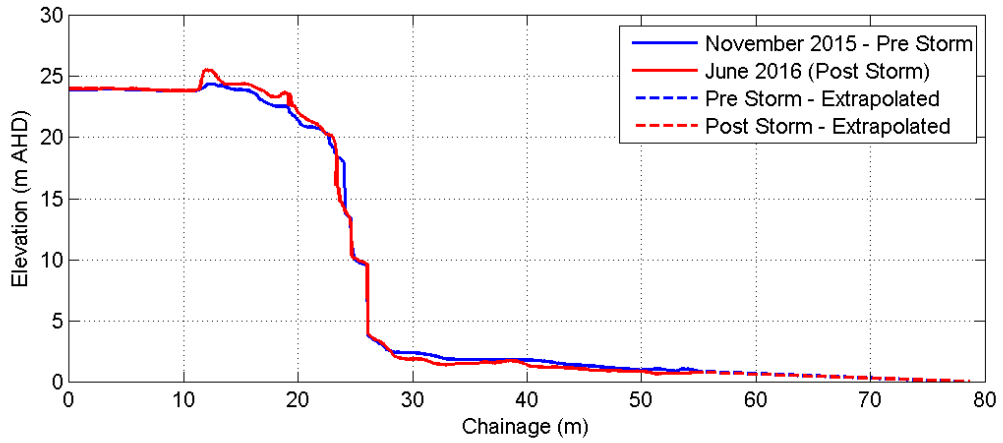
Figure 4-5: Jenny Dixon Profile

Jenny Dixon has significant rock outcrops present along the beach and the beach width was not considered adequate to perform any accurate beach volume change calculations. Inspection of the two ortho-mosaic images indicated that previously buried bed rock was exposed in the June 2016 survey. Anecdotal reports by local residents suggested that the erosion occurred following the ECL event, but that significant sand volumes had returned to the beach between the storm (4th June) and the UAV survey undertaken on the 17th June. This may have contributed to the minimal change in the beach profile at Jenny Dixon as shown in Figure 4-5 and Figure 4-6.

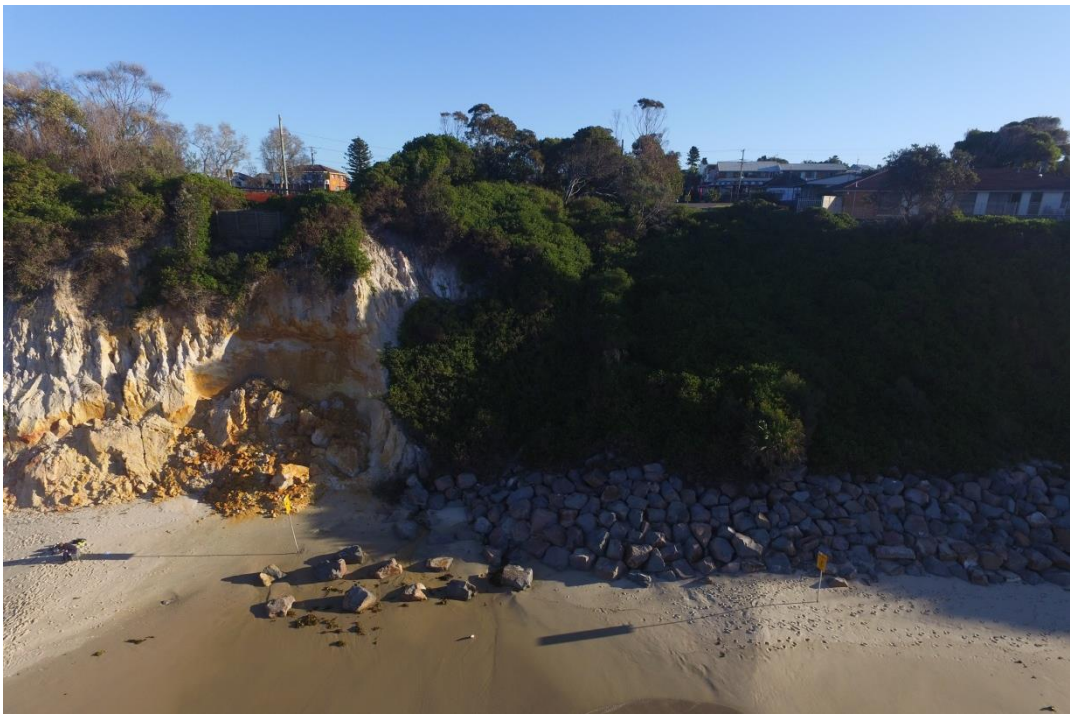
Figure 4-9: Photo of partial cliff collapse

However, during the survey, WRL identified the collapse of a cliff located near Profile 3 (Figure 4-10). Figure 4-9, Figure 4-11 and Figure 4-12 show 3D imagery of the cliff from November 2015 and June 2016 respectively. These figures clearly show the extent of the partial cliff collapse and the complete removal of vegetation at the base of the cliff. The Wyong Coastal Zone Management Plan (BMT WBM, 2015) identifies the cliff at Cabbage Tree Bay constituted by indurated sands (commonly known as coffee rock) that likely undermined during the June 2016 wave event due to direct wave attack and the loss of vegetation. A preliminary analysis of the UAV survey data estimates the total volume of material collapsed from the cliff is in excess of 90 m³. Figure 4-8 shows the profile taken through the region of the cliff collapse. The cliff has significantly steepened, which may lead to further geotechnical instability.

The most significant change observed at Cabbage Tree Bay was the partial cliff collapse at the centre of the cliff region, with substantial vegetation removed from the foot of the cliff. It is understood that this cliff collapse occurred as a direct result of the June 2016 storm.

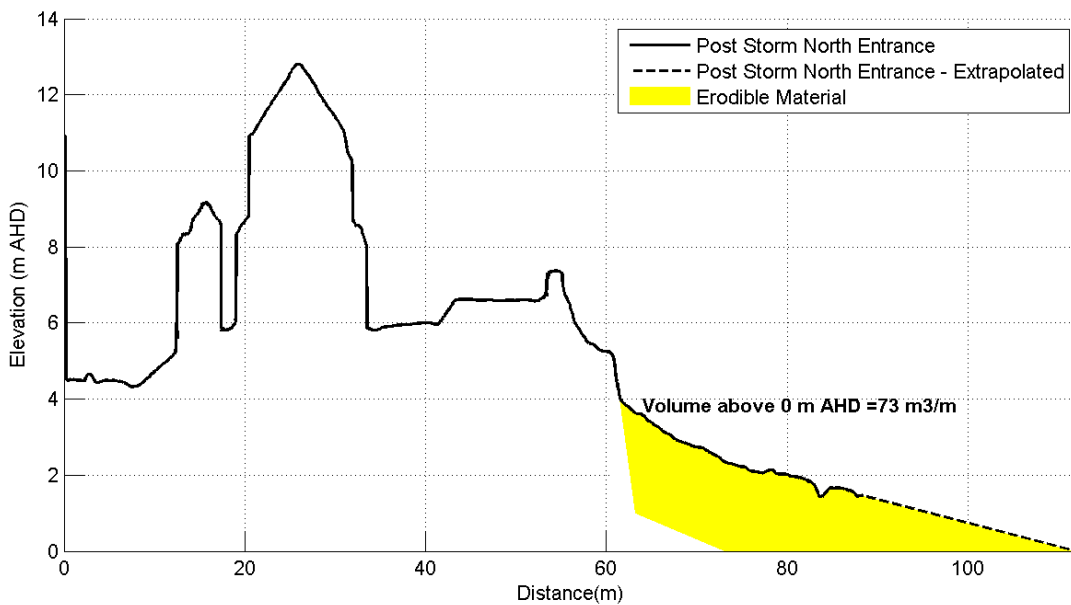
Figure 4-13: The Entrance North Profile (near Curtis Pde), Post Storm

The majority of The Entrance is highly developed close to the active beach. The erosion north of the Tuggerah Lake entrance was between 50 – 130 m³/m at all the profiles considered (Figure 4-15). This is between 30 – 75 % of the stated design storm demand of 170 m³/m (BMT WBM, 2015). Two of the profile locations have significant residential infrastructure located near the beach; Hutton Rd near Hargraves St (The Entrance Profile 1) and Curtis Pde (Entrance North Profile). As shown in the erosion intensity map (Figure 4-14) both of these locations have been substantially eroded between the two survey dates. At the two profiles, the 2 m AHD contour moved landward by approximately 15 m and at both locations erosion proceeded landward to the vegetated dunes. The erosion extent reached approximately 60 m landward of the 0 m AHD contour. The remaining sand buffer at The Entrance North Profile (near Curtis Pde) is approximately 70 m³/m, significantly less than the design storm demand of 170 m³/m (BMT WBM, 2015). If a storm of a similar intensity and wave direction of the June ECL occurs before the beach has time to recover, then there is significant potential for increased risk to residential infrastructure.

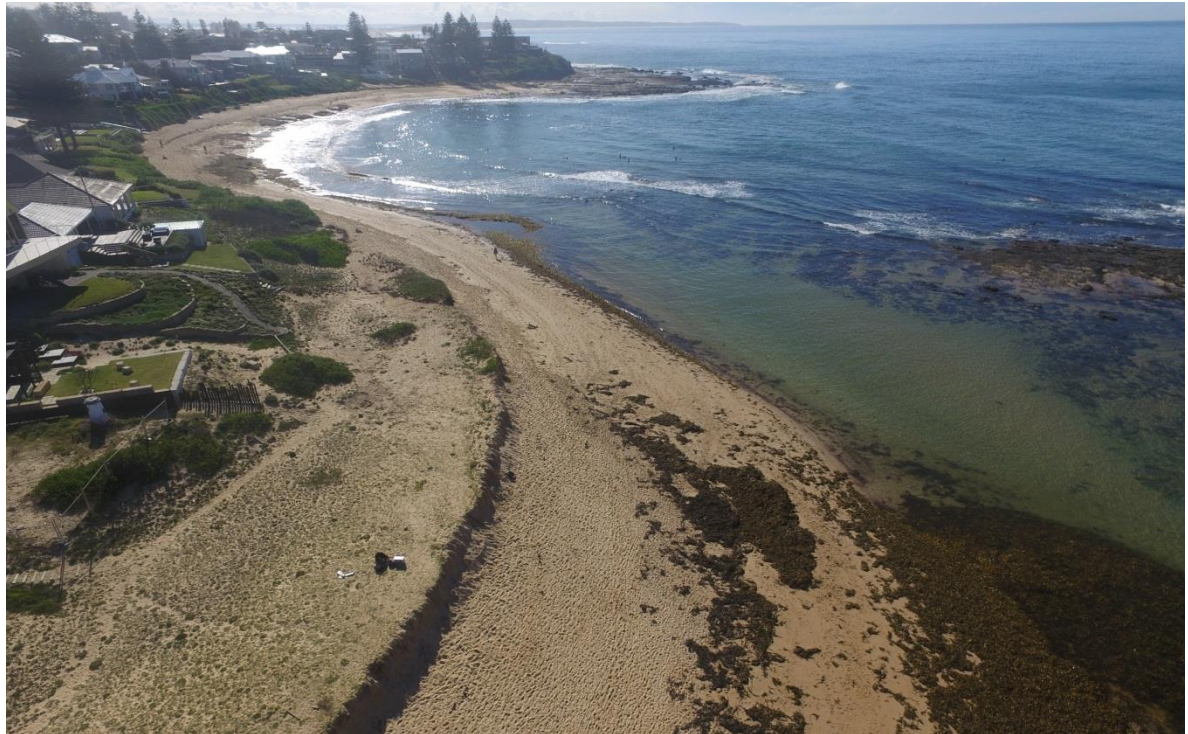
The only major erosion zone identified by the erosion intensity map occurred at the salient that separates Blue Bay and Toowoon Bay (Figure 4-17), which showed elevation changes of up to -1.5 m. It is unclear whether this is erosion caused by the June 2016 storm or long term temporal changes in the salient profile that occurred over the 7 months between the surveys. It is possible, however, that the long wave period, large waves heights and north-easterly direction associated with the June 2016 ECL event allowed waves to refract and propagate into the usually low wave energy zone around the salient. The erosion occurred at least 30 m seaward of any infrastructure. In comparison, the salient on the southern end of Toowoon Bay accreted between November 2015 and June 2016.

Figure 4-17: Blue Bay salient looking north. Note the significant weed build-up and dune scarp

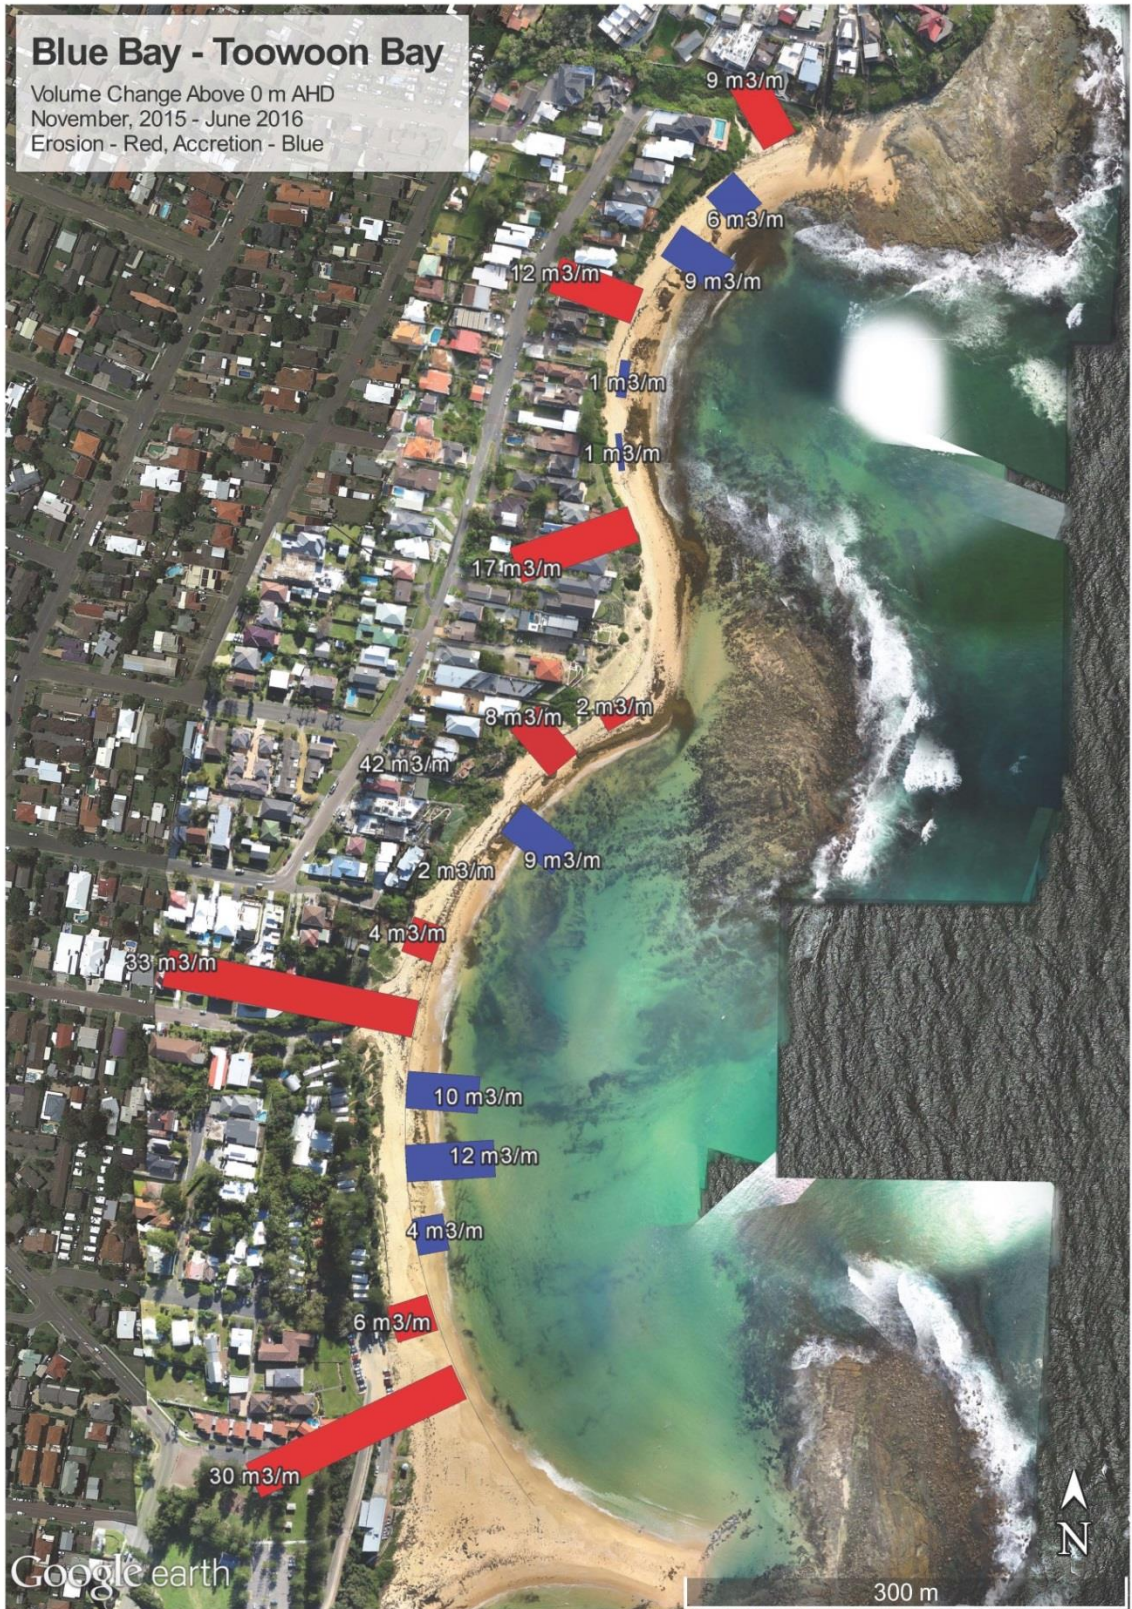
Figure 4-19: Blue Bay and Toowoon Bay volume change along the beach

Blue Bay and Toowoon Bay are protected by rock platforms and offshore reefs from the north and south which dissipate wave energy. As a result, the volumetric and beach profile changes were much less significant at these beaches than most other analysed locations. While erosion did occur along the beach (shown in the erosion intensity map in Figure 4-18 and the volumetric change map in Figure 4-19), the erosion is unlikely to have caused any significant concern to the residential buildings along the beach. A maximum volume loss of approximately 30 m³/m was observed. The accretion and erosion were not uniform along the beach, as shown in Figure 4-19. It is unclear whether the inconsistency in beach change was a result of the beaches' response to the June 2016 storm, or as a result of long term changes occurring between November 2015 and June 2016.

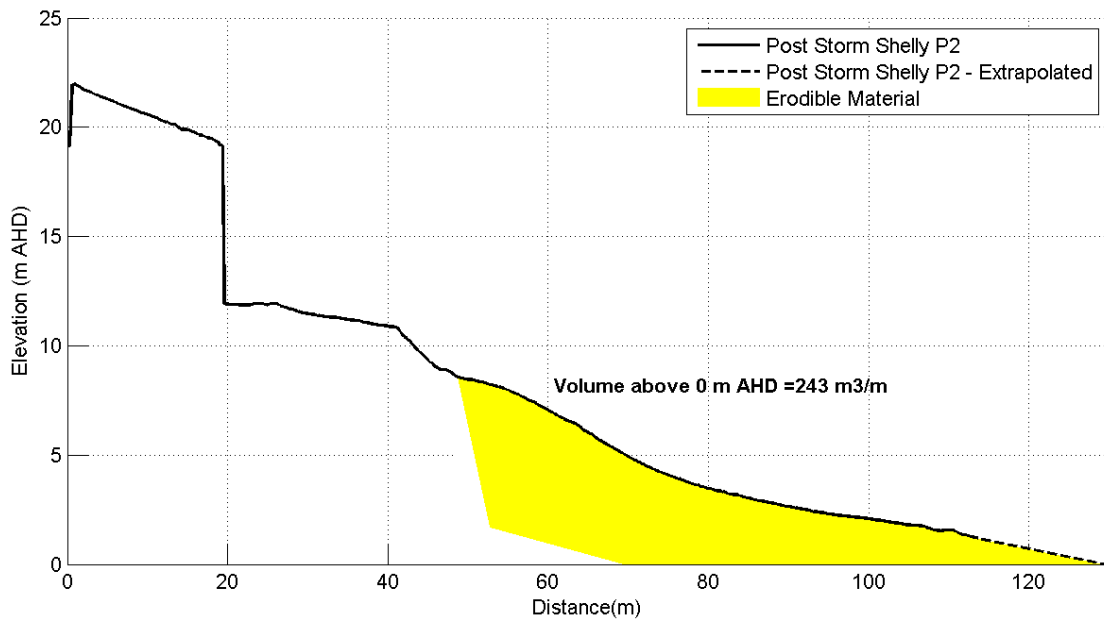
Figure 4-20: Shelly Beach Profile 2 (SLSC), Post Storm

Shelly Beach erosion intensity map (Figure 4-21) and the volume change along the beach (Figure 4-22) show two very distinct changes along the beach. The southern end accreted significantly, while the northern end experienced considerable erosion. The area in front of the SLSC (Shelly Beach Profile 2) and caravan park (Shelly Beach Profile 1) accreted over the time period under investigation. While the impact of the storm cannot be separated from long term accretion and erosion trends, it is unlikely the June 2016 storm caused significant erosion at the southern end of beach. Even with the accretion between the two survey dates, the sand buffer in front of Shelly SLSC is approximately 240 m³/m, less than the design storm demand of 290 m³/m.
