School of Civil and Environmental Engineering
Water Research Laboratory

Narrabeen Lagoon Entrance Clearance Operation Design

WRL TR 2018/16 | August 2018

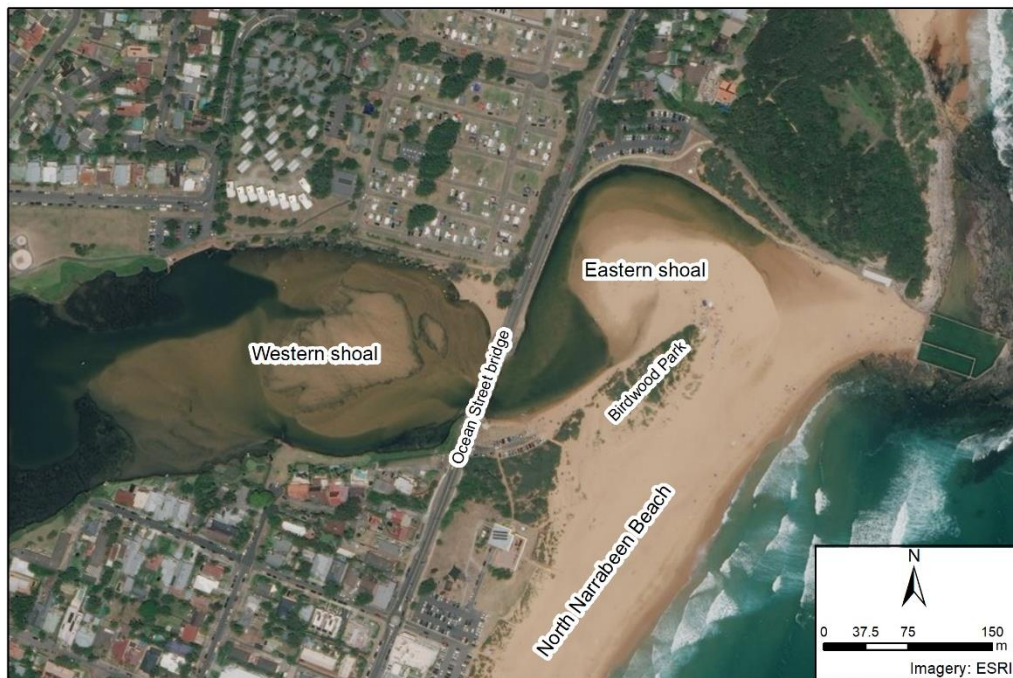
Figure 1: Narrabeen Lagoon entrance

Council has requested the UNSW Sydney (University of New South Wales) Water Research Laboratory’s (WRL) assistance developing cross-sections for excavation of the Narrabeen Lagoon entrance and design criteria for the subsequent replenishment on Collaroy-Narrabeen Beach. This information will be used to assist the development of a Review of Environmental Factors (REF). The following report outlines the criteria for the development of cross-sections in addition to methodologies to be considered during excavation. Sand will be removed from two shoals located on the east and west side of Ocean Street bridge (Figure 1) and placed upon Collaroy-Narrabeen

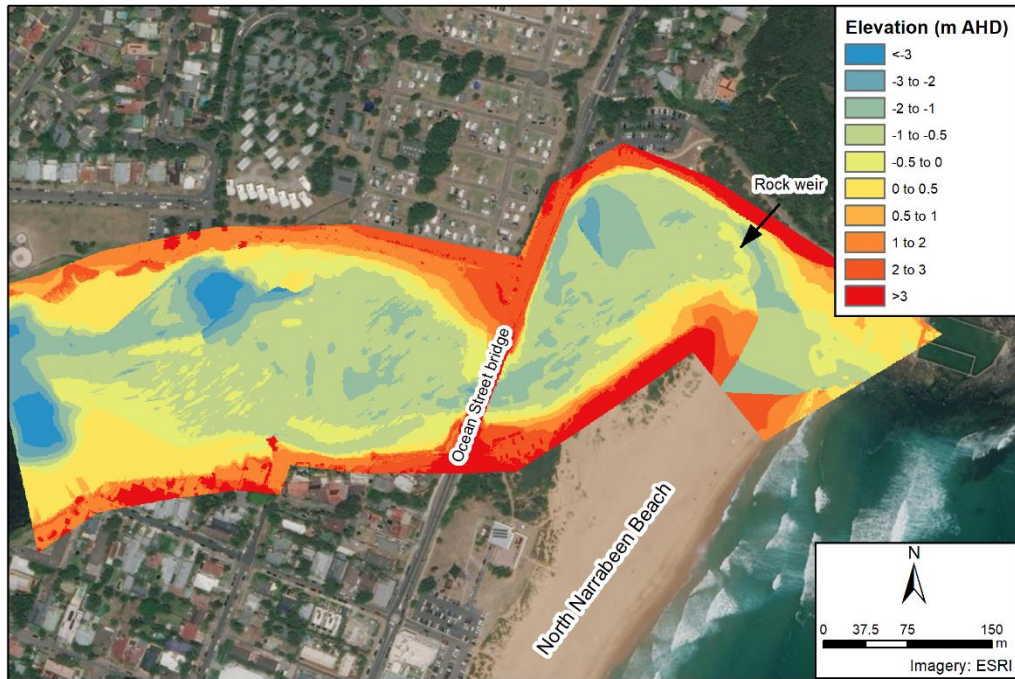
Where survey data was digital, or able to be digitised, it was turned from point data into a surface using natural neighbour interpolation. A digital elevation model (DEM) showing the survey limit was then created by combining these datasets and extracting the lowest elevation. This is shown in Figure 3, which is comprised of data from:

- 1976 Manly Hydraulics Laboratory (MHL) survey of the rock weir;
- 2002 post excavation survey of the lagoon;
- 2015 CMS Surveyors survey of the rock weir;
- 2016 post excavation survey of the lagoon; and
- 2018 WRL bathymetry survey.

Figure 3: Lagoon bathymetry maximum excavation survey limit

The deepest excavation within the western shoal was found in the 2011 excavation plans where a minimum elevation of -1.05 m AHD was reached on the eastern side closest to the Ocean Street bridge. This excavation generally tapered up to an elevation of -0.4 m AHD on the western side of the shoal. Excavation footprints generally varied from year to year, dependent upon macroalgae and seagrass locations (Craig and Rhodes, 2002, Cardno, 2011 and Cardno, 2016).

Surveys undertaken for the eastern shoal showed a minimum elevation of -0.8 m AHD closest to Ocean Street bridge. This tapered up to a level of -0.5 m AHD closest to the entrance. There is a rock weir at approximately 0 m AHD that constricts flow and subsequently limits excavations at the point of Birdwood Park. Surveys on the downstream side of this rock weir showed that the rock shelf lowers again to below -1 m AHD.

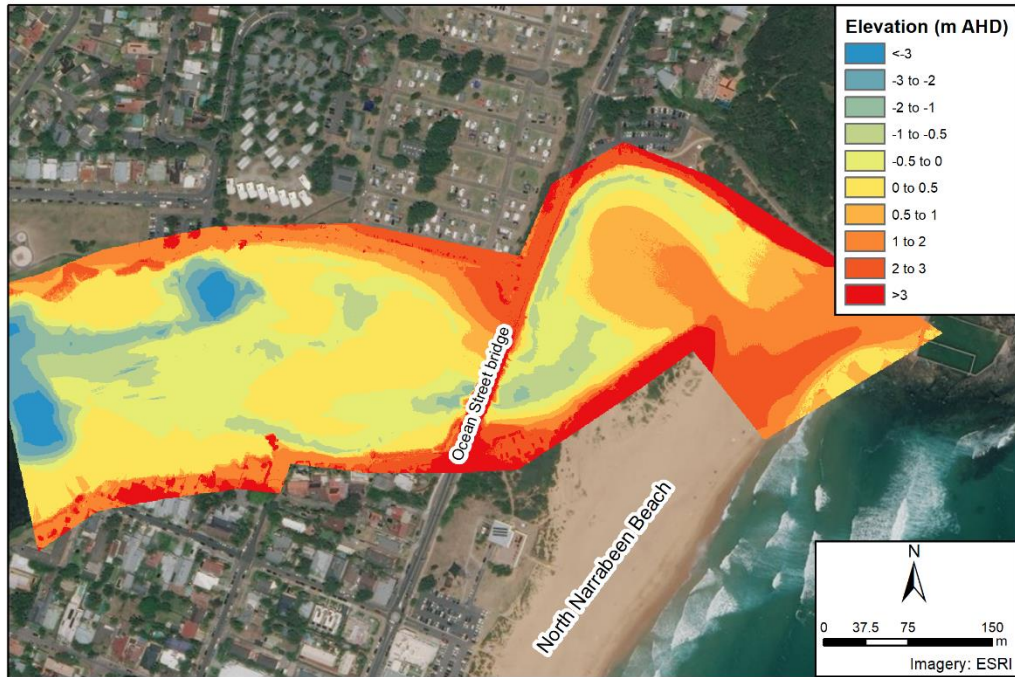
A DEM was also created for the existing bathymetry from the most recent 2018 survey (Figure 4) (WRL, 2018). Both DEM's were sampled at a 0.5 m interval for analysis.

Figure 4: Lagoon bathymetry as surveyed from May to June 2018 (WRL, 2018)

Three different survey techniques were used to compile the DEM for the existing (2018) lagoon bathymetry:

1. Unmanned Aerial System (UAS) photogrammetry;
2. Standalone Real Time Kinetic (RTK) GPS surveys; and
3. Boat mounted echo sounding surveys corrected by RTK-GPS.

Each survey technique has a small error associated with its measurements. The specific root mean square (RMS) error for each technique is shown in Table 2. While the errors are small, the excavation footprint of the lagoon has a total area of almost 50,000 m² (see Section 3.2) meaning the total volume uncertainty is not insignificant. This area was separated into zones depending on how it was surveyed. The total uncertainty in volume was subsequently calculated to be $\pm 1,300$ m³ (< 3% of the total volume to be excavated).

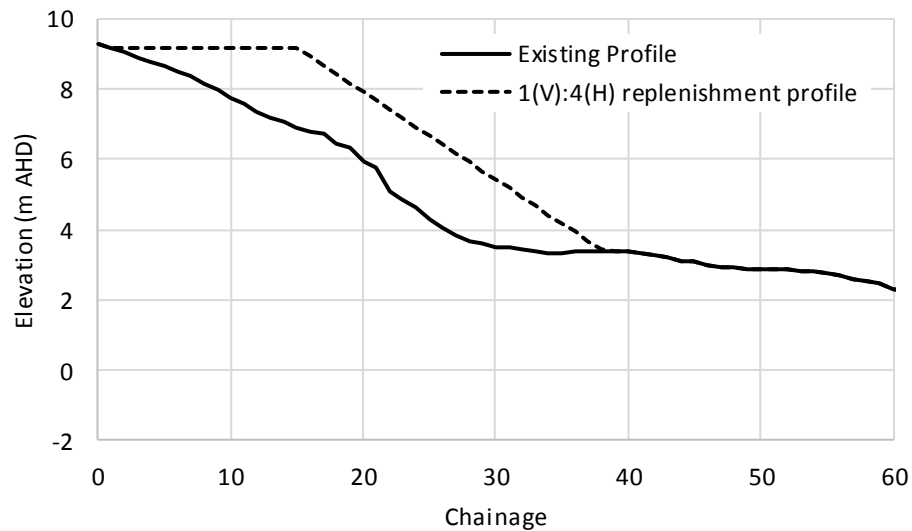
Figure 6: Indicative replenishment profile overlain on a cross section taken at Narrabeen Street on 13 June 2018 with a volume of 55 m³/m

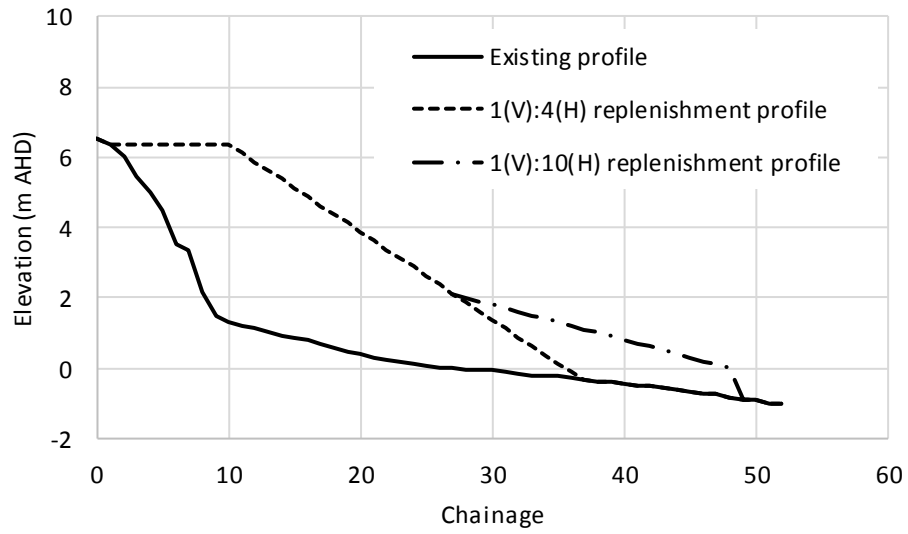
Figure 7: Indicative replenishment profile overlain on a cross section taken at Wetherill Street on 13 June 2018 with a volume of 115 m³/m

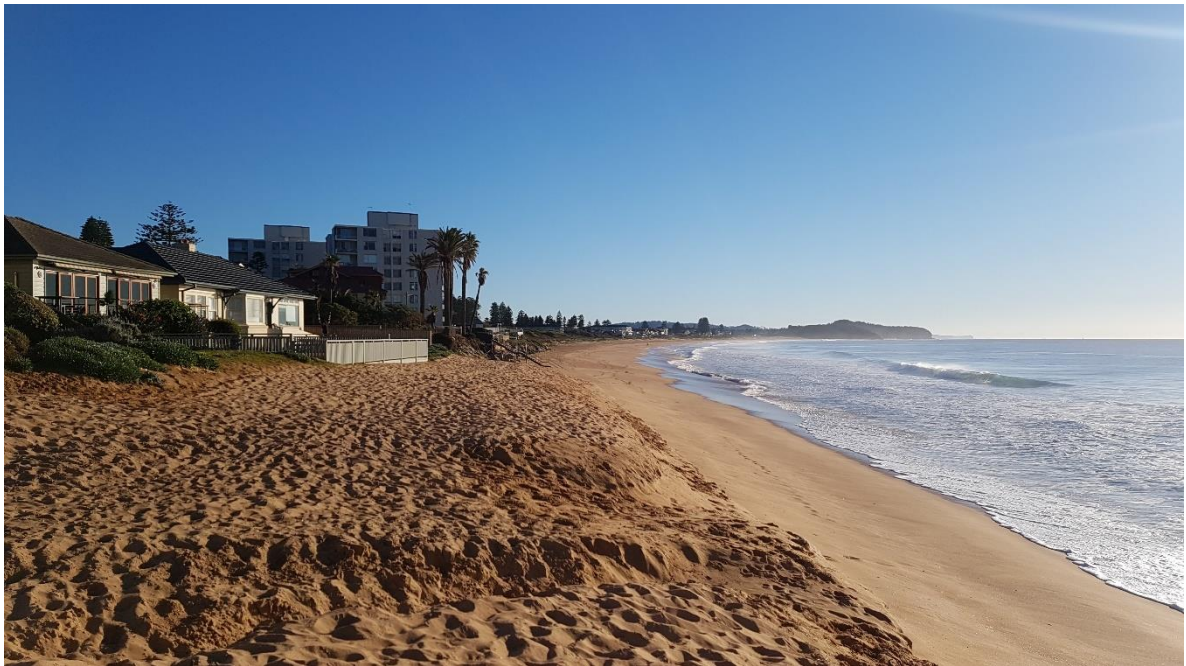
Figure 8: Erosion as seen from Mactier Street looking north on 13 July 2018

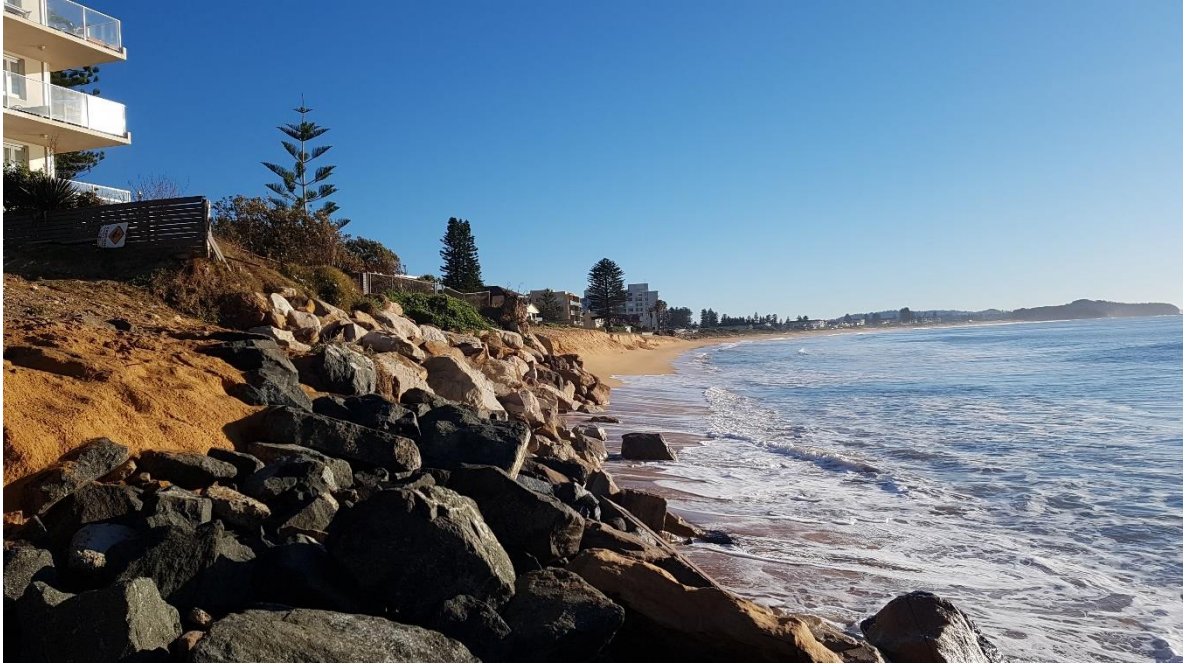
Figure 9: Erosion as seen from Wetherill Street looking north on 13 July 2018

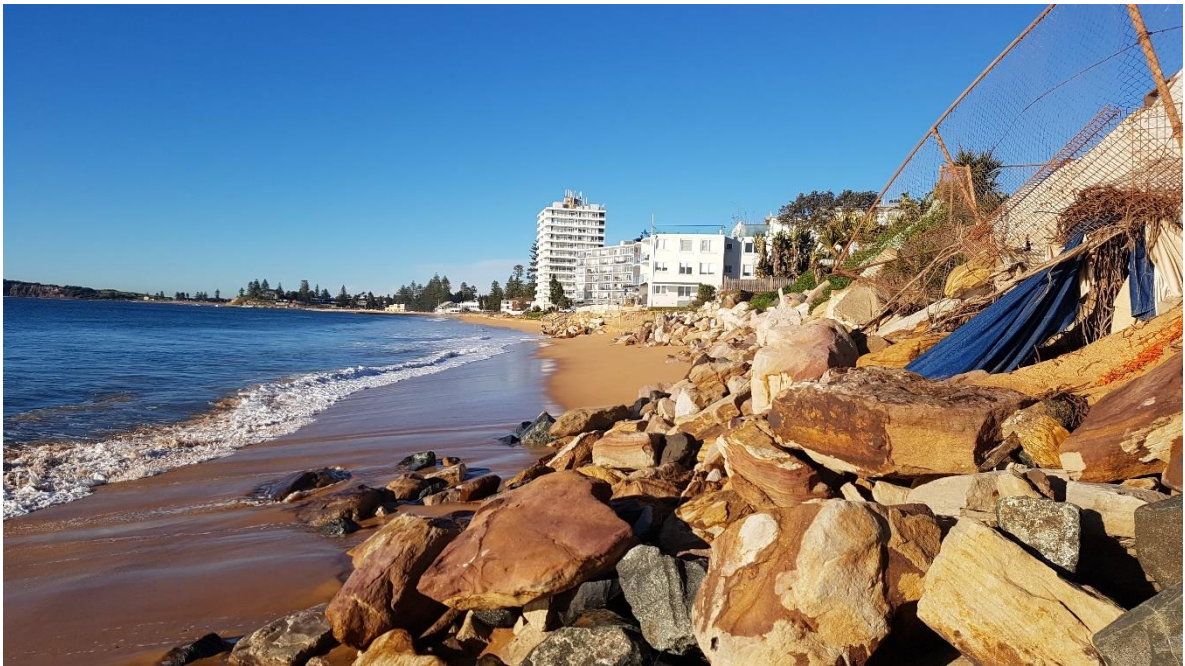
Figure 10: Erosion as seen from Wetherill Street looking south on 13 July 2018

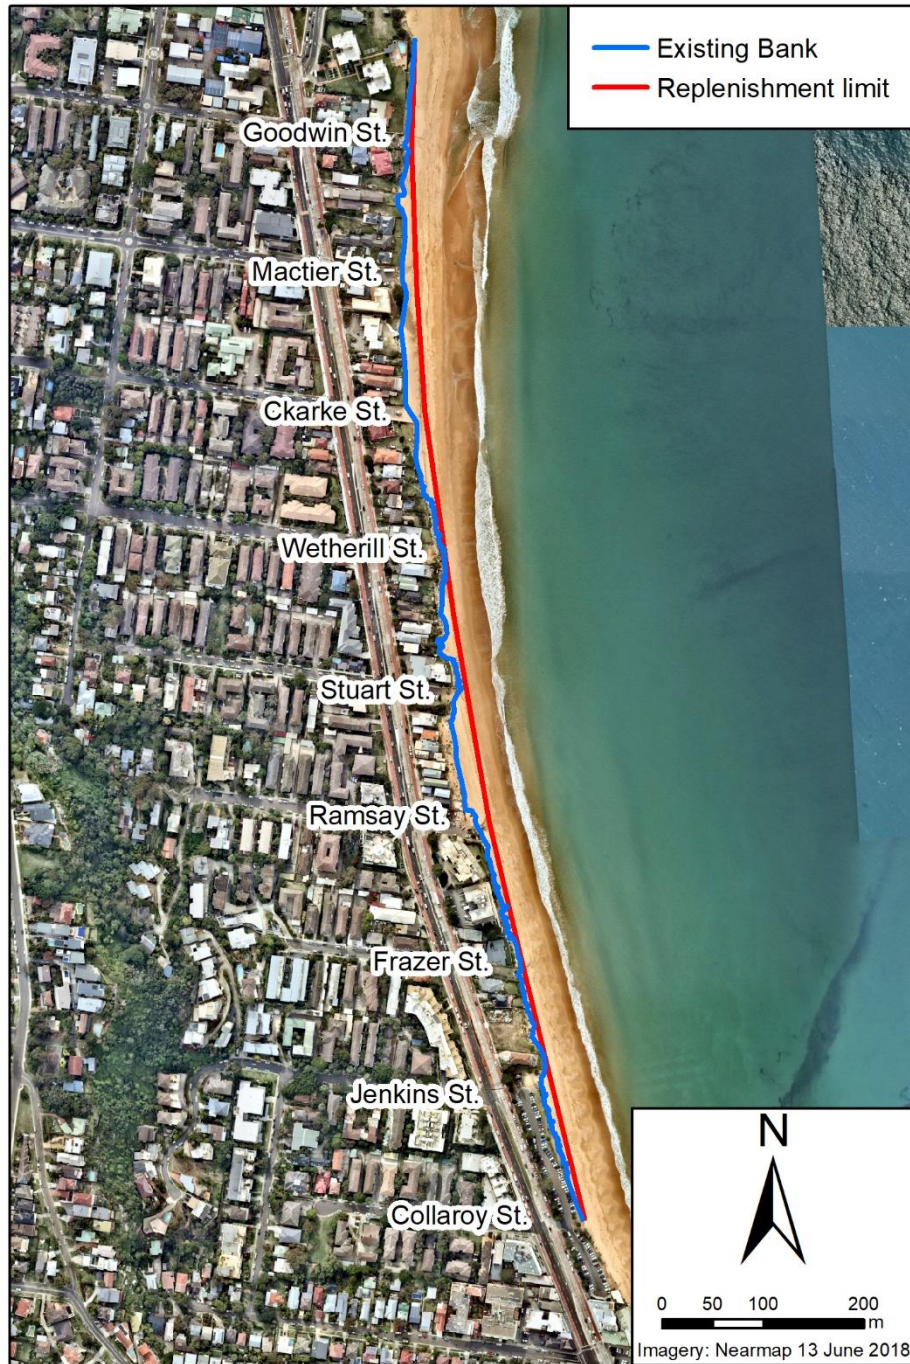
The alongshore location where Collaroy-Narrabeen Beach should be replenished is shown in Figure 11. Replenishment should be completed so that the limit of the profile closest to the shore along the length of the replenished area has a smooth embayed shape. Having areas which protrude could lead to rip currents developing and increased concentrated erosion adjacent to these areas. During summer and autumn there is likely to be prevailing conditions that would lead to longshore transport to the south (Harley et al., 2011). Additionally, access to Collaroy-Narrabeen Beach for replenishment is limited to Mactier Street. For this reason replenishment should start at Mactier Street and continue south until excavated materials runs out. If there is enough sand, areas to the north of Mactier Street can be replenished.

Figure 11: Beach replenishment location

Beach (see Figure 11 in Section 4.2). Criteria outlined in this report are pending any findings of the REF.

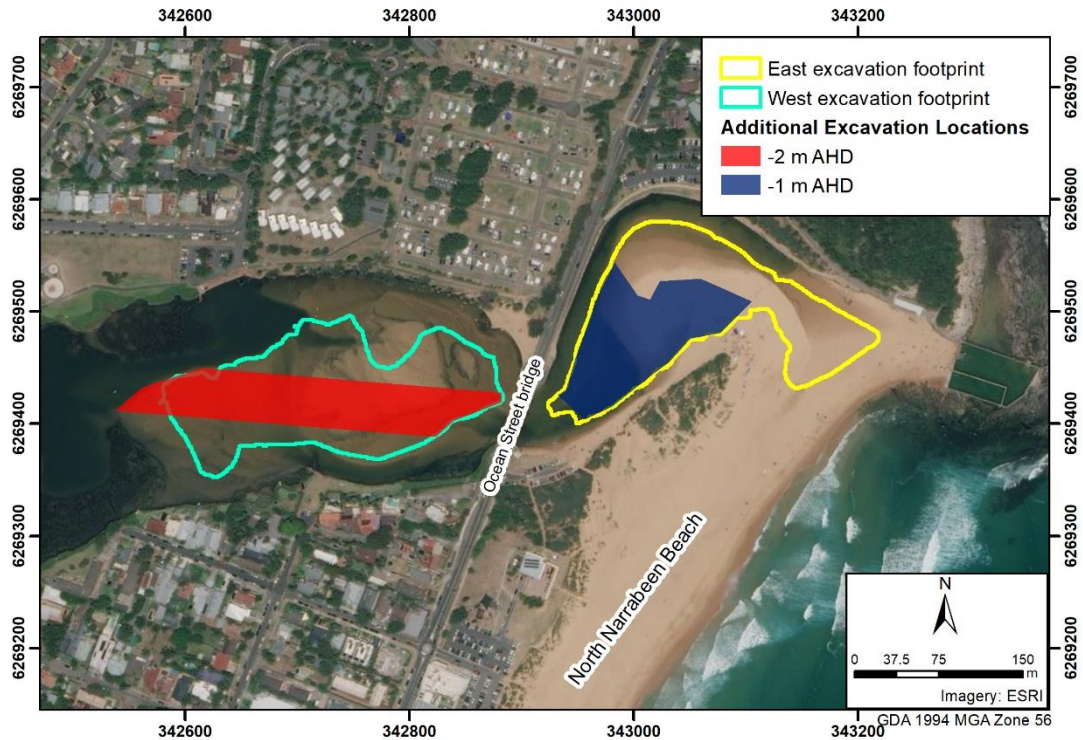
Excavation of a channel on the western side of Ocean Street bridge (As shown in Figure 12) will help alleviate erosion to the southern bank by redirecting flow through the centre of the lagoon. However, due to the nature of Narrabeen Lagoon being an ICOLL, the channel will infill as the lagoon tends to closure. Maintenance will be required to ensure the channel remains free from sand.

Figure 12: Locations where the excavation limit could be lowered

Council has expressed an aspirational excavation target of 50,000 m³ from Narrabeen lagoon. In order to increase the volume of sand excavated within Narrabeen Lagoon from 39,100 m³ to 50,000 m³ it is feasible that the excavation limit could be lowered at specific locations as shown in Figure 12. It is estimated that approximately 15,000 m³ of sand is available in these locations. Higgs (1977) found that marine sand was deposited to a depth below the bed of 1.5 m west of Ocean Street bridge and 1.2 m to the east. Core samples taken as a part of this investigation did not have the spatial resolution to determine if sand was of acceptable quality for large scale excavation. Ideally, sand samples in these areas would be obtained prior to any excavation to ensure they are suitable for beach replenishment. To expedite the process, a suitably qualified coastal engineer could supervise the excavation of sand in these areas to ensure its quality. There is potential for suitable sand to be excavated on the east of Ocean Street bridge to an elevation of -1 m AHD and to an elevation of -2 m AHD on the west (see Figure 12). On the east where additional excavation is suggested to an elevation of -1 m AHD, there is a high likelihood that rock could be encountered. For this reason suitable checks should be conducted, alongside the inspection of sand quality, prior to excavating this area. These works would need to be in compliance with the REF. It is recommended that detailed surveys be undertaken to benefit future clearance operations should additional excavations be completed.

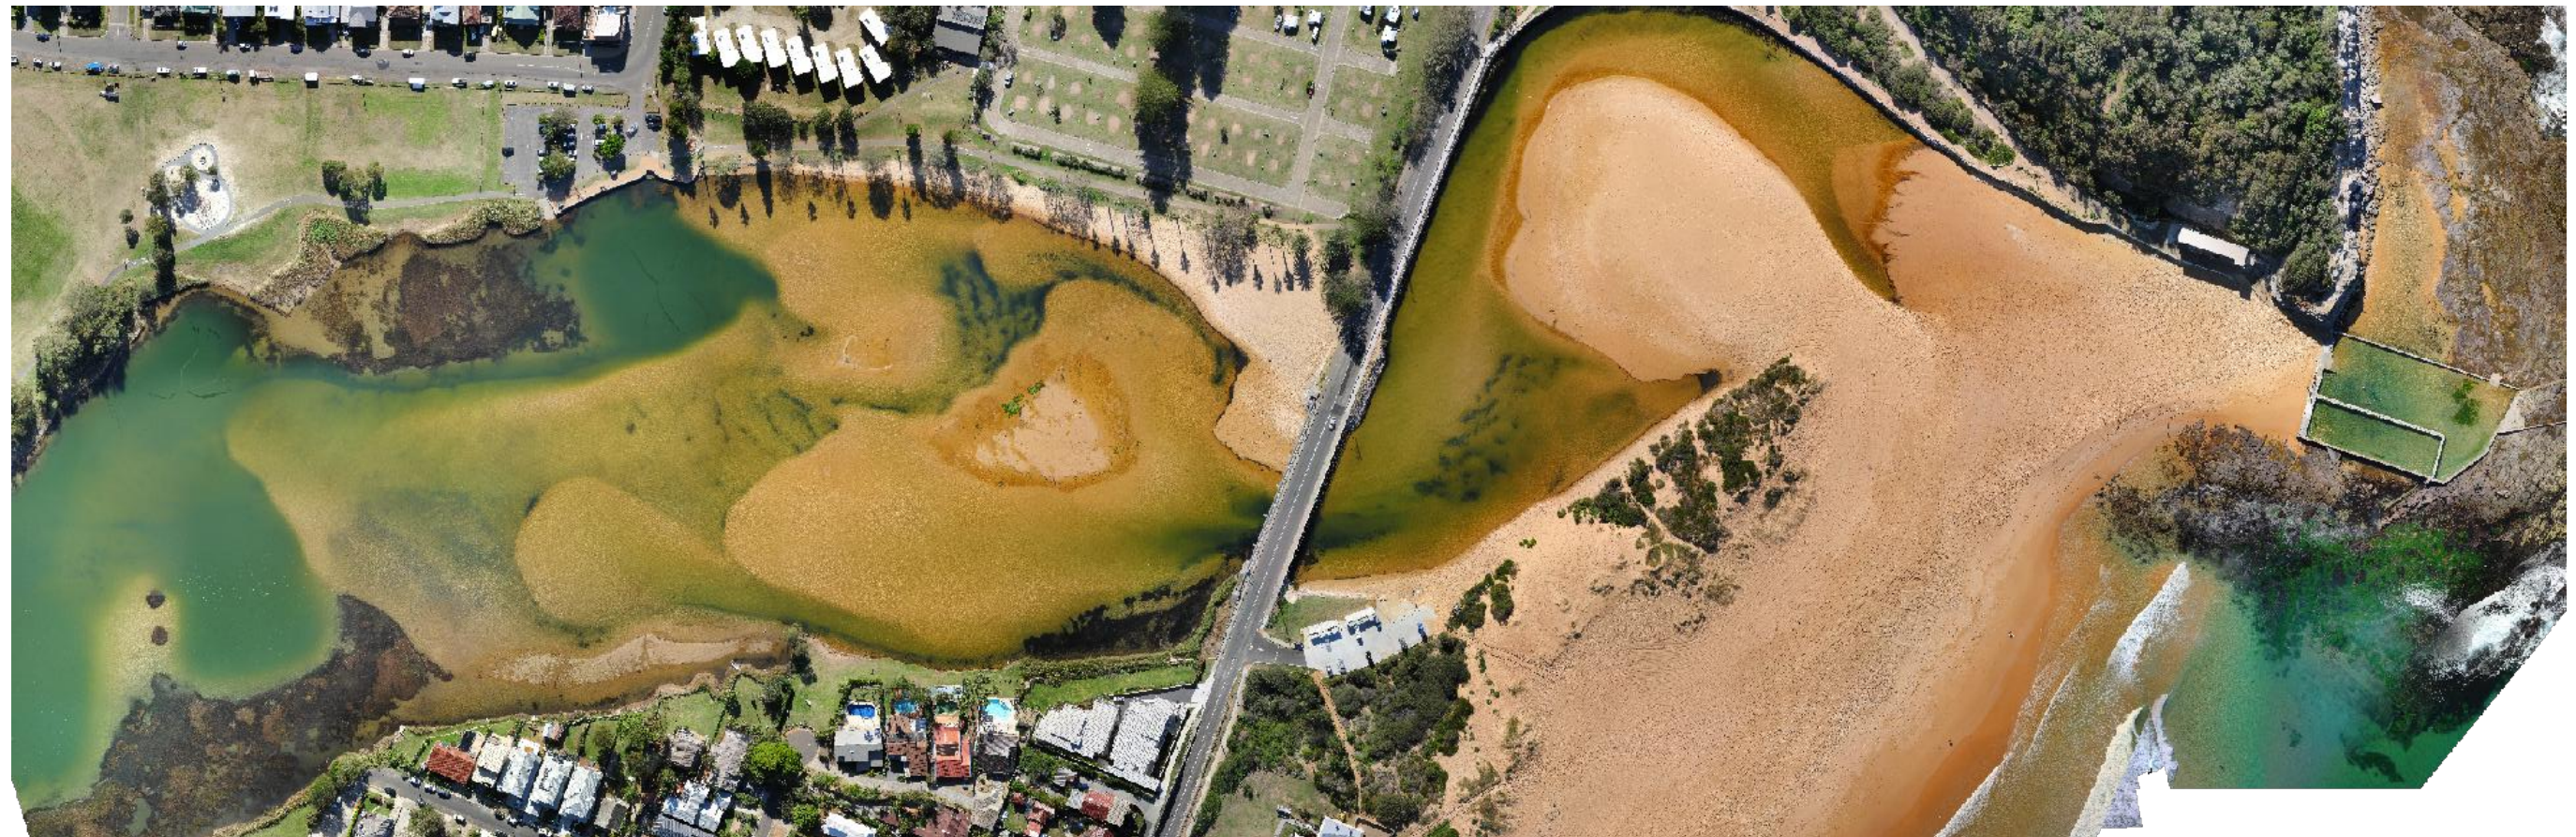
Narrabeen Lagoon Clearance Operation 2018

Imagery: WRL 29 May 2018

4. Cross-sections east of the Ocean Street bridge are close to the rock shelf and pre-excavation checks should be conducted to ensure the rock shelf is not damaged

The ideal excavation procedure should start with cross-sections E01 to E015 (Figure 5 and Appendix A). This will reduce the impact of any turbidity created during excavation to the area east of the Ocean Street bridge. This should be followed by excavation of the western shoal. To facilitate movement of machinery, the western shoal should be cleared from west to east. Finally, cross-sections E16 to E19 should be cleared from west to east. Once completed, the lagoon should be mechanically opened. In summary, it is recommended that cross-sections are excavated in the following order:

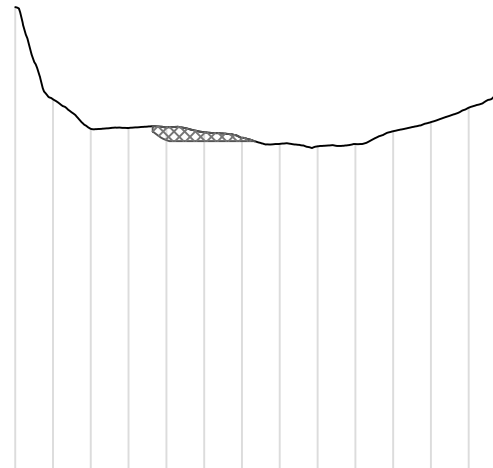
Section E01

Existing	2.74	0.31	-0.48	-0.45	-0.44	-0.57	-0.71	-0.87	-0.94	-0.88	-0.54	-0.30	0.08
Excavation					-0.77	-0.80	-0.80						
Difference					0.34	0.23	0.09						
Chainage	0	5	10	15	20	25	30	35	40	45	50	55	60

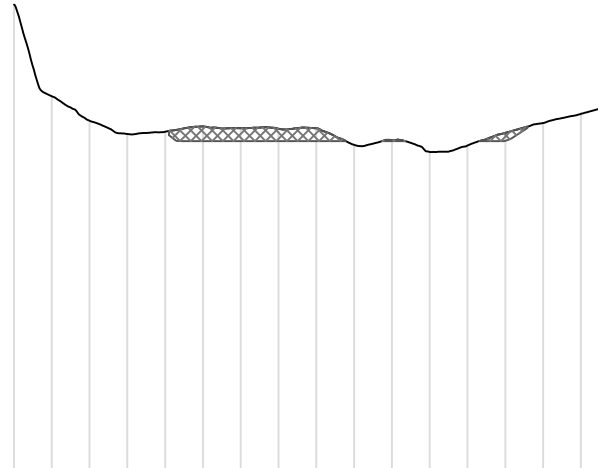
Section E02

Existing	2.81	0.38	-0.26	-0.61	-0.55	-0.41	-0.46	-0.47	-0.46	-0.90	-0.77	-1.09	-0.92	-0.58	-0.32	-0.08
Excavation						-0.80	-0.80	-0.80	-0.80					-0.79		
Difference						0.39	0.34	0.33	0.34					0.21		
Chainage	0	5	10	15	20	25	30	35	40	45	50	55	60	65	70	75

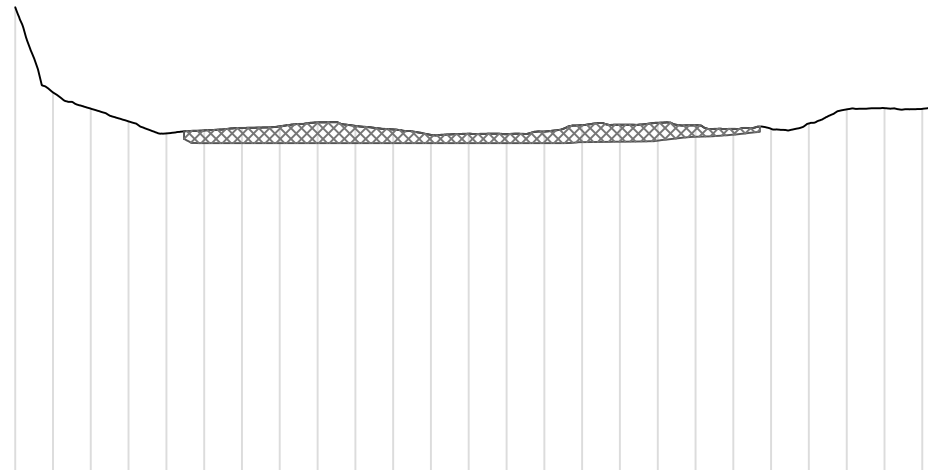
Section E03

Existing	2.79	0.54	0.11	-0.23	-0.54	-0.80	-0.46	-0.40	-0.36	-0.25	-0.34	-0.44	-0.58	-0.55	-0.56	-0.50	-0.33	-0.31	-0.26	-0.33	-0.42	-0.42	-0.28	0.09	0.12	0.10
Excavation						-0.80	-0.80	-0.80	-0.80	-0.80	-0.80	-0.80	-0.80	-0.80	-0.80	-0.80	-0.78	-0.76	-0.74	-0.63	-0.58					
Difference						0.34	0.40	0.44	0.55	0.46	0.36	0.22	0.22	0.25	0.24	0.30	0.45	0.45	0.47	0.30	0.15					
Chainage	0	5	10	15	20	25	30	35	40	45	50	55	60	65	70	75	80	85	90	95	100	105	110	115	120

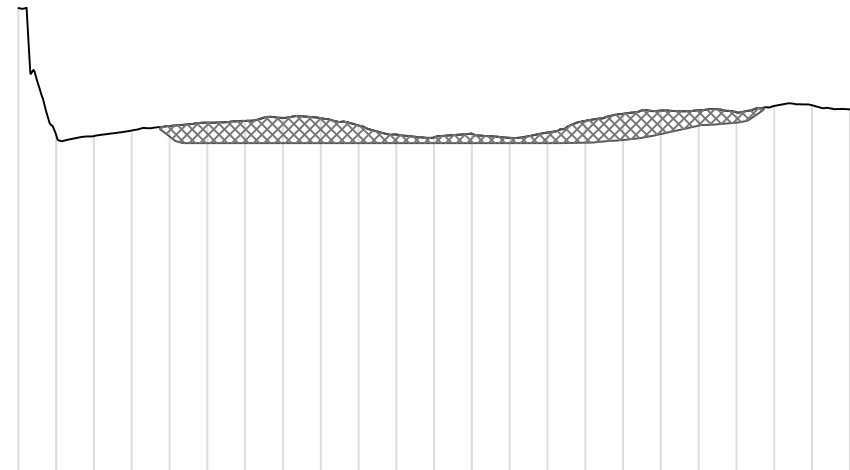
Section E04

Existing	2.77	-0.59	-0.61	-0.47	-0.35	-0.26	-0.21	-0.13	-0.14	-0.33	-0.58	-0.65	-0.55	-0.66	-0.52	-0.21	-0.03	0.06	0.07	0.02	0.18	0.20	0.09	
Excavation					-0.62	-0.80	-0.80	-0.80	-0.80	-0.80	-0.80	-0.80	-0.80	-0.80	-0.80	-0.79	-0.72	-0.56	-0.34	-0.26				
Difference					0.28	0.54	0.59	0.67	0.66	0.47	0.22	0.15	0.25	0.14	0.28	0.58	0.69	0.62	0.41	0.27				
Chainage	0	5	10	15	20	25	30	35	40	45	50	55	60	65	70	75	80	85	90	95	100	105	110

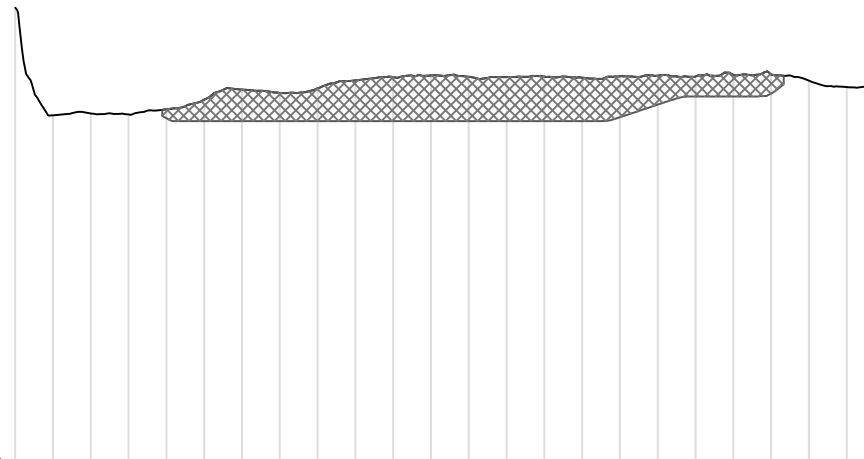
Section E05

Existing	2.20	-0.65	-0.60	-0.62	-0.49	-0.23	0.03	-0.05	0.06	0.28	0.36	0.41	0.37	0.37	0.35	0.39	0.40	0.38	0.42	0.44	0.27	0.10	
Excavation					-0.72	-0.80	-0.80	-0.80	-0.80	-0.80	-0.80	-0.80	-0.80	-0.80	-0.80	-0.70	-0.36	-0.15	-0.15	-0.07			
Difference					0.24	0.57	0.83	0.74	0.86	1.08	1.16	1.21	1.17	1.17	1.15	1.08	0.77	0.53	0.57	0.51			
Chainage	0	5	10	15	20	25	30	35	40	45	50	55	60	65	70	75	80	85	90	95	100	105	110

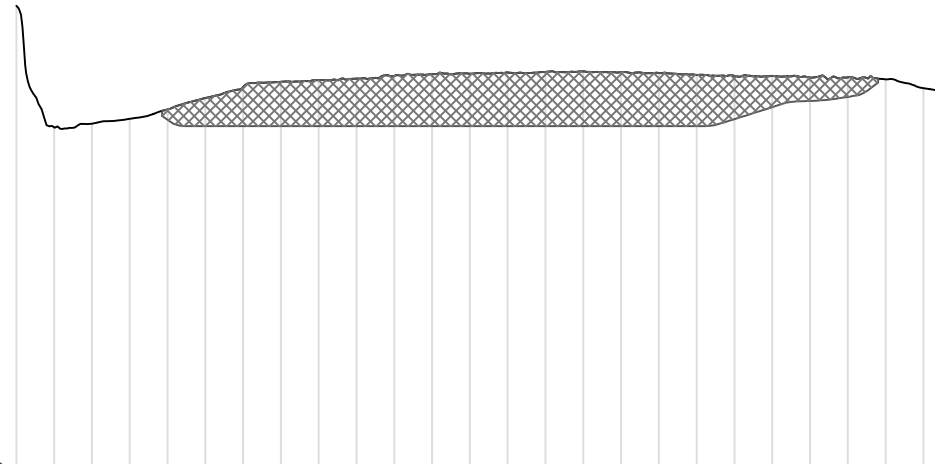
Section E06

Existing	2.38	-0.83	-0.74	-0.60	-0.36	-0.06	0.23	0.37	0.42	0.46	0.53	0.58	0.58	0.62	0.63	0.65	0.63	0.61	0.55	0.53	0.49	0.49	0.44	0.20	
Excavation					-0.63	-0.80	-0.80	-0.80	-0.80	-0.80	-0.80	-0.80	-0.80	-0.80	-0.80	-0.80	-0.80	-0.80	-0.80	-0.80	-0.80	-0.80	-0.80	-0.80	
Difference					0.27	0.74	1.03	1.17	1.22	1.26	1.33	1.38	1.38	1.42	1.43	1.45	1.43	1.41	1.35	1.15	0.62	0.30	0.35	0.20	
Chainage	0	5	10	15	20	25	30	35	40	45	50	55	60	65	70	75	80	85	90	95	100	105	110	115	120

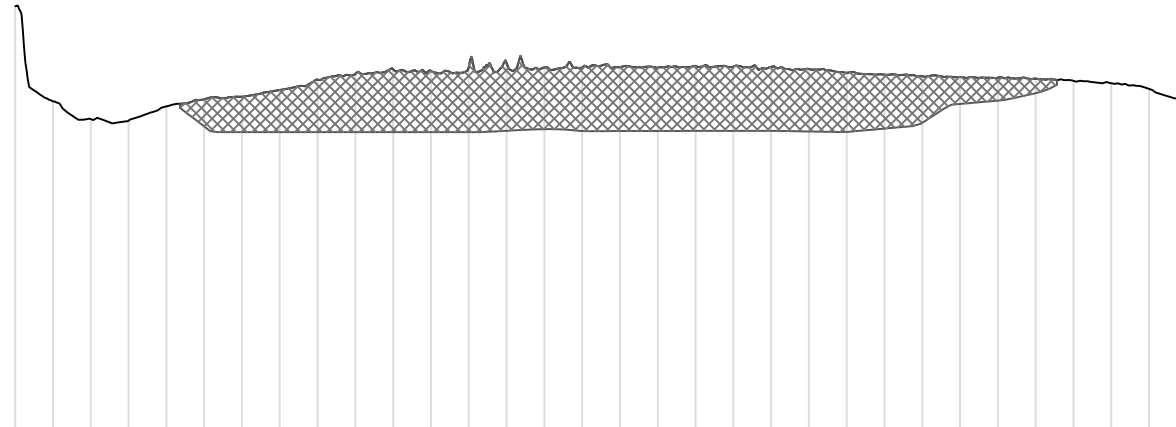
Section E10

Existing	2.53	0.01	-0.46	-0.49	-0.12	0.07	0.14	0.31	0.59	0.74	0.86	0.82	0.92	1.03	0.91	0.91	0.92	0.91	0.94	0.93	0.93	0.87	0.77	0.68	0.66	0.64	0.61	0.56	0.49	0.34		
Excavation						-0.65	-0.80	-0.80	-0.80	-0.80	-0.80	-0.80	-0.80	-0.77	-0.72	-0.77	-0.77	-0.77	-0.77	-0.77	-0.77	-0.78	-0.80	-0.71	-0.55	-0.06	0.03	0.23				
Difference						0.72	0.94	1.11	1.39	1.54	1.66	1.62	1.72	1.79	1.63	1.68	1.69	1.68	1.71	1.70	1.70	1.65	1.57	1.43	1.23	0.71	0.61	0.38	0.61	0.56	0.49	0.34
Chainage	0	5	10	15	20	25	30	35	40	45	50	55	60	65	70	75	80	85	90	95	100	105	110	115	120	125	130	135	140	145	150

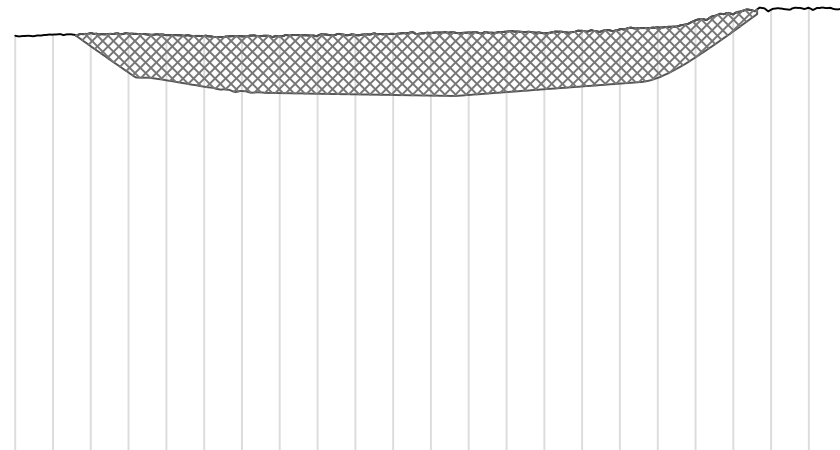
Section E19

Existing	1.51	1.54	1.58	1.57	1.53	1.51	1.50	1.49	1.51	1.53	1.56	1.59	1.59	1.62	1.58	1.64	1.68	1.73	1.92	2.08	2.20	2.25
Excavation		0.35	0.53	0.33	0.16	0.05	-0.01	-0.02	-0.04	-0.06	-0.07	-0.05	0.02	0.09	0.17	0.24	0.40	0.94	1.63			
Difference																						
Chainage	5	10	15	20	25	30	35	40	45	50	55	60	65	70	75	80	85	90	95	100	105

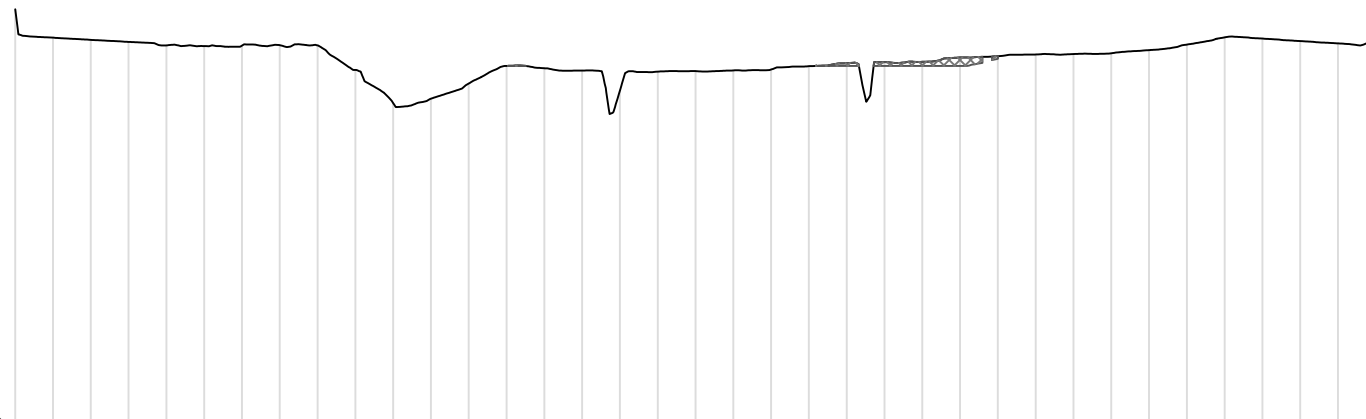
Section W01

Existing	1.10	0.35	0.29	0.24	0.14	0.13	0.14	0.15	0.15	-0.51	-1.38	-1.26	-0.86	-0.40	-0.46	-0.52	-1.05	-0.55	-0.54	-0.52	-0.49	-0.41	-0.33	-0.30	-0.29	-0.18	-0.14	-0.10	-0.08	-0.07	0.02	0.17	0.36	0.32	0.26	0.20	0.30		
Excavation																																							
Difference																																							
Chainage	5	10	15	20	25	30	35	40	45	50	55	60	65	70	75	80	85	90	95	100	105	110	115	120	125	130	135	140	145	150	155	160	165	170	175	180

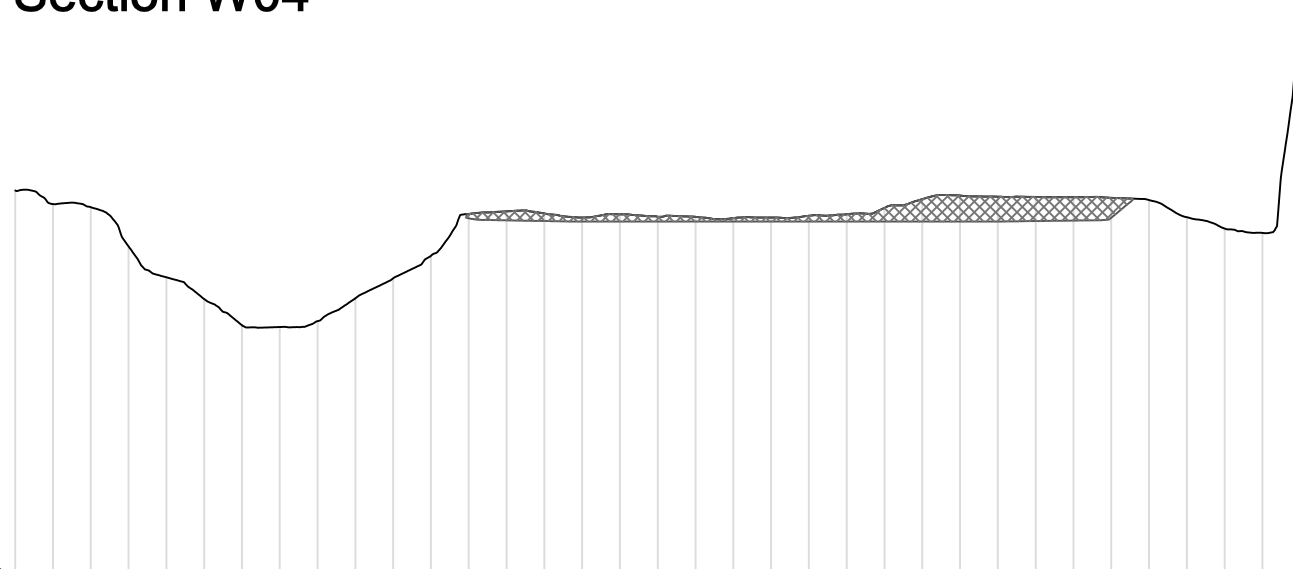
Section W04

Existing	Excavation	Difference	Chainage
0.27			5
-0.09			10
-0.17			15
-1.21			20
-2.02			25
-2.60			30
-3.29			35
-3.34			40
-3.18			45
-2.58			50
-2.05			55
-1.45			60
0.12	-0.46	-0.35	65
0.24	-0.52	-0.28	70
0.20	-0.53	-0.34	75
0.11	-0.55	-0.44	80
0.19	-0.55	-0.36	85
0.13	-0.55	-0.42	90
0.12	-0.55	-0.42	95
0.09	-0.55	-0.45	100
0.11	-0.55	-0.44	105
0.15	-0.55	-0.39	110
0.19	-0.55	-0.36	115
0.36	-0.55	-0.19	120
0.59	-0.55	0.04	125
0.69	-0.55	0.14	130
0.66	-0.55	0.11	135
0.64	-0.53	0.10	140
0.62	-0.52	0.10	145
0.53	-0.45	0.08	150
0.02			155
-0.43			160
-0.73			165
-0.85

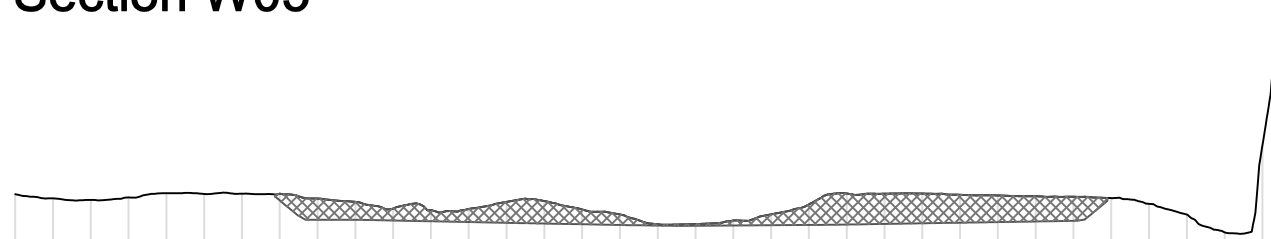
Section W05

Existing	0.18	0.07	0.02	0.09	0.20	0.18	0.19	0.19	0.01	0.19	0.06	0.03	0.20	0.24	0.21	0.03	0.00	0.23	0.36	0.09	0.19	0.19	0.16	0.14	0.12	0.11	0.07	0.08	0.36	0.83	1.47			
Excavation									0.01		-0.50	-0.50	-0.52	-0.54	-0.56	-0.58	-0.60	-0.62	-0.64	-0.65	-0.63	-0.61	-0.59	-0.56	-0.55	-0.53								
Difference									0.18	0.19	0.56	0.53	0.52	0.54	0.56	0.55	0.60	0.62	0.64	0.65	0.63	0.61	0.59	0.56	0.55	0.53								
Chainage	0	5	10	15	20	25	30	35	40	45	50	55	60	65	70	75	80	85	90	95	100	105	110	115	120	125	130	135	140	145	150	155	160	165

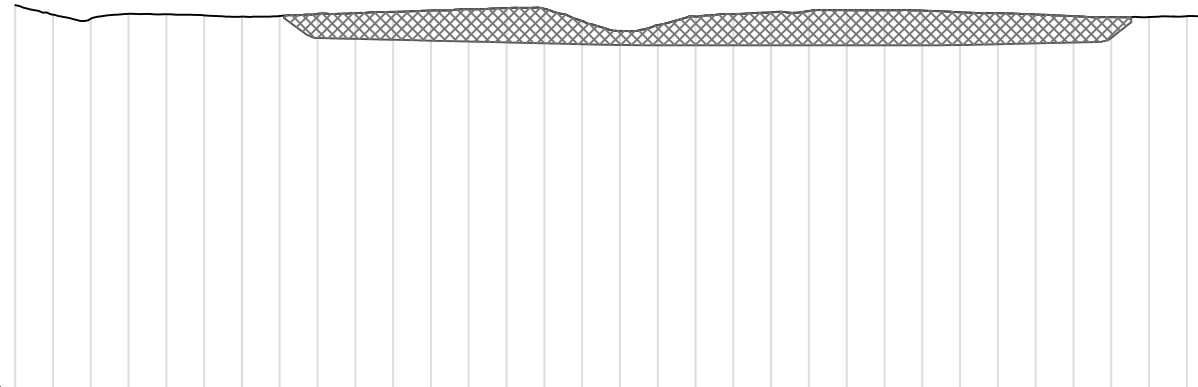
Section W06

Existing	0.36	0.11	0.00	0.13	0.12	0.09	0.06	0.08	0.13	0.15	0.19	0.22	0.25	0.29	0.27	0.06	0.32	0.17	0.21	0.23	0.23	0.22	0.17	0.15	0.12	0.07	0.04	0.05	0.07		
Excavation									-0.51	-0.53	-0.55	-0.58	-0.60	-0.62	-0.65	-0.67	-0.69	-0.70	-0.70	-0.70	-0.70	-0.70	-0.69	-0.67	-0.65	-0.63	-0.50				
Difference									0.64	0.68	0.74	0.80	0.85	0.91	0.91	0.61	0.37	0.53	0.76	0.83	0.87	0.91	0.93	0.92	0.87	0.77	0.70	0.55			
Chainage	5	10	15	20	25	30	35	40	45	50	55	60	65	70	75	80	85	90	95	100	105	110	115	120	125	130	135	140	145	150	155

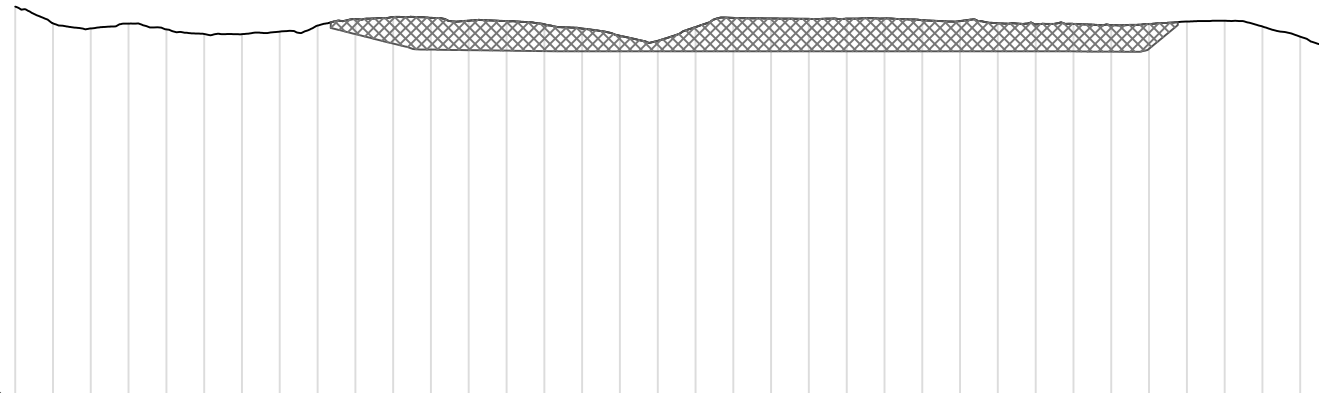
Section W07

Existing	0.48	0.04	-0.10	0.03	-0.12	-0.24	-0.25	-0.18	-0.02	0.15	0.21	0.18	0.11	0.10	0.01	-0.10	-0.29	-0.42	-0.06	0.18	0.17	0.16	0.16	0.17	0.12	0.10	0.04	0.01	0.03	-0.01	0.02	0.09	0.11	-0.04	-0.31	
Excavation										-0.24	-0.50	-0.65	-0.67	-0.68	-0.69	-0.70	-0.70	-0.70	-0.70	-0.70	-0.70	-0.70	-0.70	-0.70	-0.70	-0.70	-0.70	-0.70	-0.71	-0.63						
Difference										0.40	0.70	0.84	0.78	0.78	0.71	0.60	0.41	0.28	0.64	0.88	0.87	0.86	0.86	0.87	0.82	0.80	0.74	0.71	0.70	0.66	0.66	0.63	0.09	0.11	-0.04	-0.31
Chainage	5	10	15	20	25	30	35	40	45	50	55	60	65	70	75	80	85	90	95	100	105	110	115	120	125	130	135	140	145	150	155	160	165	170

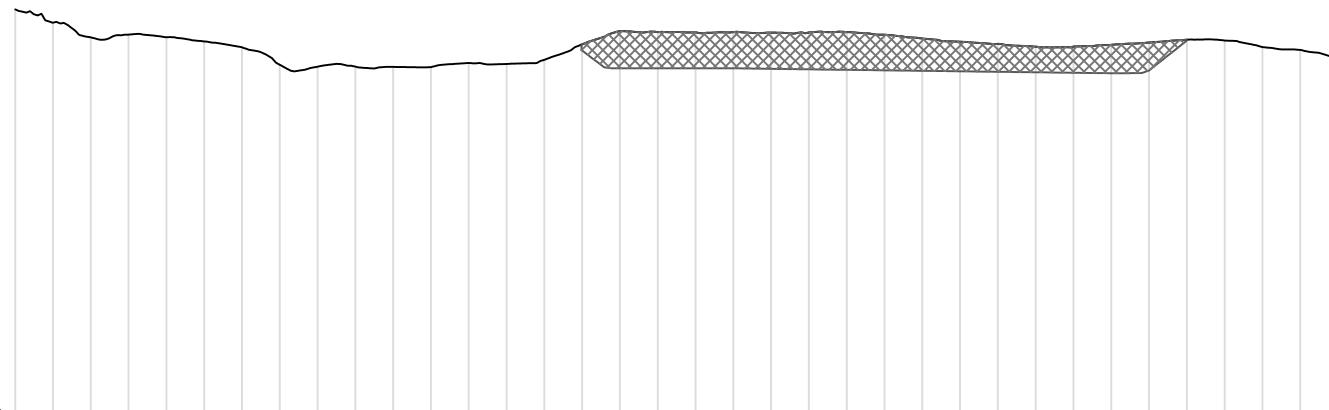
Section W08

Chainage	Existing	Excavation	Difference
5	0.86		
10	0.51		
15	0.12		
20	0.19		
25	0.12		
30	0.01		
35	-0.14		
40	-0.61		
45	-0.66		
50	-0.66		
55	-0.67		
60	-0.56		
65	-0.59		
70	-0.47		
75	0.17	-0.23	-0.07
80	0.98	-0.70	0.28
85	0.96	-0.70	0.26
90	0.95	-0.70	0.25
95	0.96	-0.70	0.26
100	0.96	-0.71	0.24
105	0.97	-0.73	0.25
110	1.00	-0.74	0.26
115	0.94	-0.75	0.19
120	0.85	-0.77	0.09
125	0.78	-0.78	0.00
130	0.74	-0.79	-0.05
135	0.68	-0.80	-0.13
140	0.69	-0.82	-0.13
145	0.75	-0.83	-0.08
150	0.74	-0.76	-0.02
155			0.06
160			0.04
165			-0.14
170			-0.21
175			-0.46

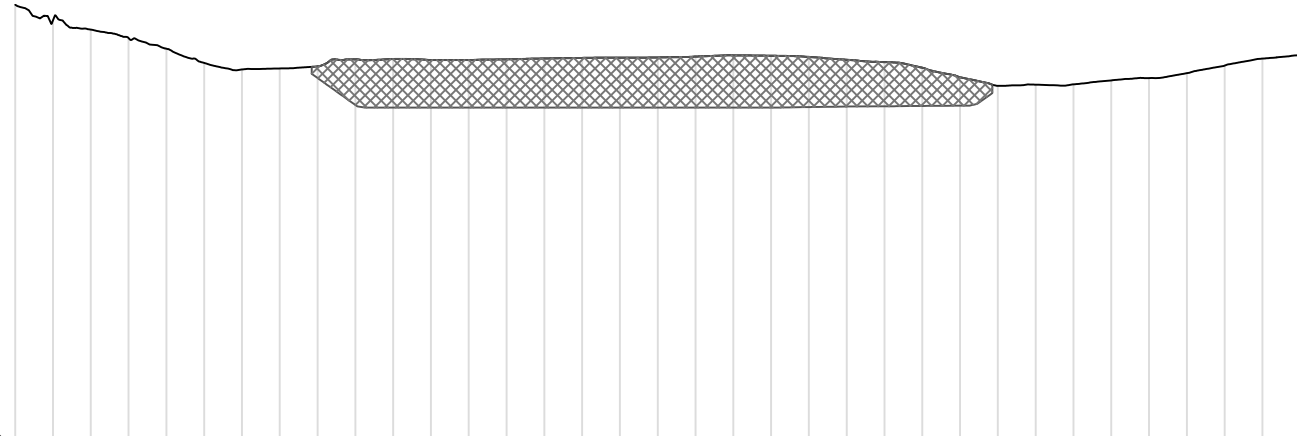
Section W10

Chainage	Existing	Excavation	Difference
5	1.67		
10	1.26		
15	1.01		
20	0.79		
25	0.51		
30	0.13		
35	-0.04		
40	-0.02		
45	0.04		
50	0.23		
55	0.23		
60	0.21		
65	0.21		
70	0.23		
75	0.25		
80	0.26		
85	0.27		
90	0.28		
95	0.30		
100	0.33		
105	0.32		
110	0.29		
115	0.21		
120	0.15		
125	0.00		
130	-0.25		
135	-0.47		
140	-0.44		
145	-0.44		
150	-0.33		
155	-0.27		
160	-0.14		
165	0.06		
170	0.24		
170	0.34

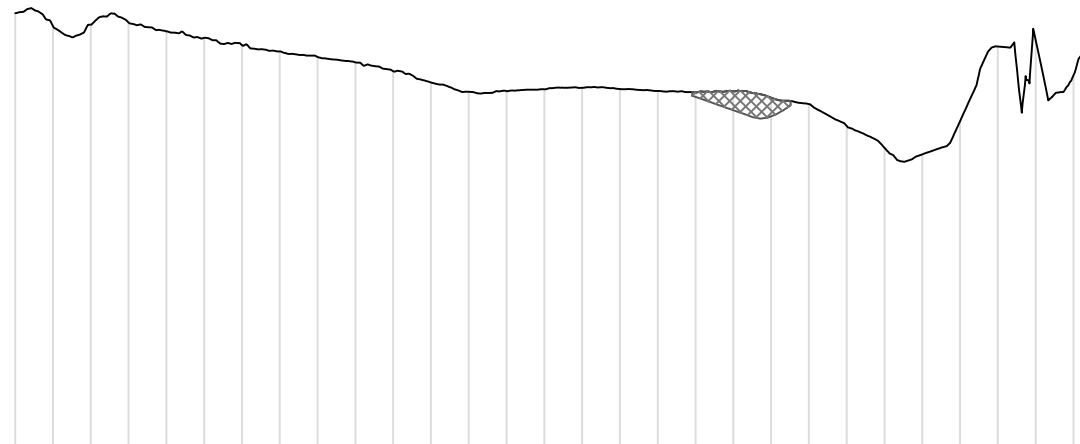
Section W12

Existing	2.53	2.19	2.23	2.28	2.05	1.88	1.68	1.52	1.37	1.23	1.00	0.70	0.45	0.47	0.52	0.56	0.52	0.47	0.44	0.47	0.30	0.13	-0.45	-1.03	-1.20	-0.32	1.65	1.82	0.88
Excavation																			0.12	0.32	0.44								
Difference																													
Chainage	0	5	10	15	20	25	30	35	40	45	50	55	60	65	70	75	80	85	90	95	100	105	110	115	120	125	130	135	140
