Manly Lagoon: Review of environmental processes

WRL TR 2021/23, May 2023

By T A Tucker, D S Rayner and A J Harrison

UNSW
Water Research
Laboratory

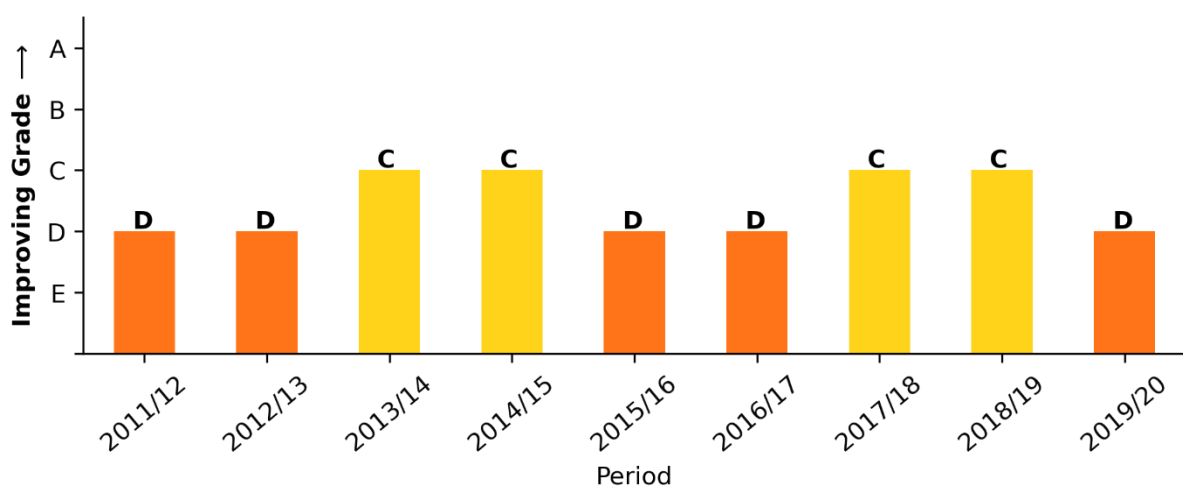
Figure 3.2: Grading of Manly Lagoon using trigger values developed by Roper et al. (2011) for NSW Estuaries (see Appendix A for further details)

Roper et al., (2011) developed default guideline for turbidity and chlorophyll-a using the 80th percentile values for data collected for reference estuaries within NSW. Comparison of water quality measurements sampled within Manly Lagoon to these trigger values gives the lagoon an overall grade of poor to fair (Figure 2.2). Further details regarding this grading can be found in Appendix A.

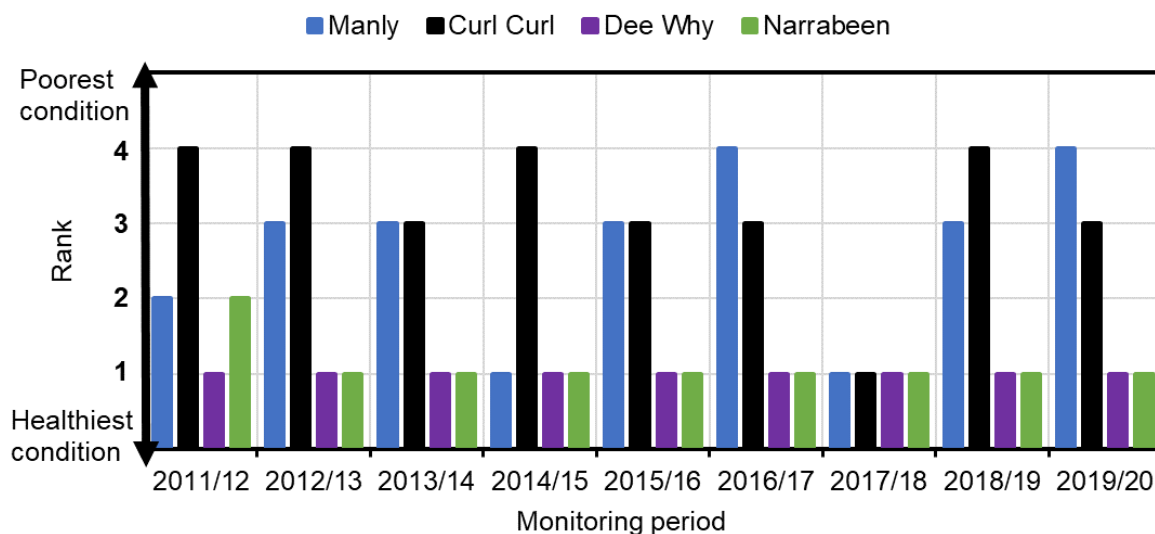
Figure 3.3: Ranking of eco-health for Northern Beaches estuaries

Each of these lagoons has been compared with Manly Lagoon in terms of eco-health using chlorophyll-a and turbidity data. The lagoons have then been ranked based upon which has the best or worst eco-health. Figure 3.3 shows that Dee Why and Narrabeen Lagoons are continually the healthiest on the Northern Beaches. Curl Curl Lagoon generally had the worst health of all the lagoons, however, Manly Lagoon has also been identified as having the worst health for a number of monitoring periods.

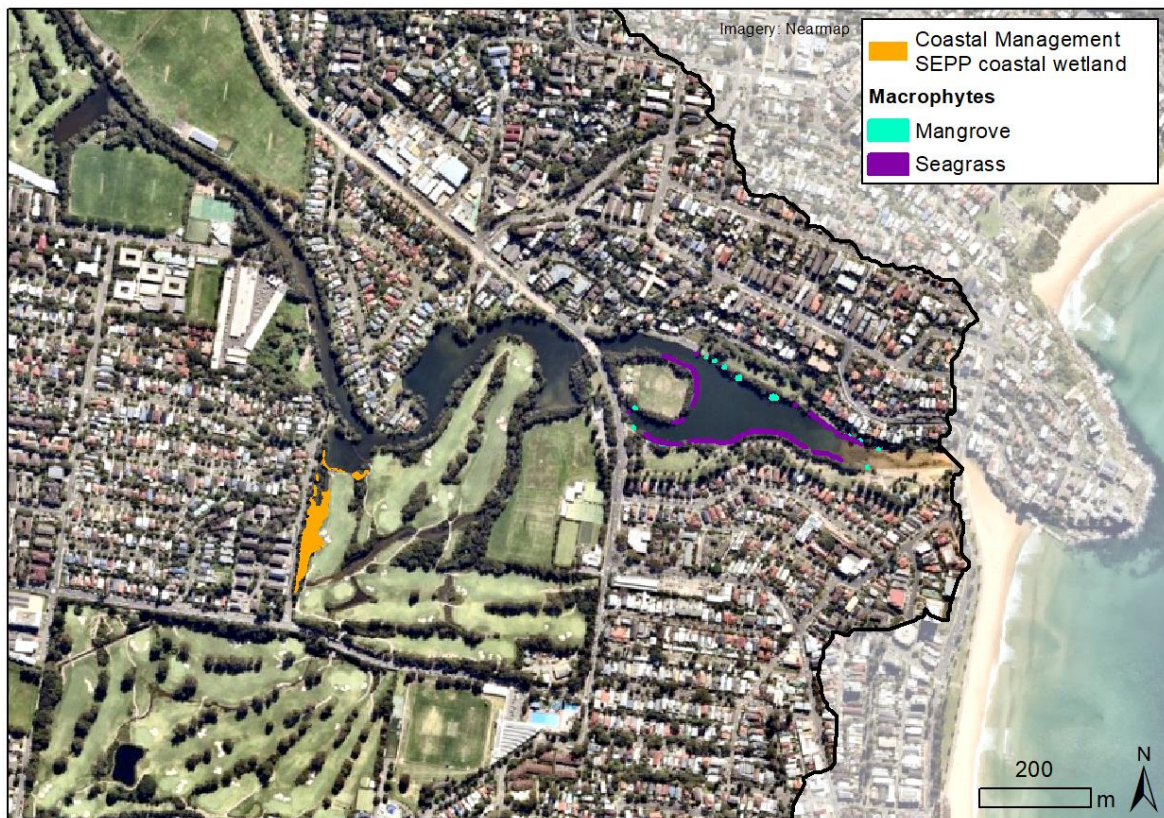
Figure 4.2: Coastal Management SEPP coastal wetlands and estuarine macrophytes (DECCW, 2016; DPIE, 2018)

Manly Lagoon provides social, cultural and economic values because of the habitat within the aquatic estuary. Mapping of aquatic habitat has been completed for:

- Coastal Management SEPP coastal wetlands (Figure 4.2)
- Mangrove and seagrass habitat (Figure 4.2)
- Key fish habitat (Figure 4.3)

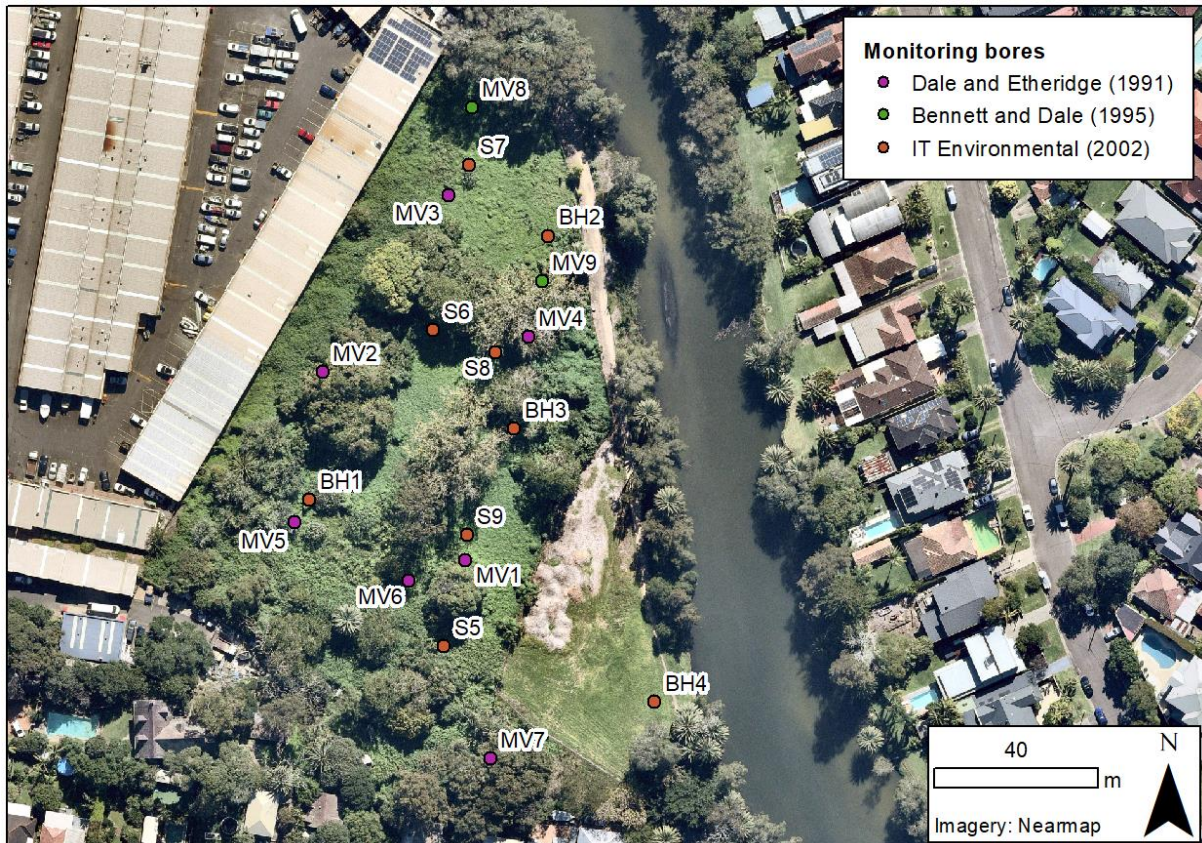
A.2: Historic monitoring bores at the Addiscombe Road remediation site

In 2008, Parsons Brinkerhoff (2008a; 2008b) reviewed the groundwater monitoring completed at the site over the previous decade for the development of a groundwater management plan and a remedial action plan. Upon reviewing the monitoring data they concluded that the primary contaminants of concern for the site are heavy metals (zinc, copper, cadmium and lead), PAHs, total petroleum hydrocarbons (TPHs), and ammonia. Of these they noted that zinc was consistently at higher concentrations than guideline values. Review of groundwater flow by Parsons Brinkerhoff (2008a; 2008b) found that there is a hydraulic gradient of approximately 0.005 m across the site with the groundwater flowing in an easterly to north-easterly direction.

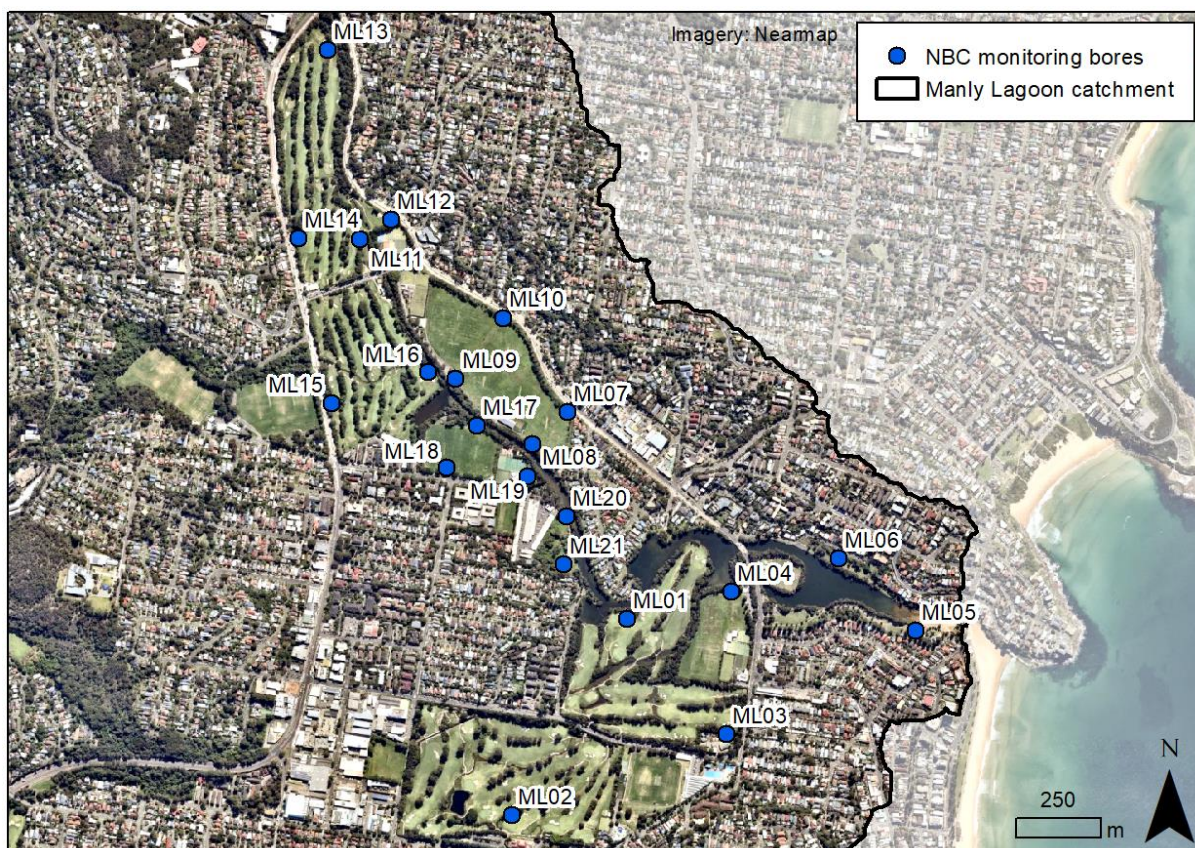
A.3: Monitoring bores including 21 constructed by Northern Beaches Council (NBC) in 2017

Other bores in the Manly Lagoon catchment include 21 monitoring bores constructed by Northern Beaches Council in March 2017 for the purpose of measuring groundwater quality and levels (Figure A.2). The 21 monitoring bores were constructed by Northern Beaches Council off the back of radon experiments completed in July 2016 which identified that there was an interaction between the groundwater and surface water of Manly Lagoon. Since their construction in 2017, the bores have been monitored for water quality in June 2018, March 2019, and August 2021, as well as for continuous water levels from June 2018 until July 2020.

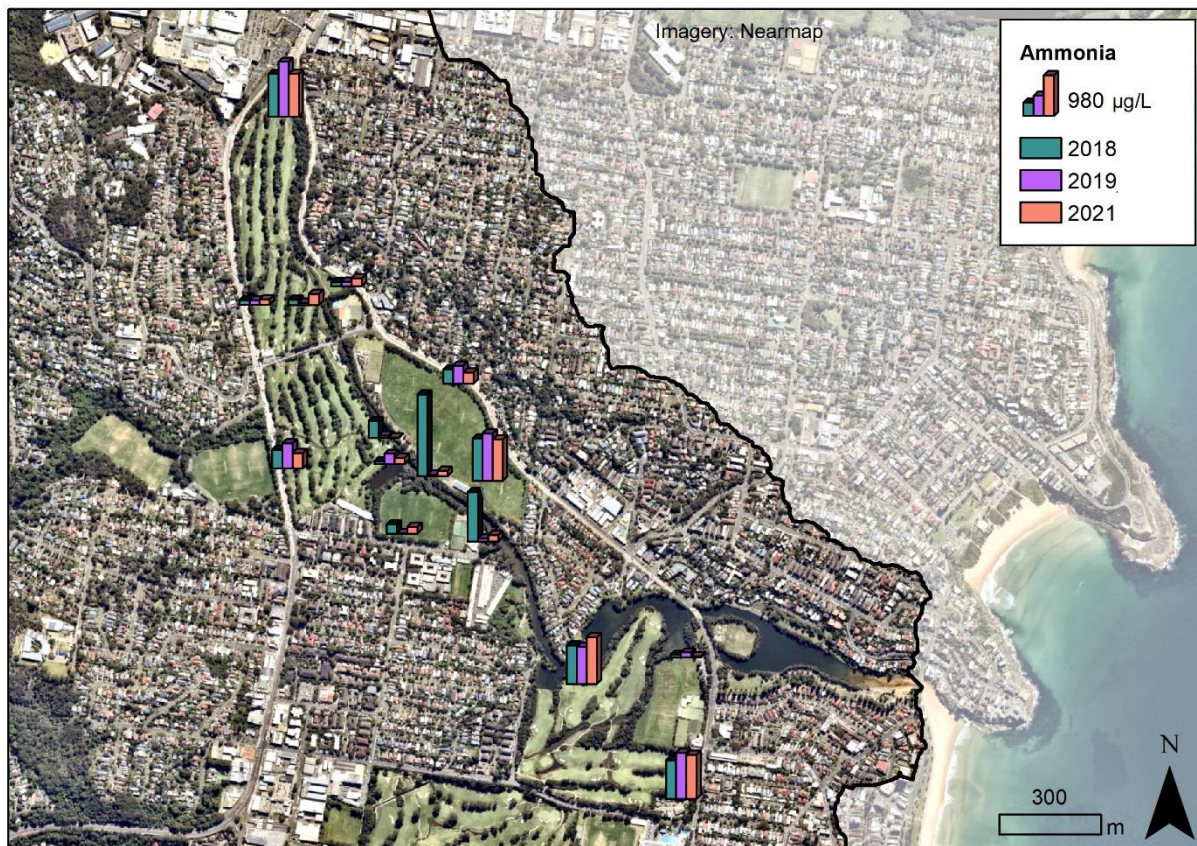
A.4: Comparison of ammonia sampled at Manly Lagoon

Ammonia, total filtered nitrogen and total filtered phosphorus were measured during the 2018 (dry weather), 2019 (wet weather) and 2021 (dry weather) sampling programs. A comparison between the sampling events is shown in Figure A.4, Figure A.5 and Figure A.6. Note that measurements of analytes across the site were extremely variable. Despite this, on both monitoring occasions, nutrient samples at all bores were observed above the ANZECC and ARMCANZ (2000) guideline values for aquatic ecosystems.

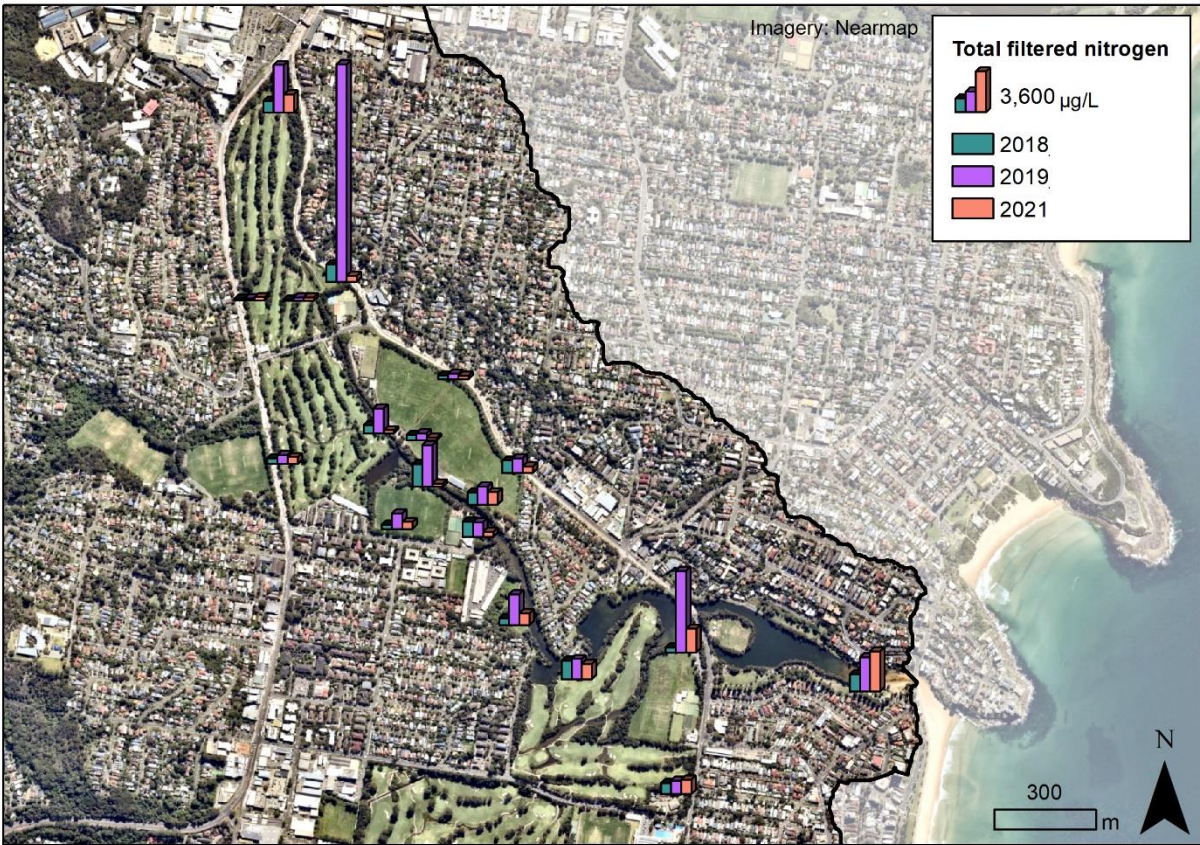
A.5: Comparison of total filtered nitrogen sampled at Manly Lagoon

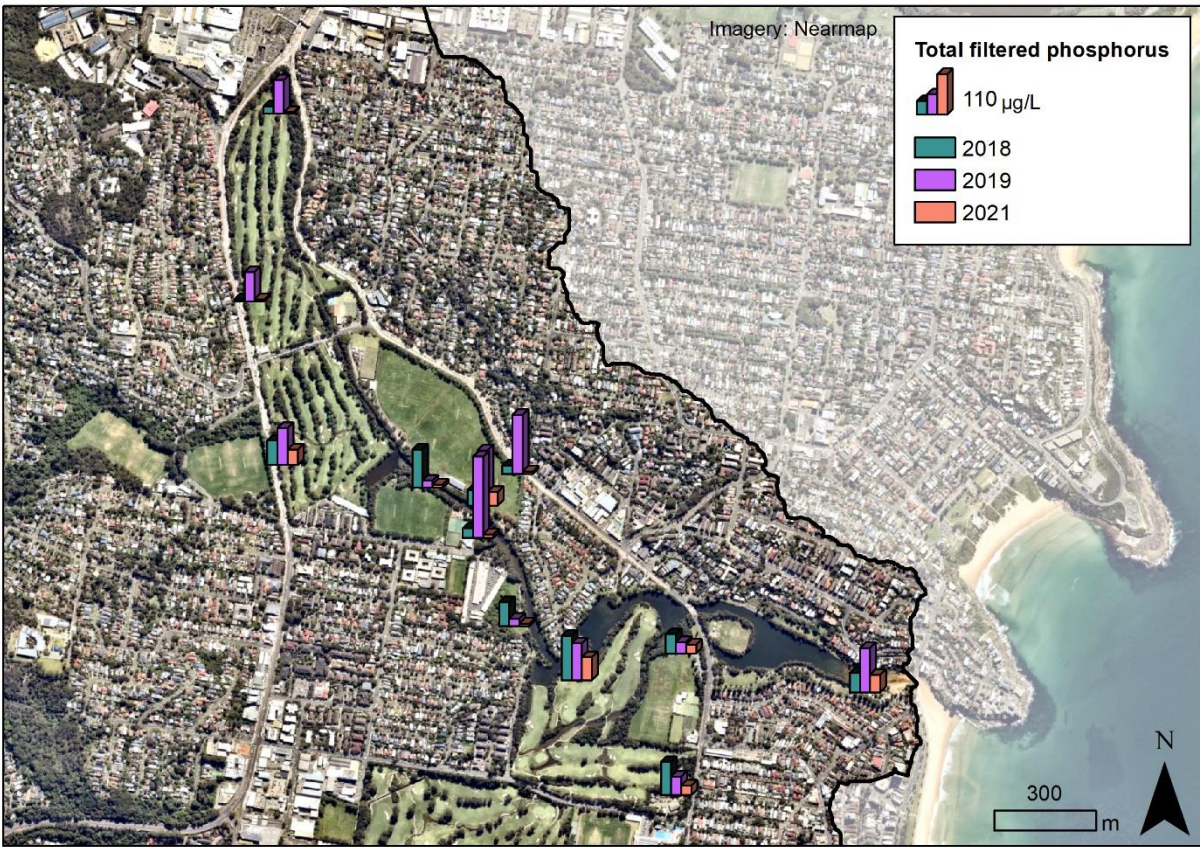
A.6: Comparison of total filtered phosphorus sampled at Manly Lagoon

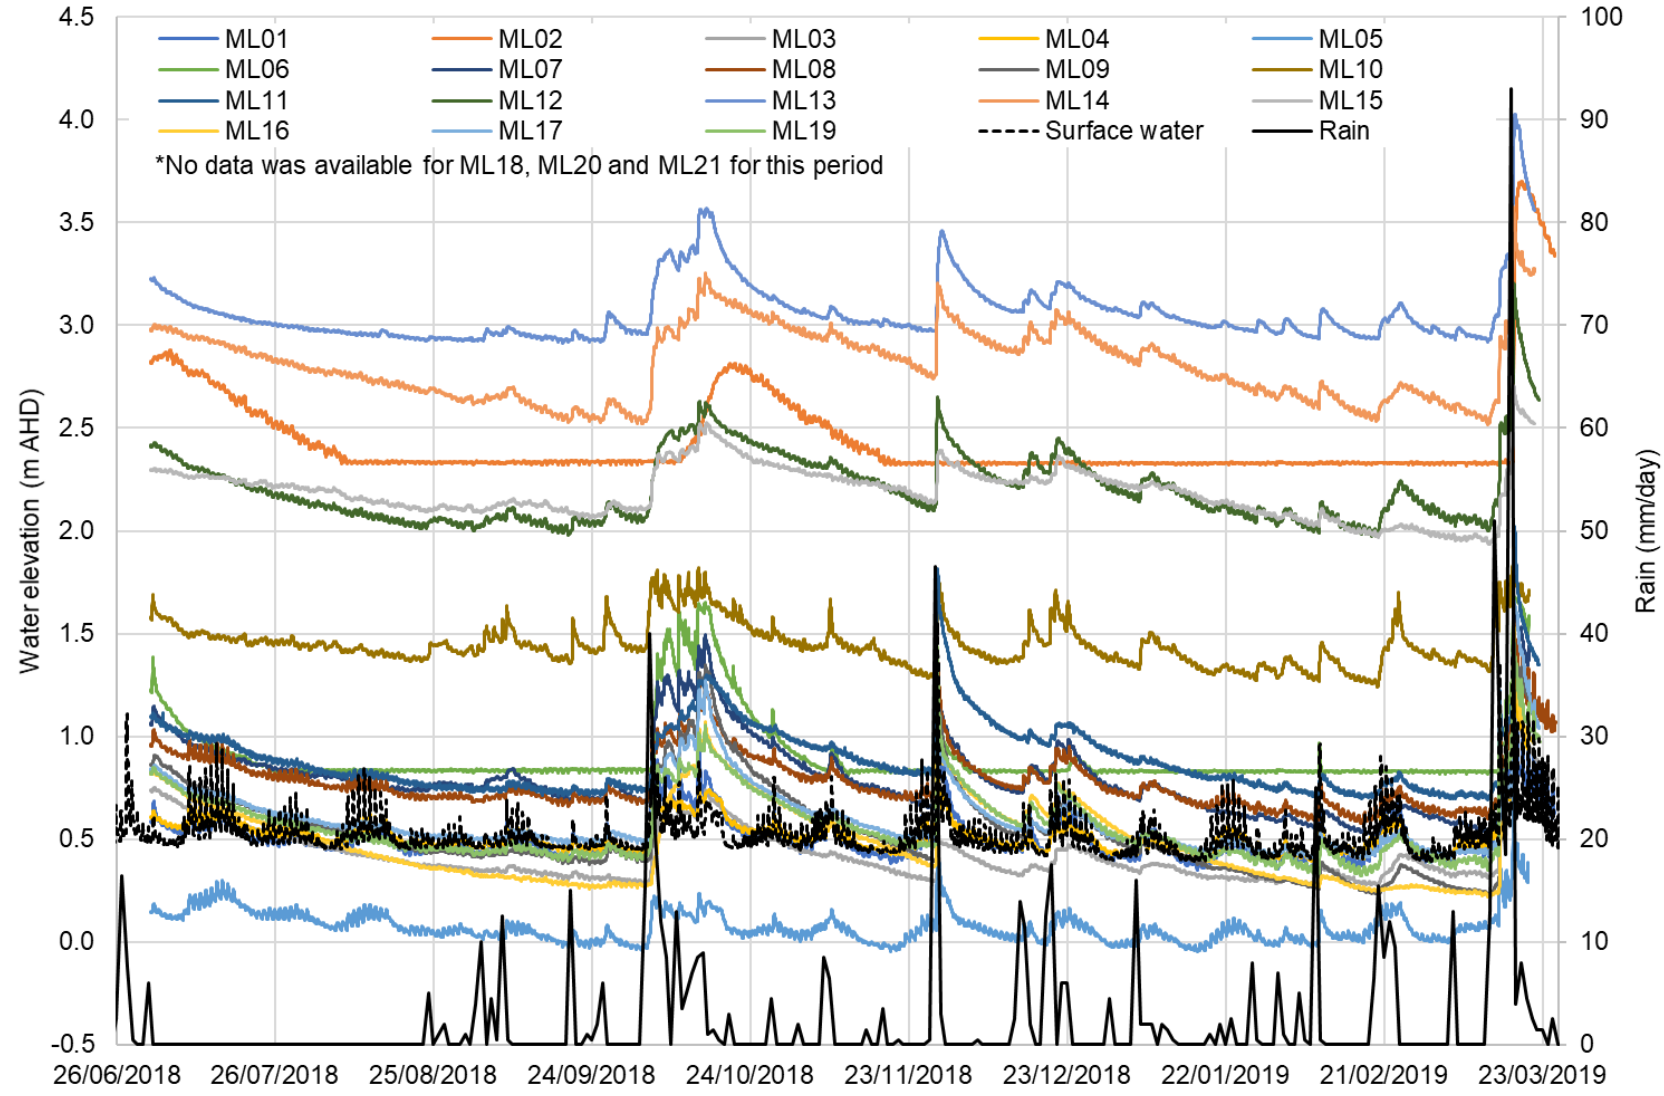
A.11: Groundwater levels as recured by data loggers for each borehole (2018-2019)

Long-term monitoring of groundwater levels is currently available from June 2018 to March 2019 (recent monitoring data is yet to be published). Water levels for the period available is shown in Figure A.11 along with rainfall data as measured in the Manly CBD (MHL, 2021). Figure A.12 shows the comparison between lagoon water levels and groundwater levels at varying distances from the lagoon.

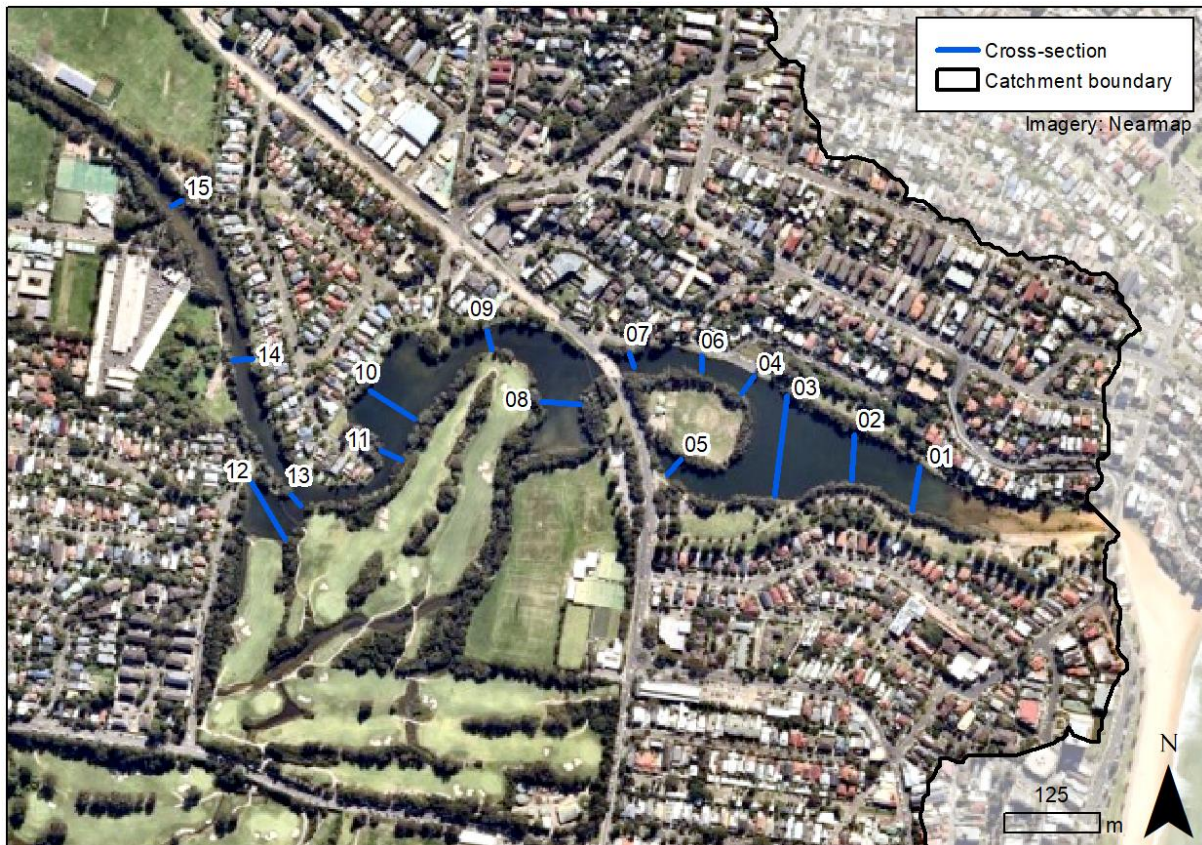
A.16: Location of cross-sections where 2011 and 2017 data was compared

Bathymetry measured in 2011 has also been compared to recent measurements taken in 2017 by Harrison and Rayner (2019). Figure A.16 shows the cross-section locations where bathymetry data has been compared and Figure A.17 shows the comparisons between the two datasets. Note, measurements were gathered using an echosounder which can only take measurements underwater so the banks of the lagoon are not shown in Figure A.17.

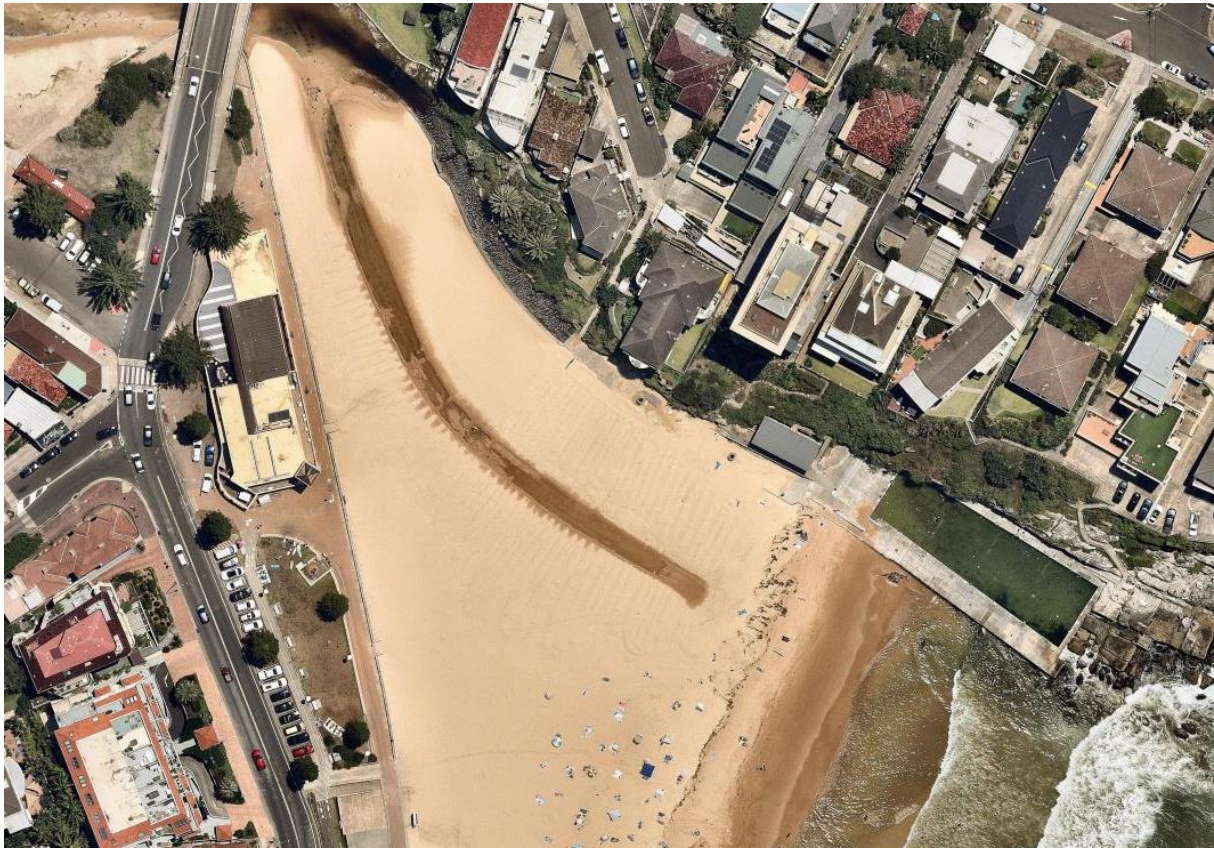
A.18: Channel across the beach used for flood mitigation (21/01/2021) (source: Nearmap)
