# Assessment of geomorphic changes, hydraulics and potential foreshore stabilisation options at Windang, Lake Illawarra

WRL TR 2023/08, December 2023

By T A Tucker, I R Coghlan and J T Carley

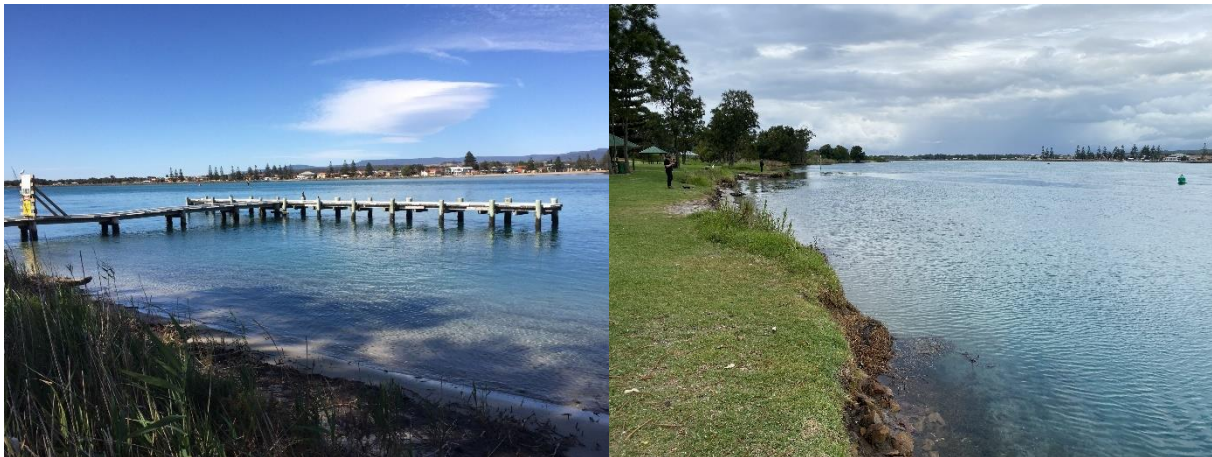
**Figure 1.2 Windang foreshore with the jetty in December 2019 (Source: AllTrails, 2023) and without the jetty in March 2023 (Source: Ian Coghlan)**

The Windang foreshore has been significantly impacted by erosion. In October 2022, following years of partial collapse, the last sections of a jetty structure (previously known as the Pine Tree Park boardwalk) located at the Windang foreshore finally collapsed and were subsequently removed (Figure 1.2). The collapse of this jetty structure highlighted how continued erosion/deepening within the entrance channel caused by the training of the ocean entrance is continuing to impact public amenity.

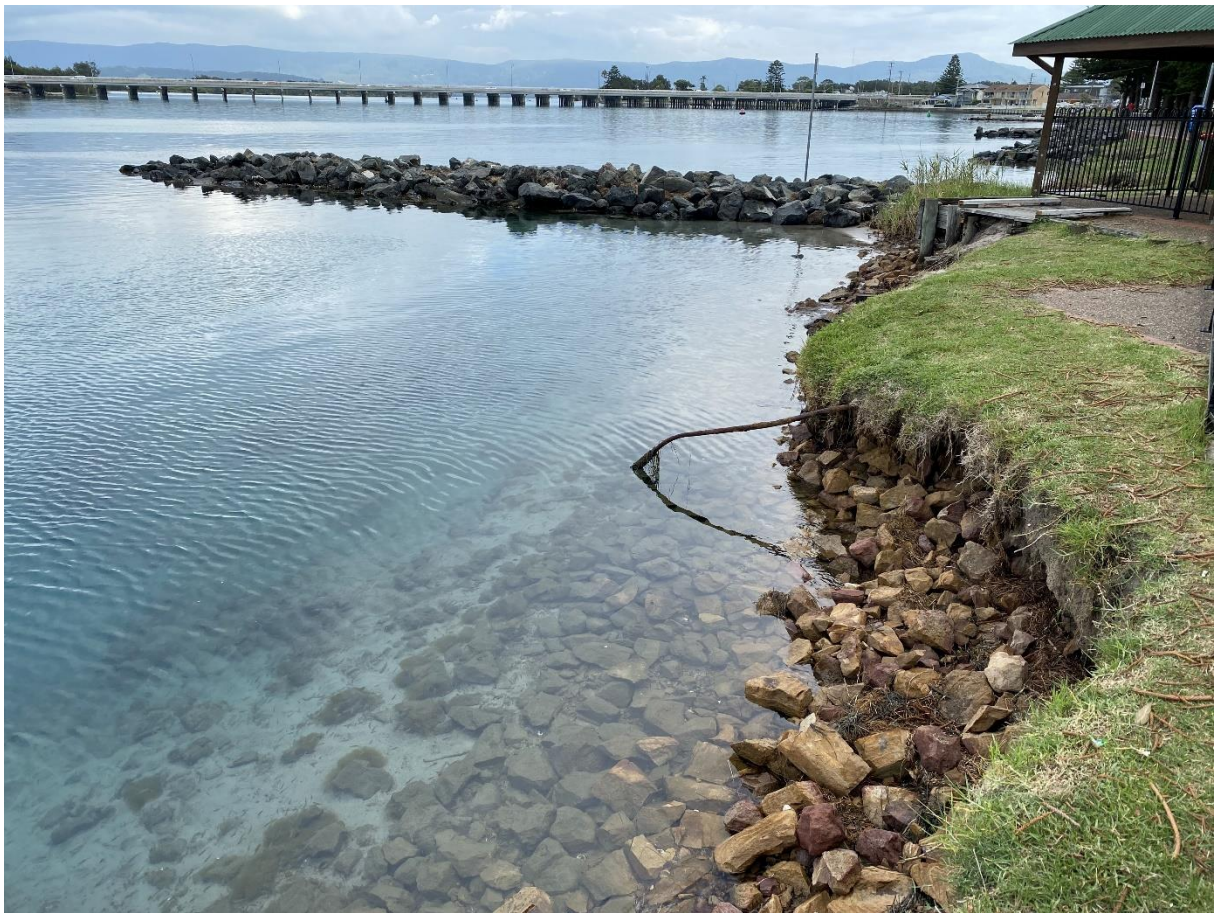
**Figure 2.1 Erosion along the Windang foreshore immediately downstream of the groyne**

On 3 March 2023, a site inspection was conducted during a falling tide by WRL engineers Ian Coghlan and Toby Tucker to assess the current condition of the Windang foreshore (Figure 2.1, Figure 2.2, Figure 2.3 and Figure 2.4). During the site inspection a number of photographs of the site were taken to document the state of the foreshore. This included a number of high-resolution photos taken using a drone (Figure 2.5, Figure 2.6 and Figure 2.7).

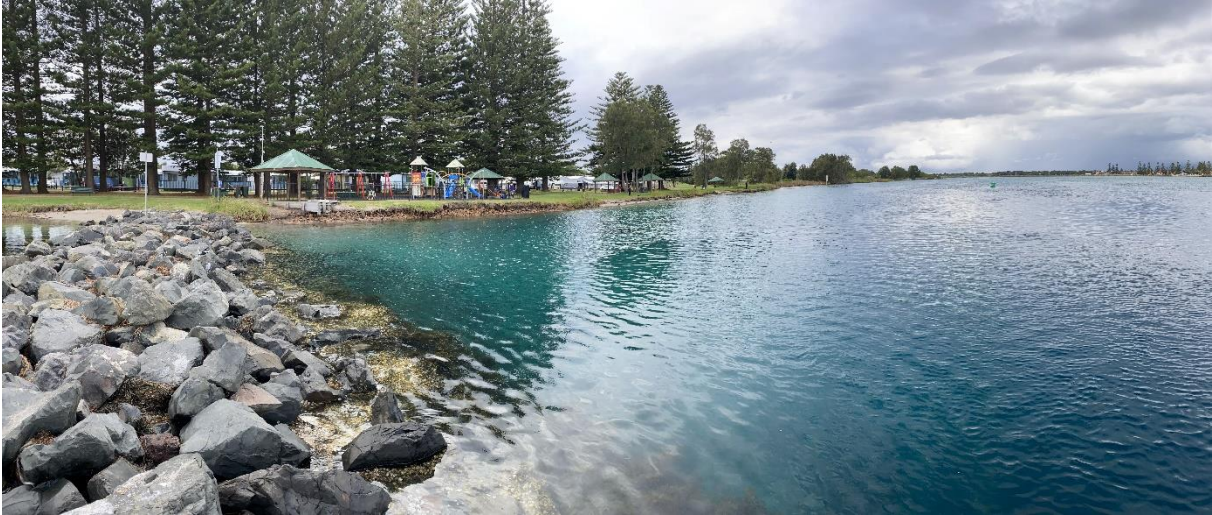
**Figure 2.2 Erosion along the Windang foreshore as viewed from the end of the groyne**

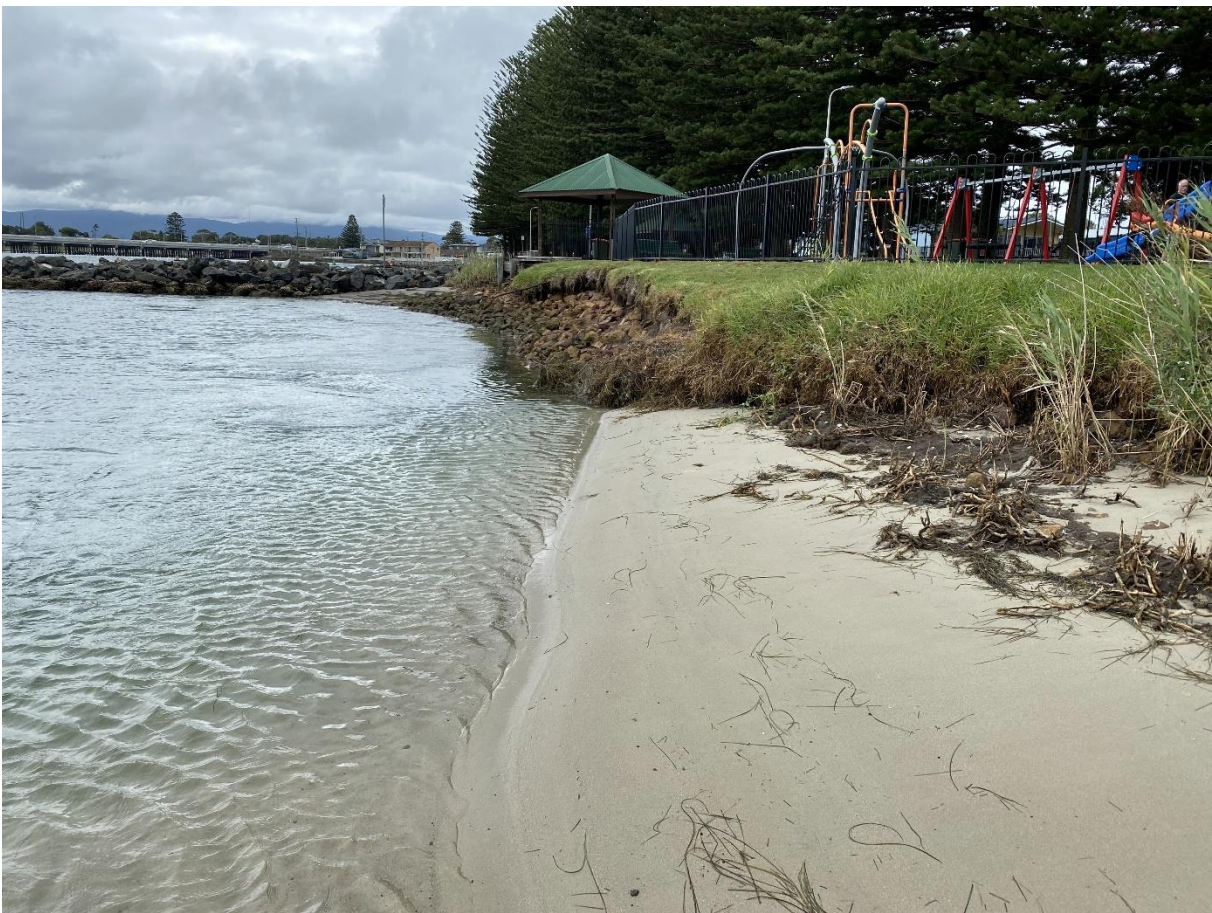
**Figure 2.3 Erosion along the Windang foreshore immediately downstream of the groyne**

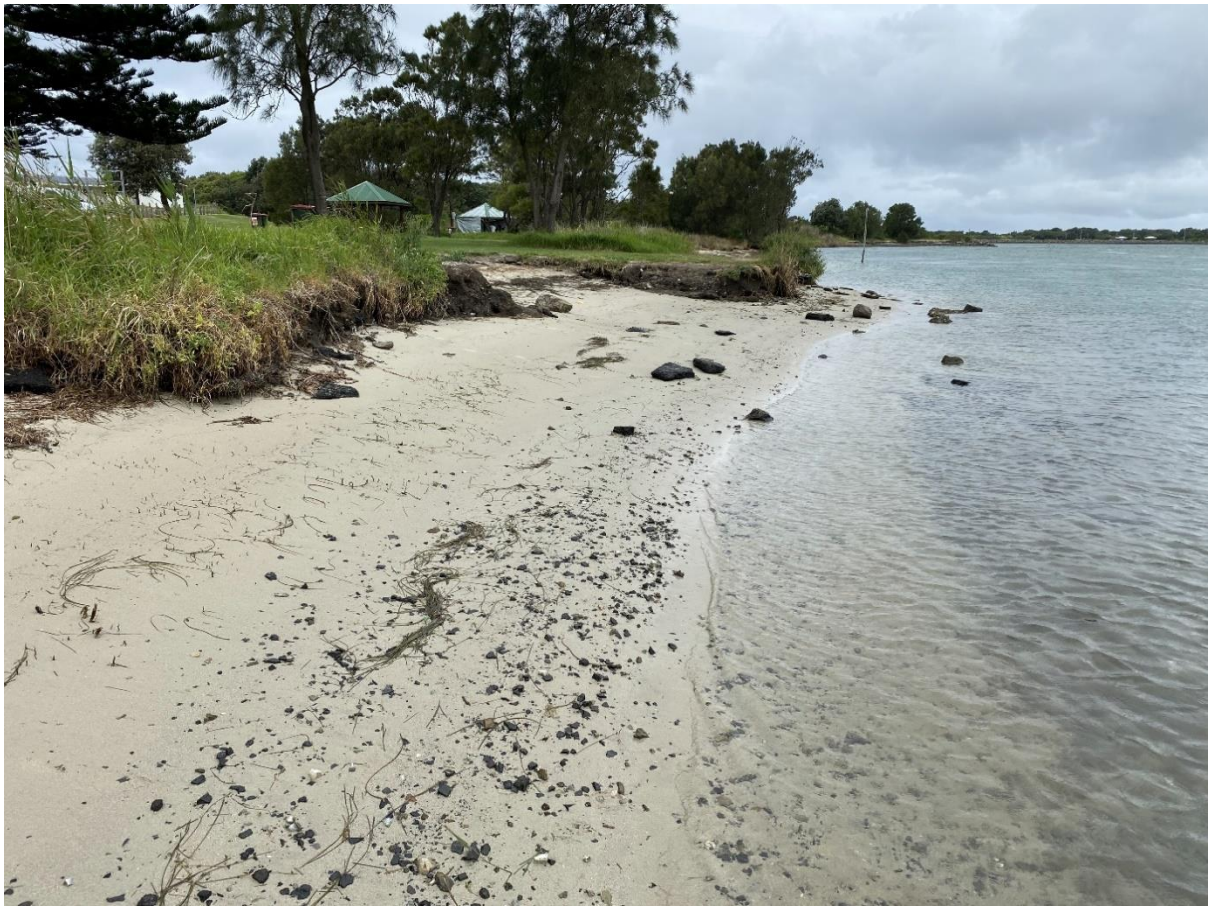
**Figure 2.4 Erosion along the Windang foreshore looking towards the ocean entrance**

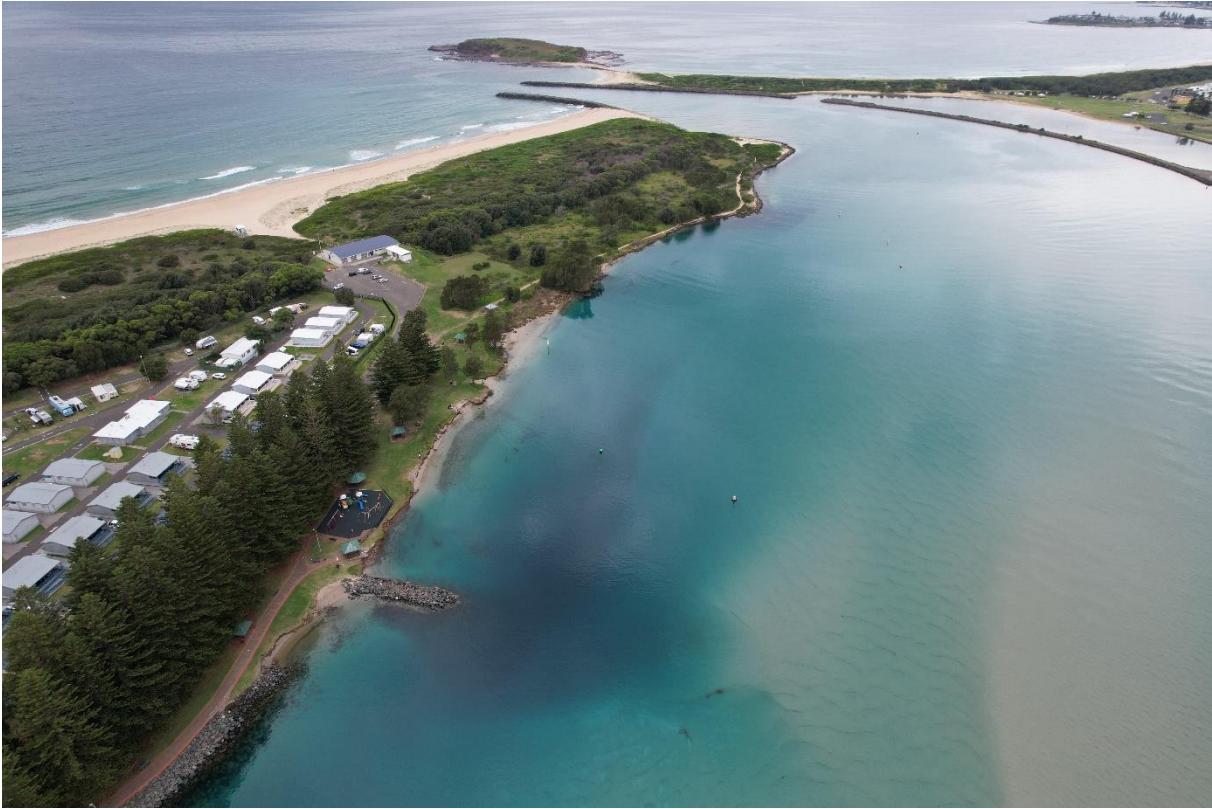
**Figure 2.5 The Windang foreshore from directly above**

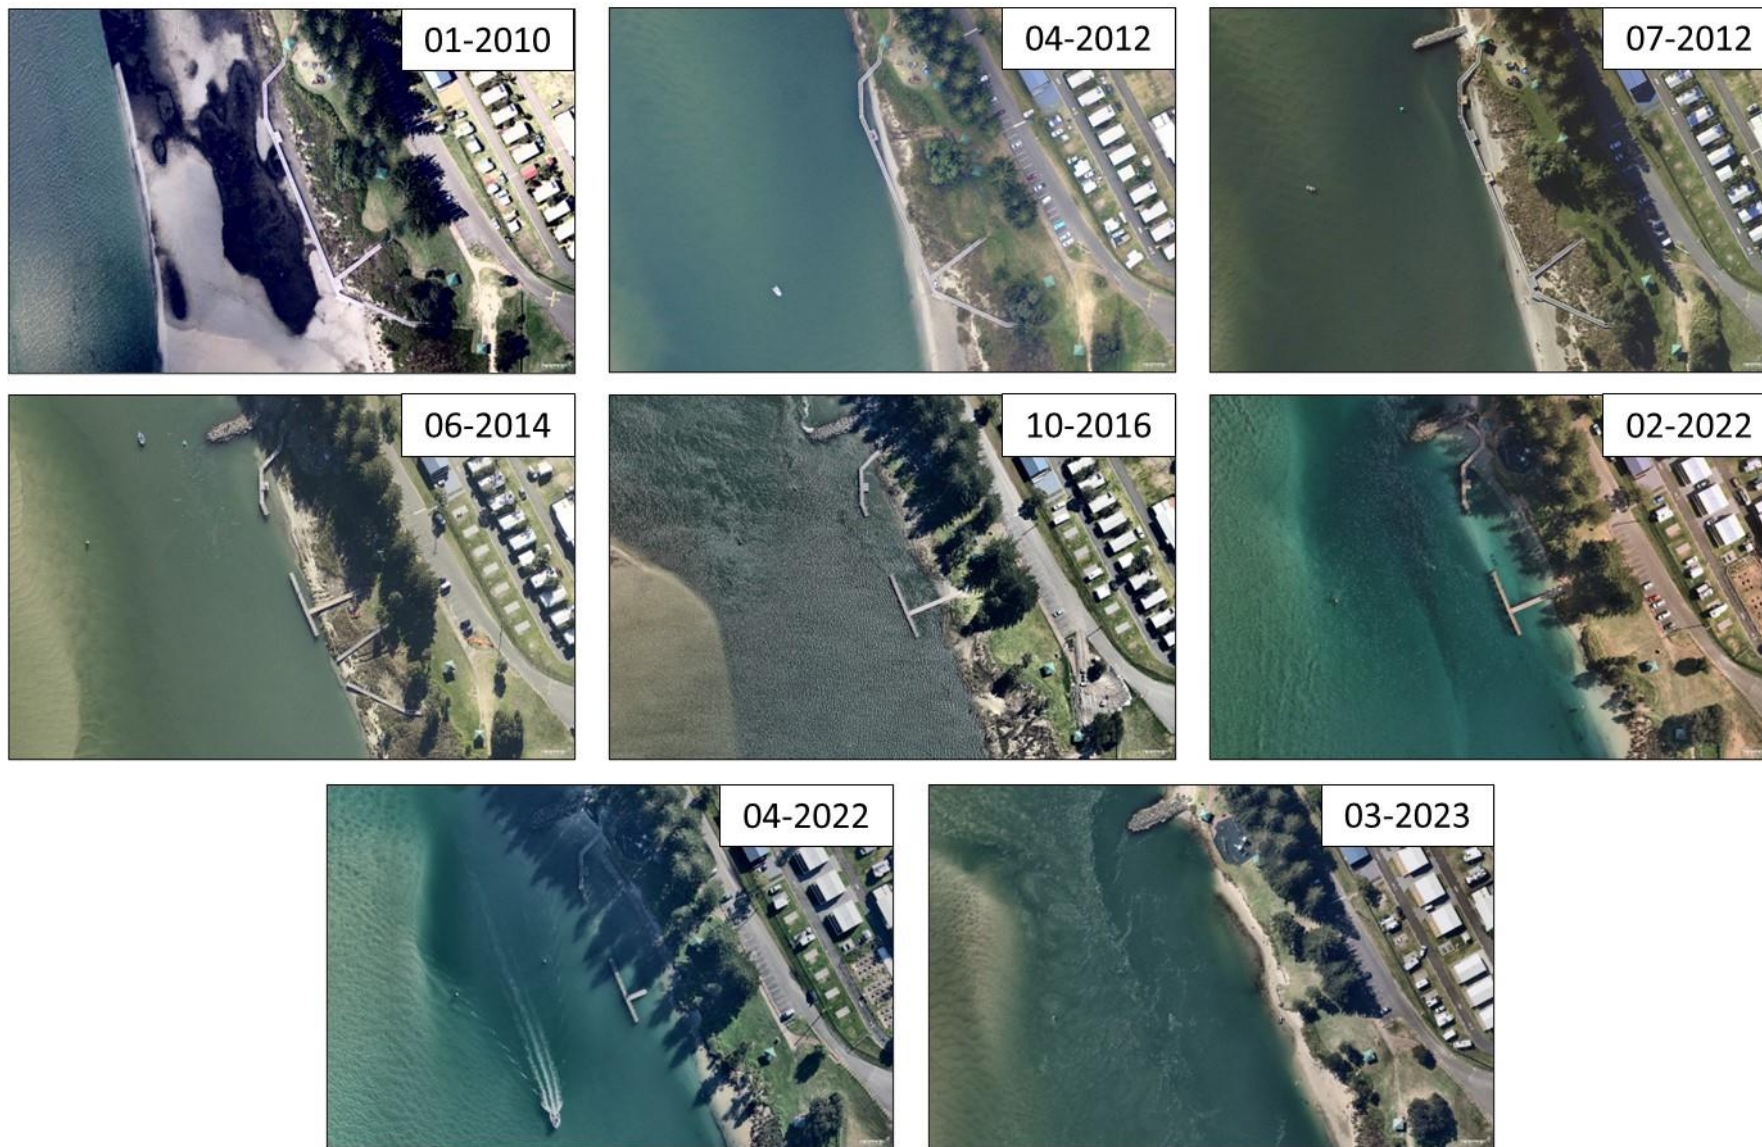
**Figure 3.1 Changes along the Windang foreshore observed in Nearmap imagery from 2010 to 2023**

Aerial imagery of the Windang foreshore study area has been captured regularly by Nearmap since 2010. By comparing selected images, key changes to the foreshore including the progressive failure of the former jetty structure can be observed (see Figure 3.1):

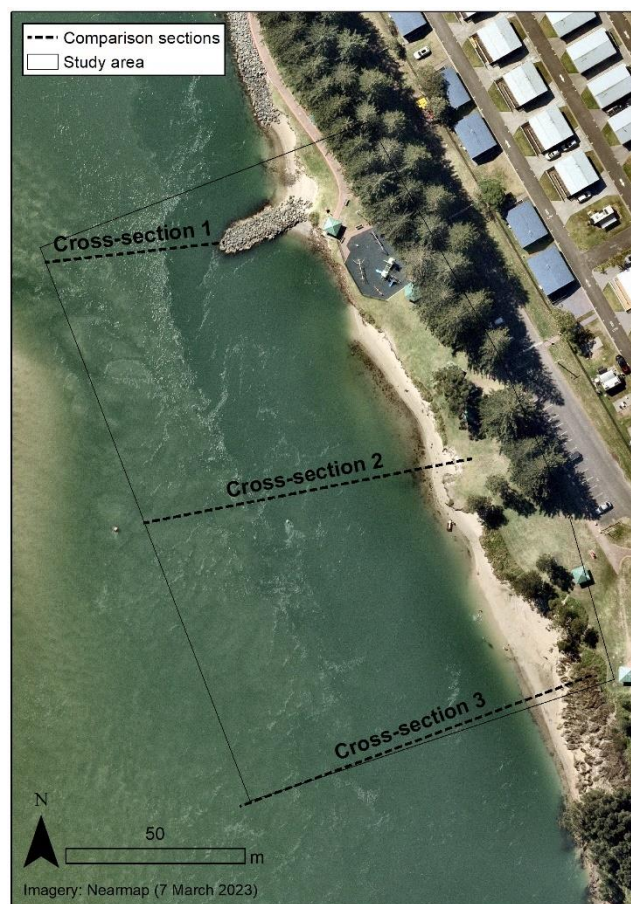
**Figure 3.2 Location of comparison cross-sections**

Analysis of cross-section data across the study area indicated that the rate of erosion across the Windang foreshore varies from year to year. While this is the case, there is still a clear long-term erosion trend as is shown in the cross-section data across the study area (see Figure 3.4, Figure 3.5 and Figure 3.6). Using a subset of these same cross-sections to ensure bathymetry data was available for all years, long-term rates of erosion have been calculated across the study site using a line of best fit (cross-section locations are shown in Figure 3.2):

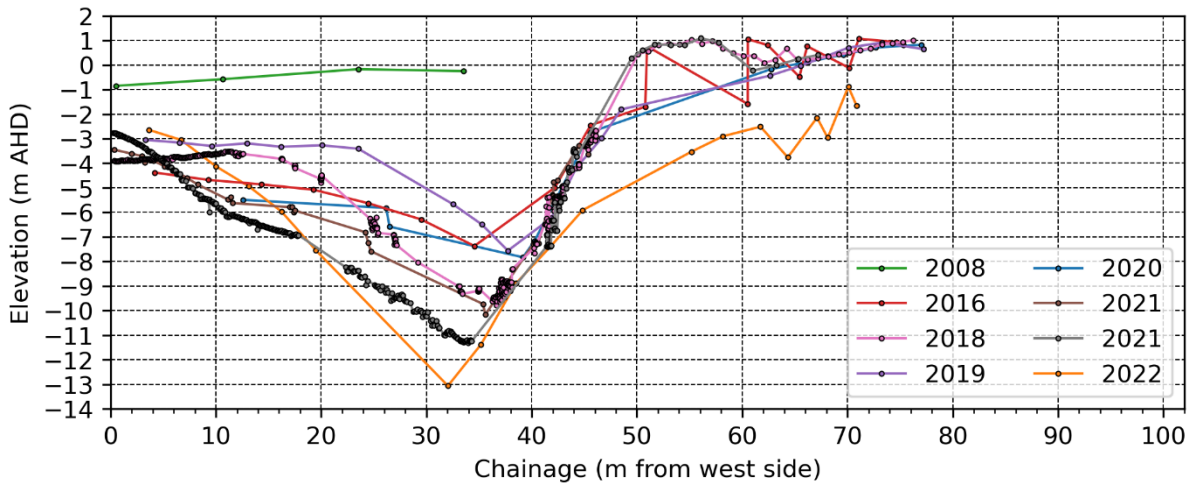
Figure 3.4 Change in bathymetry at cross-section 1 (Figure 3.2) to the north of the study area

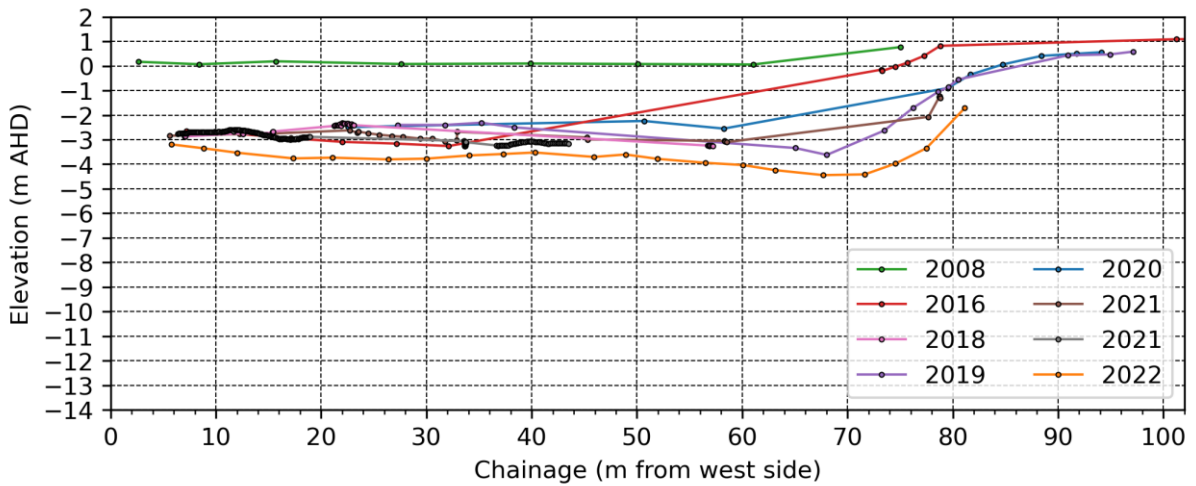
Figure 3.6 Change in bathymetry at cross-section 3 (Figure 3.2) to the south of the study area

Comparison of bathymetric data clearly shows the erosion of a hole in front of the groyne located within the study area. In Figure 3.3, the hole clearly forms between 2007 and 2018. Between 2008 and 2022 the hole caused by erosion has developed to be ~12 m deeper. Figure 3.4 shows that erosion of sand at the toe of the groyne is still continuing despite having some variability. Indeed, this is the case at each of the cross-sections identified (see Figure 3.5 and Figure 3.6).

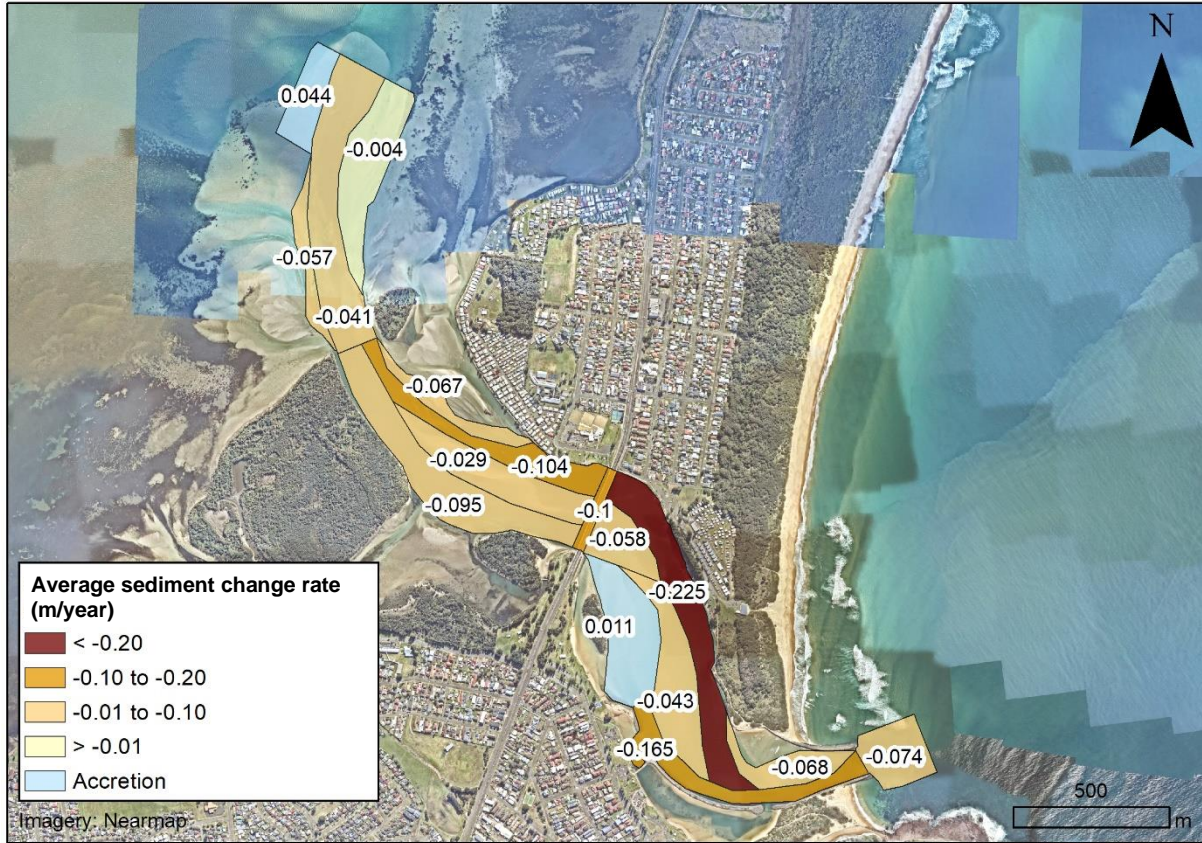
**Figure 3.7 Average annual sediment change rate within each sediment compartment of the Lake Illawarra entrance channel (Tucker et al., 2023)**

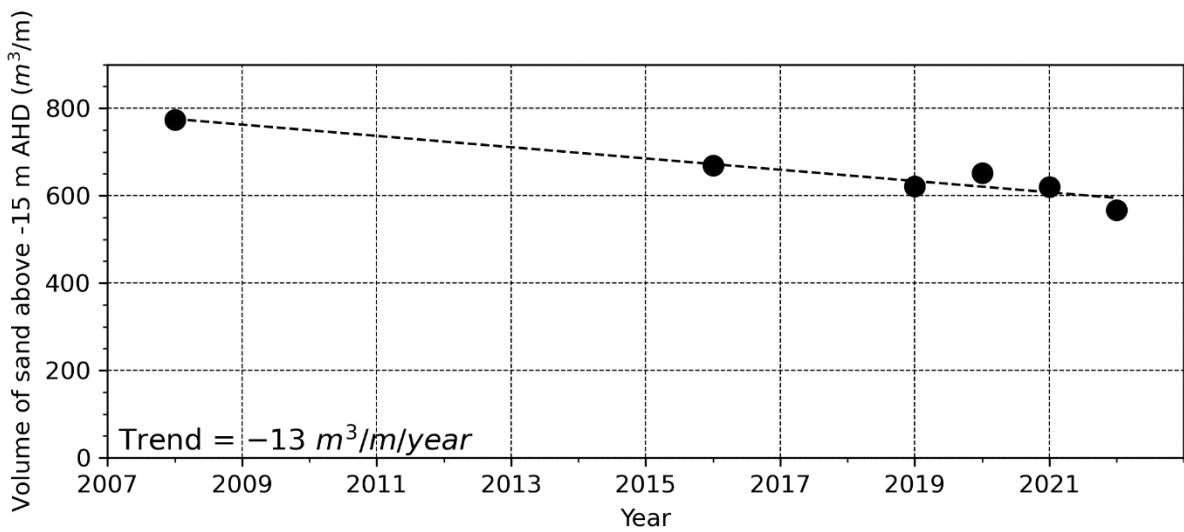
**Figure 3.10 Rate of erosion at cross-section 3 (Figure 3.2) since 2007(chainages: 24-75 m)**

Results of the assessment indicated that the rate of erosion decreased from north to south across the study area with the highest rate of erosion located at the groyne.

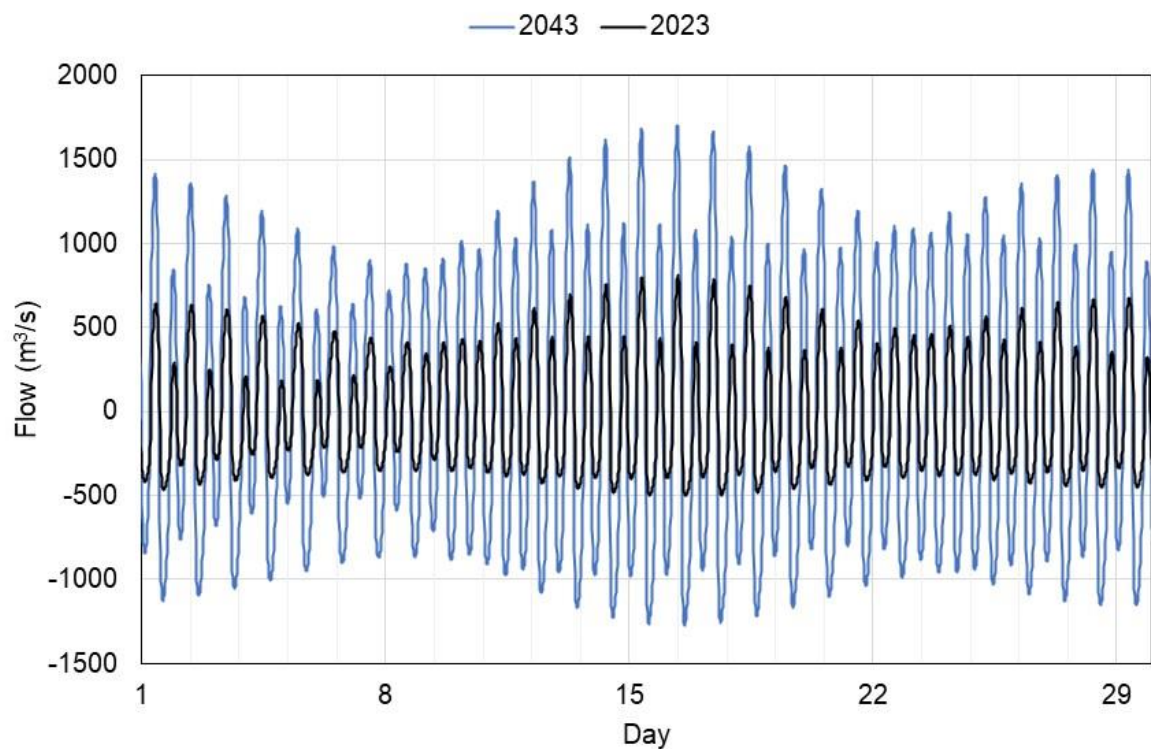
**Figure 4.2 Modelled present and future flows through the Lake Illawarra entrance channel adjacent to the Windang foreshore**

Previous investigations have found that the Lake Illawarra entrance channel is continually changing and erosion could continue for another 120 years (Glatz, 2023). Analysis of numerical model results shows how erosion within the entrance channel may influence hydraulic conditions. Water level data outputs from the numerical model show that as continued erosion within the entrance channel occurs, the tidal range will increase (note, water levels will also be influenced by sea level rise which was modelled as +0.1 m to 2043) (Figure 4.1). Similarly, as erosion and sea level rise cause a larger cross-sectional area for the entrance channel, the total flow through the Lake Illawarra entrance channel will also increase (Figure 4.2). Note, this modelling only considered a 20 year time horizon (i.e. until 2043) – for longer time horizons higher tide elevations and larger flow rates would be expected.

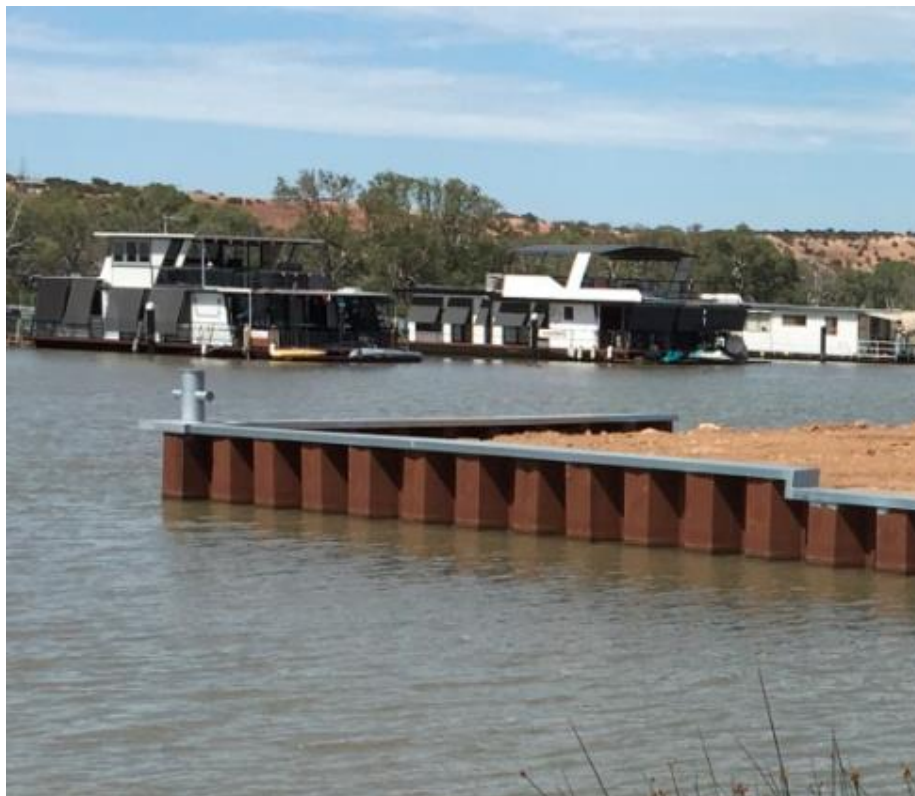
Figure 5.1 Example vertical steel sheet pile revetment

A vertical revetment comprising either steel sheet piles (Option 1, Figure 5.3) or concrete secant piles (Option 2, Figure 5.4) was developed to stabilise the Windang foreshore. Example photographs of both types of structures are shown in Figure 5.1 and Figure 5.2, respectively.

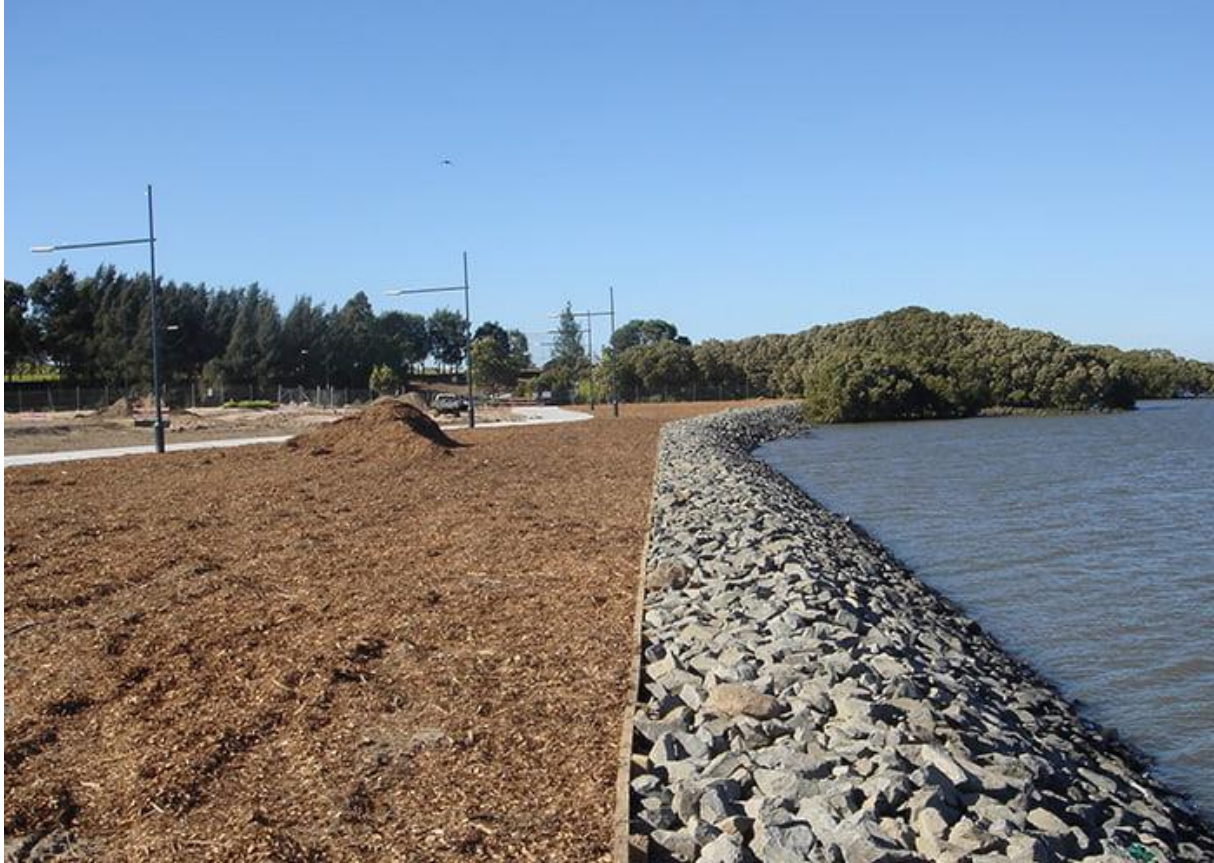
**Figure 5.5 Example rock revetment (Ermington, NSW)**

Three different rock revetment concept designs, Option 3 (Figure 5.6), Option 4 (Figure 5.7) and Option 5 (Figure 5.8), were developed to stabilise the Windang foreshore. An example photograph of this type of structure is shown in Figure 5.5, albeit with a relatively small toe.

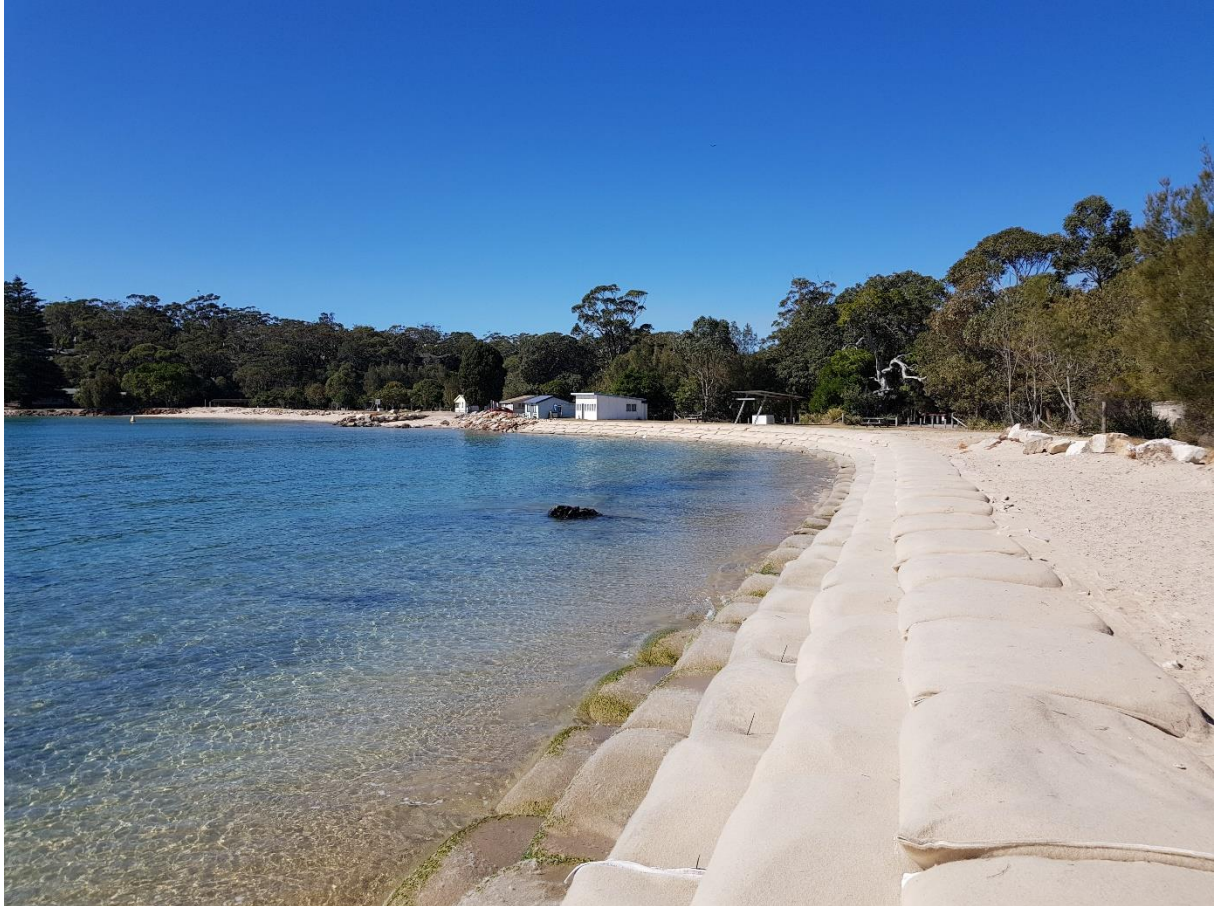
**Figure 5.9 Example geotextile container revetment (0.75 m<sup>3</sup> containers at Bonnie Vale, NSW)**

Three different geotextile container revetment concept designs, Option 6 (Figure 5.10), Option 7 (Figure 5.11) and Option 8 (Figure 5.12), were developed to stabilise the Windang foreshore which mimic the corresponding three rock revetment concept designs (Options 3, 4 and 5). An example photograph of this type of structure is shown in Figure 5.9, again with a relatively small toe.

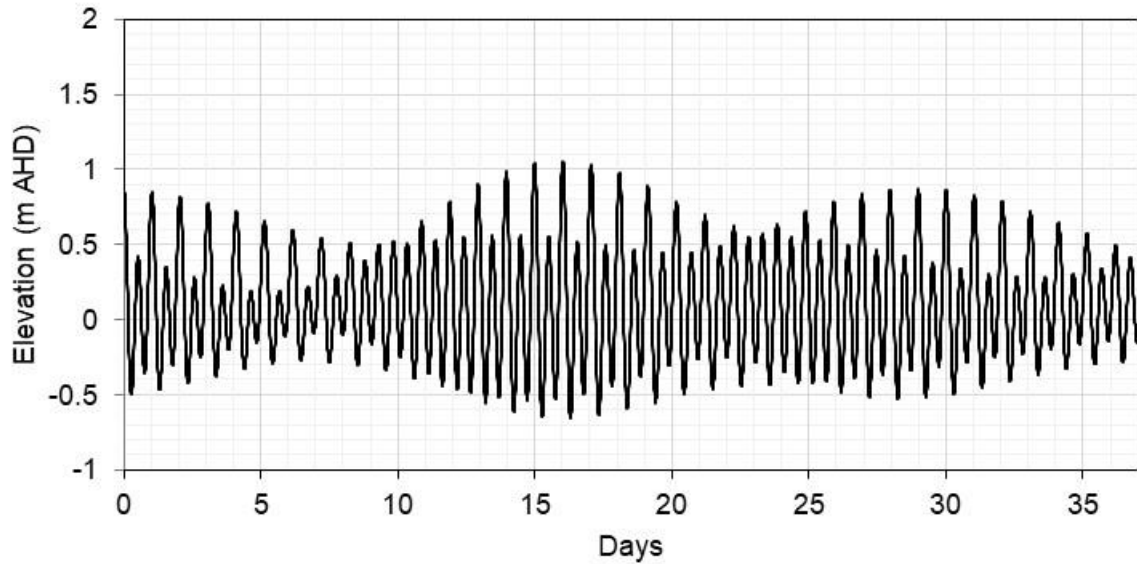
Figure A-5 Water level tidal boundary for modelling of present day (2023) conditions

A 37 day model simulation period was chosen to assess the local scale hydraulics. This period was selected to allow 1 week for the model spin up followed by a month of simulation which included larger spring tide conditions (Figure A-5). The model was run on a 15 minute timestep.
