East Kinchela (Swan Pool) Remediation Feasibility Study

WRL TR 2021/21, November 2021

By T A Tucker and D S Rayner

UNSW
Water Research
Laboratory

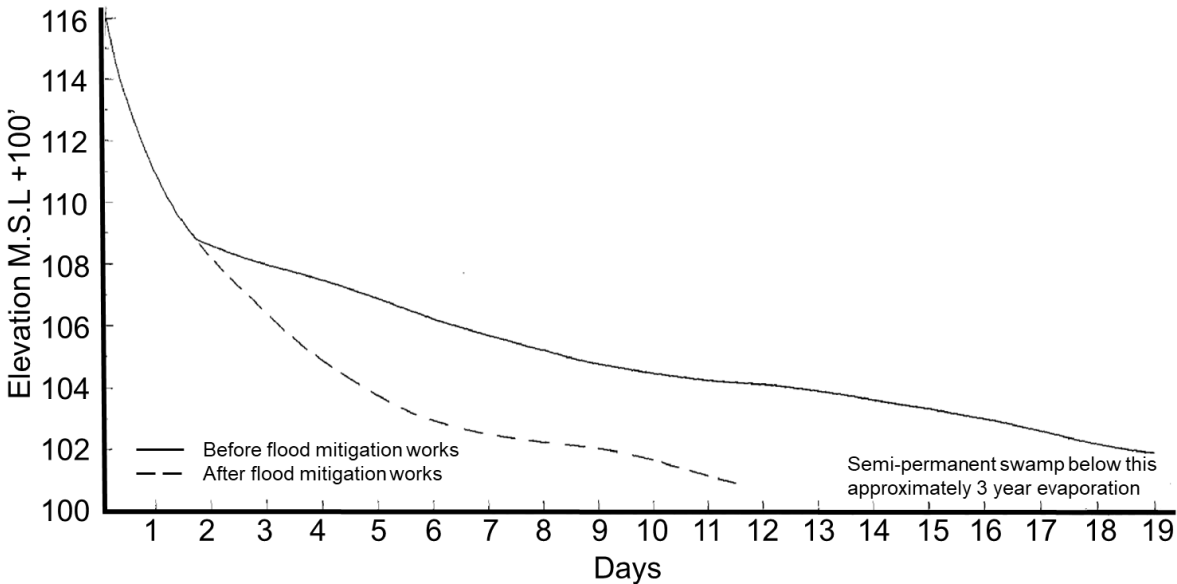
Figure 2.2: Drainage time for Kinchela Creek floodplain before (solid) and after (dashed) flood mitigation works (McDonald, 1967)

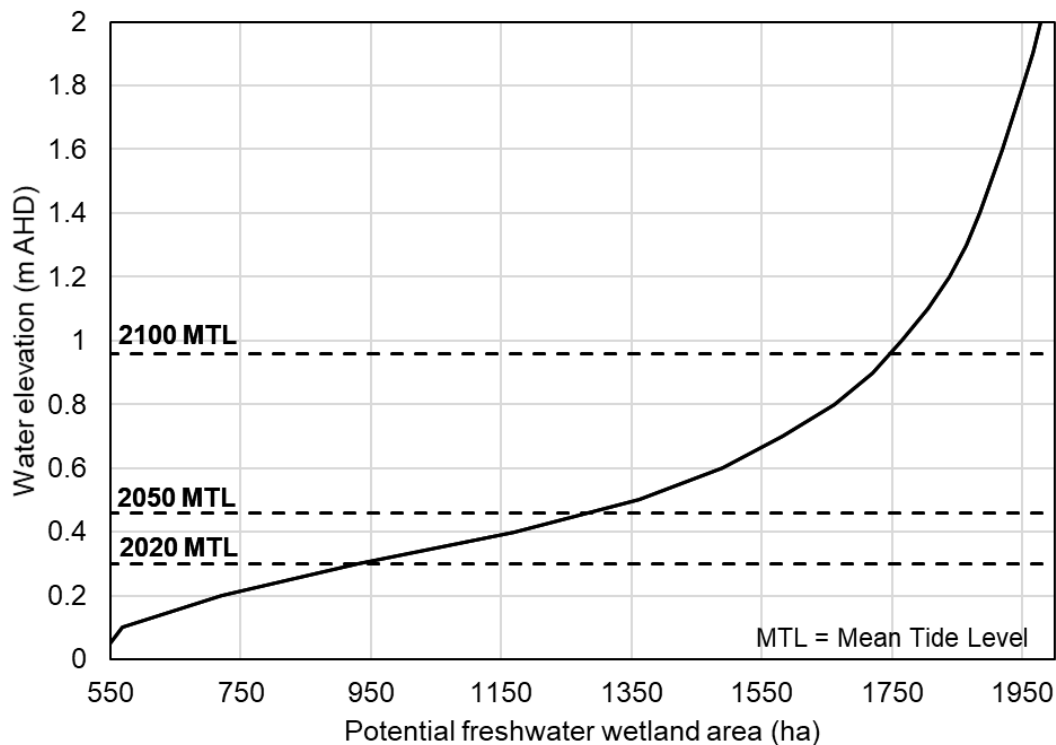
Figure 3.5: Potential freshwater wetland area across Swan Pool under sea level rise

Figure 3.5 and Figure 3.6 show the area and extent of freshwater wetland which could be created as floodplain drainage reduces. Note, the approximate mean tide level is used as an indicator for freshwater wetland extent. While floodgates act to drain the upstream water level to low tide during day-to-day drainage conditions, vegetation will hold the water level up across the floodplain (Tulau (2013) found water levels on the floodplain were up to 0.3 m higher than in major drainage channels due to vegetation effects). Note, predictions for the far future (2100) sea level rise scenario indicate that reduced drainage will result in increased connectivity of Swan Pool with the adjacent floodplains to the north and south.

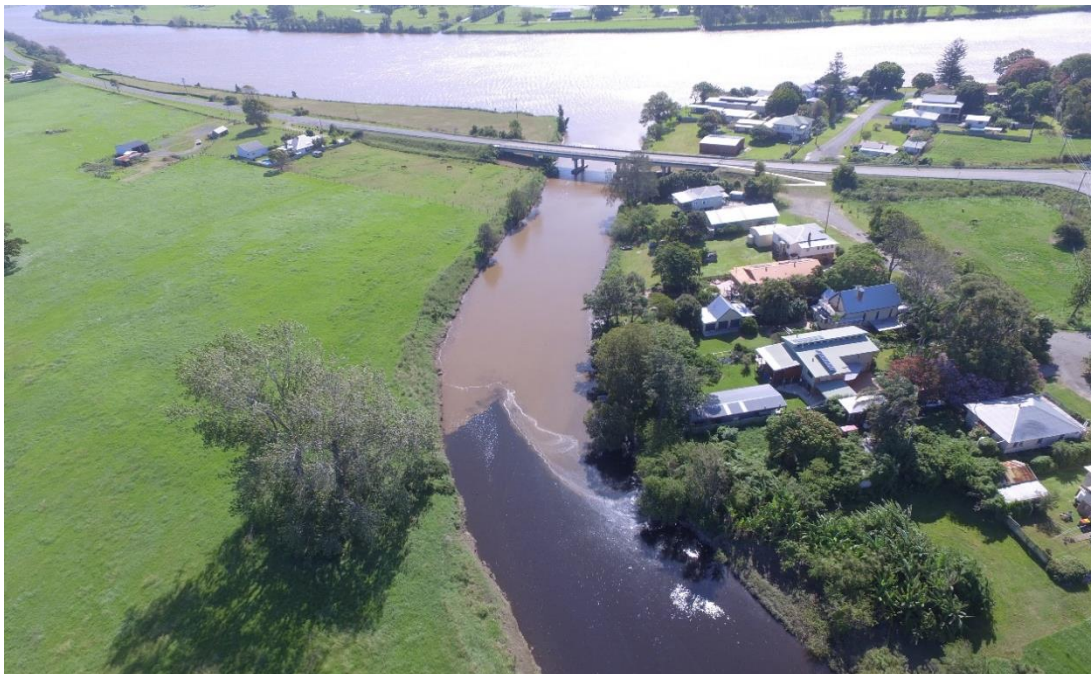
**A.3: Low oxygen blackwater discharging from Swan Pool via Kinchela Creek and about to enter the Macleay River at Kinchela (February 2020)
(Source: Max Osborne, NSW Department of Primary Industries)**

Low dissolved oxygen blackwater is caused through the prolonged inundation of water intolerant vegetation generally following flood events. When this occurs, vegetation dies off and consumes the oxygen within water as it breaks down. Once flood levels receded this low-oxygen water is then able to discharge into the estuary via efficient drainage channels causing significant environmental impacts (Figure A.3).

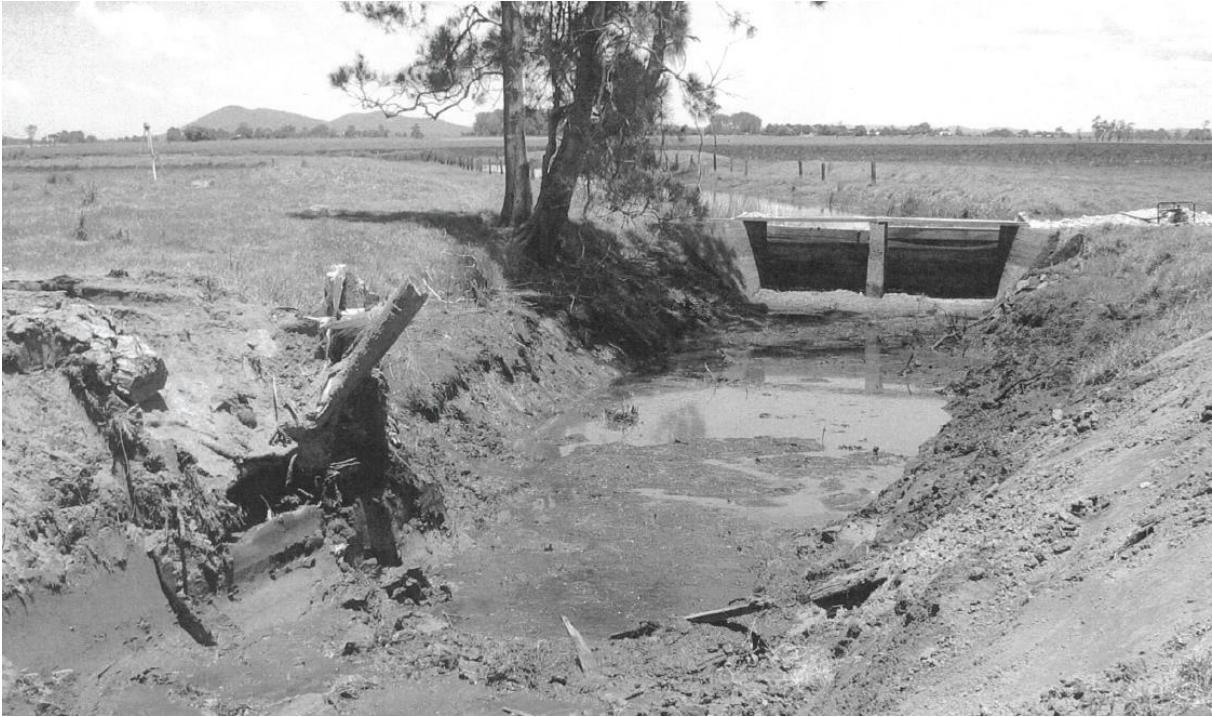
A.4: Drop boards on Kinchela No. 2 drain (Source: Ron Kemsely, Kempsey Shire Council)

The first definitive records of works being completed at Swan Pool are reported by Henderson and Tulau (2000) who noted the construction of a drop board structure in Kinchela No. 2 drain for the purpose of containing acid sulfate soils through freshwater ponding (Figure A.4). In subsequent years a number of organisations focused on efforts to precure funding for new designs and modification of floodgates at both The Lock and Korogoro Creek (NSW Fisheries, 2002; Walsh et al., 2002; Kemsley, 2003). This resulted in modifications to The Lock in 2002 where plastic floodgates and lifting devices were installed (KSC, 2007). These modifications allowed tidal water from Kinchela Creek to flow upstream to Swan Pool creating 1.4 km of fish passage (Walsh and Copeland, 2004).

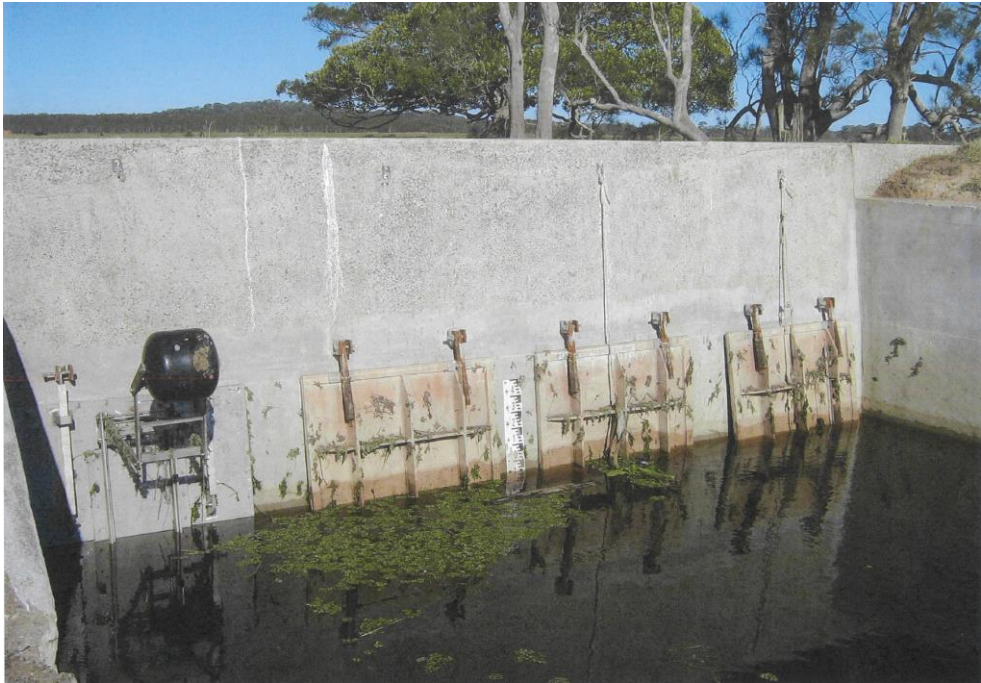
**A.6: Buoyancy controlled auto-tide gate on The Lock
(Source: Ron Kemsely, Kempsey Shire Council)**

the upstream side of the floodgates (KSC, 2007) (Figure A.6). Survey of the weir by Tulau (2013) found that the weir crest was actually at an elevation between 0.05 and 0.06 m AHD. Other works completed in the area include modifications on Kinchela No. 2 Drain where a new culvert and floodgate was installed to prevent inundation of agricultural land when tidal flushing is allowed past The Lock (Figure A.8), and construction of a low level earthen weir at 0.0 m AHD approximately 1 km upstream of The Lock on North Drain to retain high water levels within Swan Pool (Figure A.9) (KSC, 2006; KSC, 2007; pers comms. Ron Kemsely).

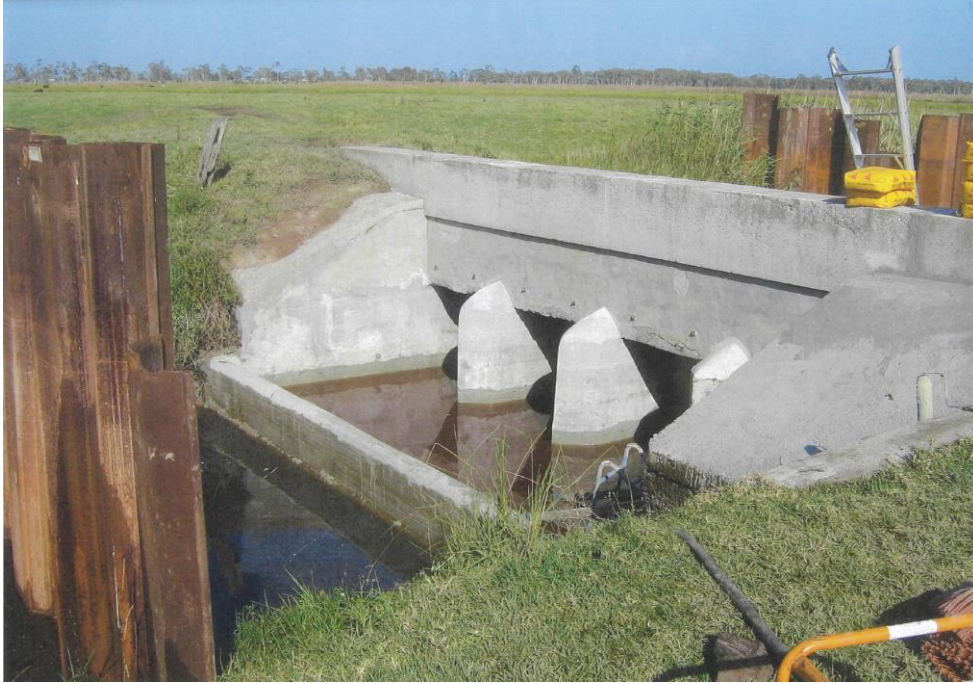
**A.7: Wier constructed on the upstream side of The Lock
(Source: Ron Kemsely, Kempsey Shire Council)**

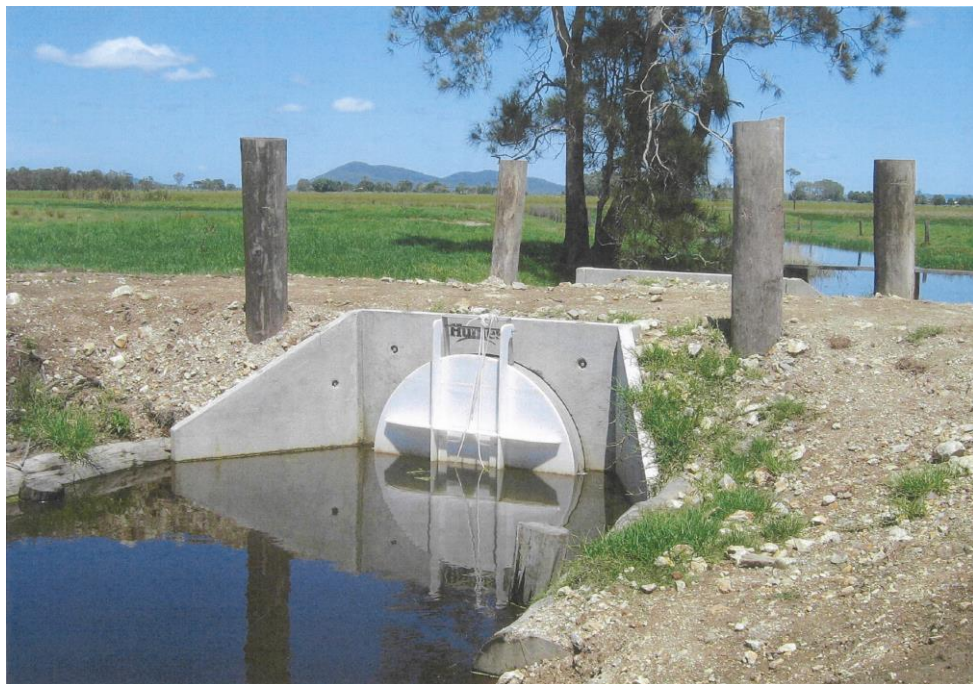
A.8: Floodgate on Kinchela No. 2 Drain (Source: Ron Kemsely, Kempsey Shire Council)

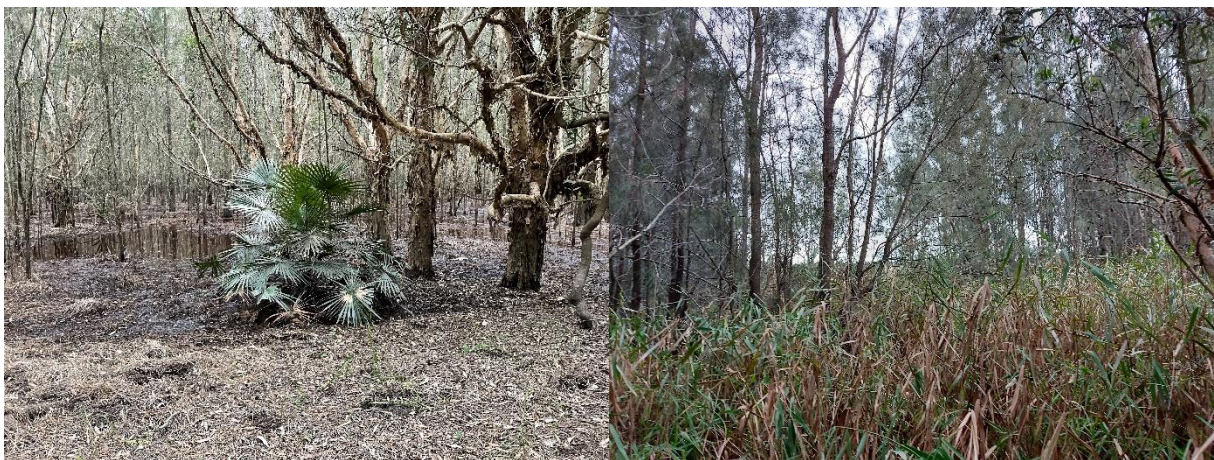
A.10: Growth of vegetation where Korogoro Cut meets Swan Pool observed on 10 June 2021

In 2015, Kempsey Shire Council proposed to remove aquatic vegetation blocking Korogoro Cut. A review of the plans completed by Tulau (2015) found that the best way to manage the area would be to implement the recommendations of Smith (2002). Site inspections conducted on 10 June 2021 found that there is significant vegetation growth at the location where Korogoro Cut meets the Swan Pool floodplain (Figure A.10).

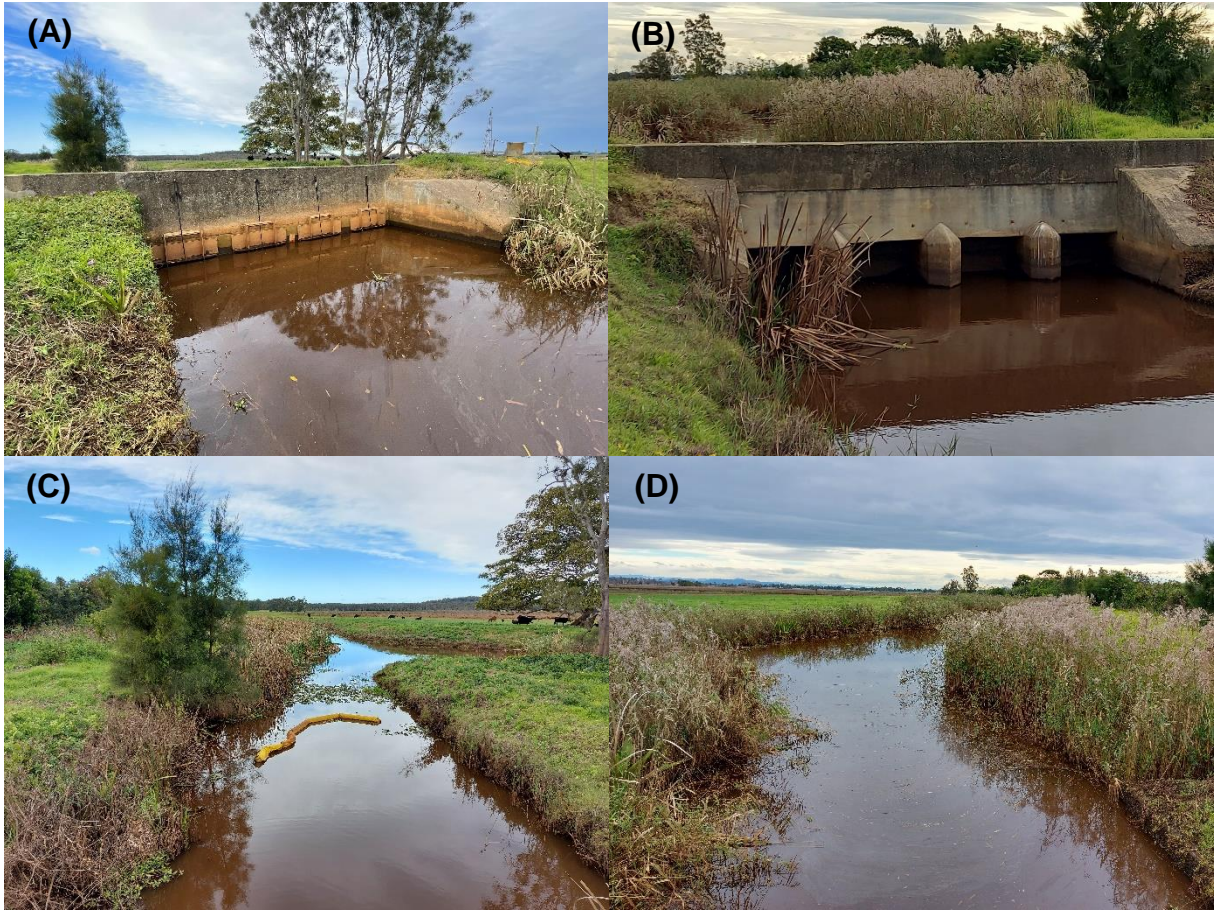
A.11: The Lock as inspected on 10 June 2021. Images are of The Lock from the downstream side (A) and upstream side (B) as well as on top of The Lock looking upstream (C) and looking downstream (D)

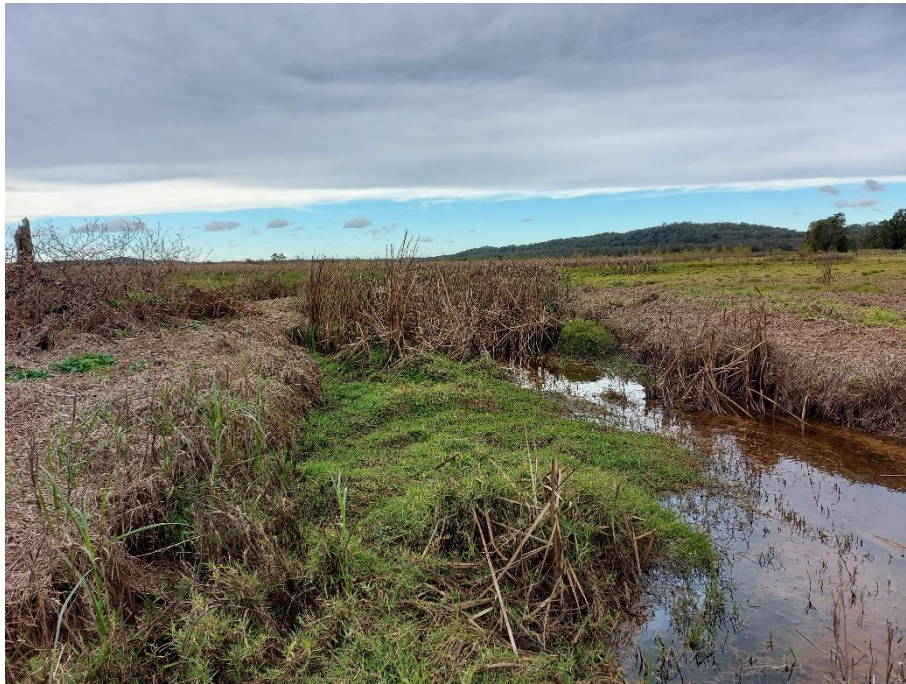
A.12: The remnants of North Drain weir as inspected on 10 June 2021

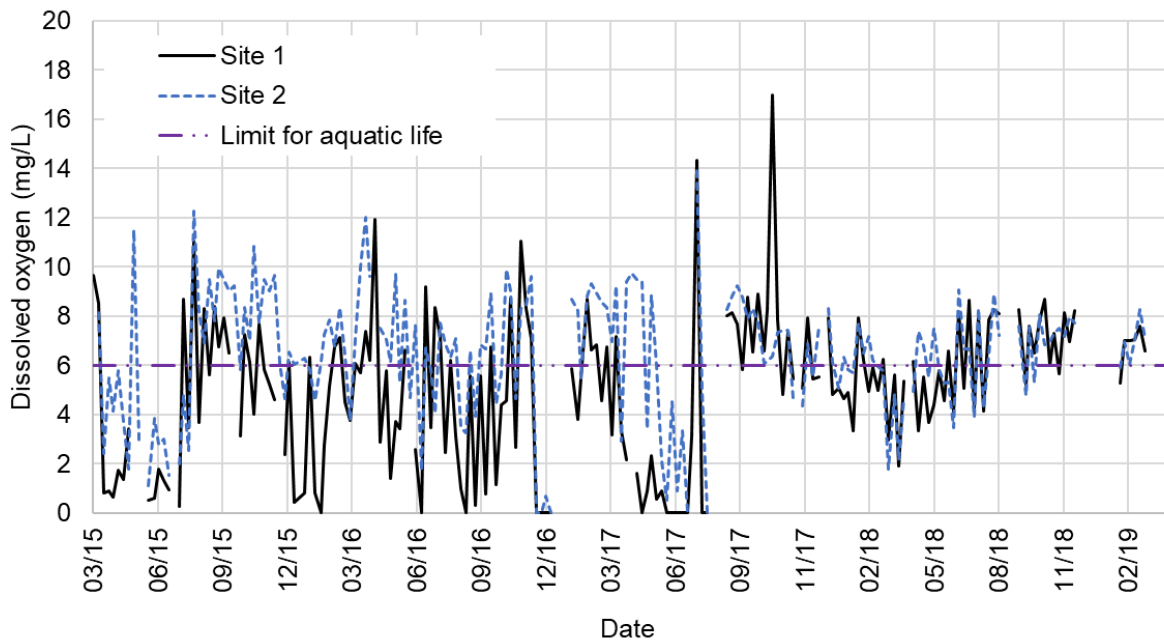
B.3: Dissolved oxygen data for Korogoro Creek (Source: Kempsey Shire Council)

Levels of pH (Figure B.2) did not indicate any influence of acid sulfate soils, however, levels of dissolved oxygen (Figure B.3) were regularly below acceptable levels for aquatic life (6mg/L) as defined by ANZECC & ARMCANZ (2000). Salinity levels showed both sites have good connectivity with the ocean (Figure B.4).

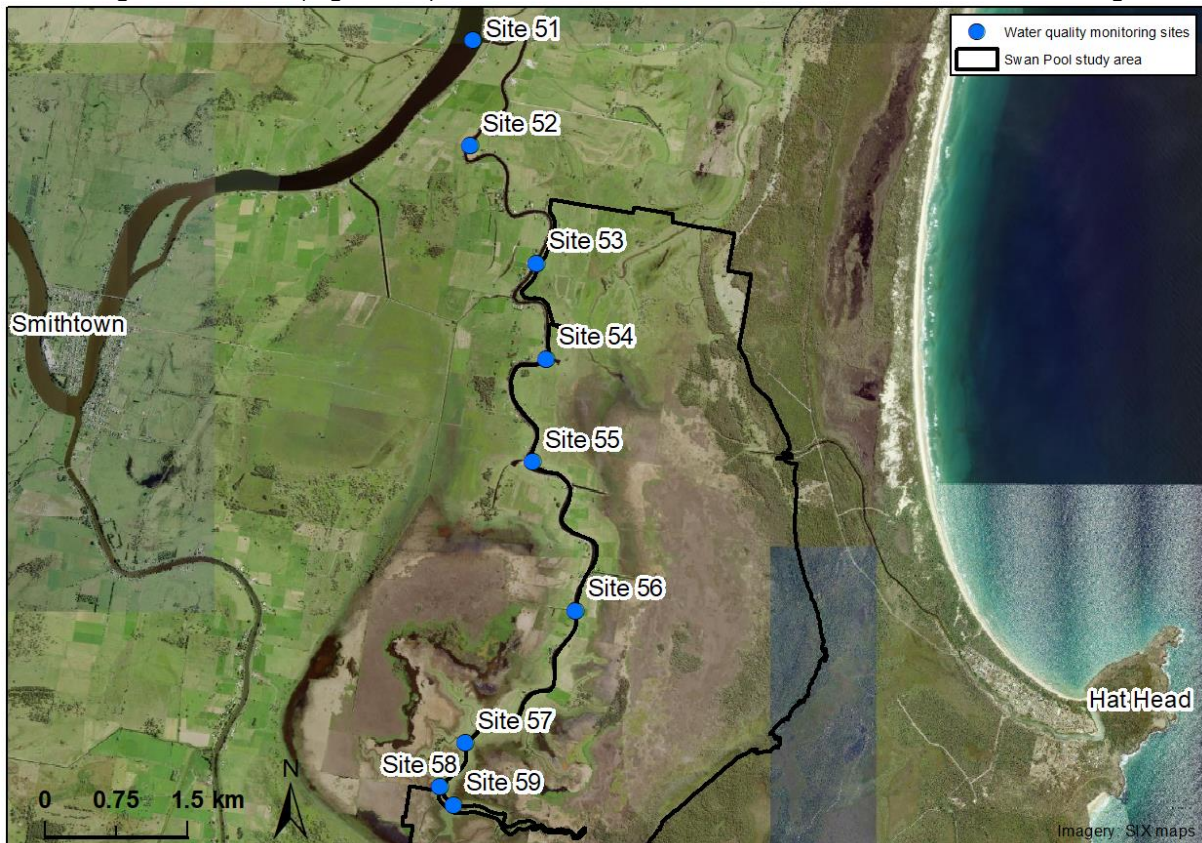
B.5: Location of Allsop and Kadluczka (2004) water quality monitoring sites on Kinchela Creek

Allsop and Kadluczka (2004) monitored water quality at nine locations within Kinchela Creek on 15 April 2003 at high and low tide (Figure B.5). Measurements are shown in Table B.1, Table B.2 and Figure B.6

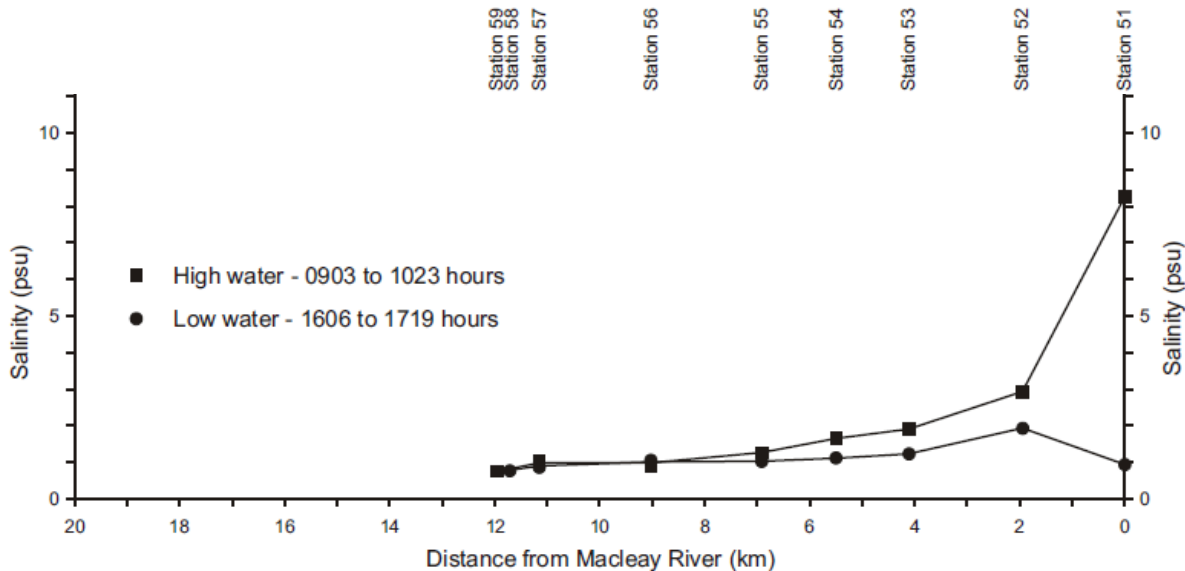
B.6: Salinity measurements within Kinchela Creek on 14 April 2003 (Allsop and Kadluczka, 2004)

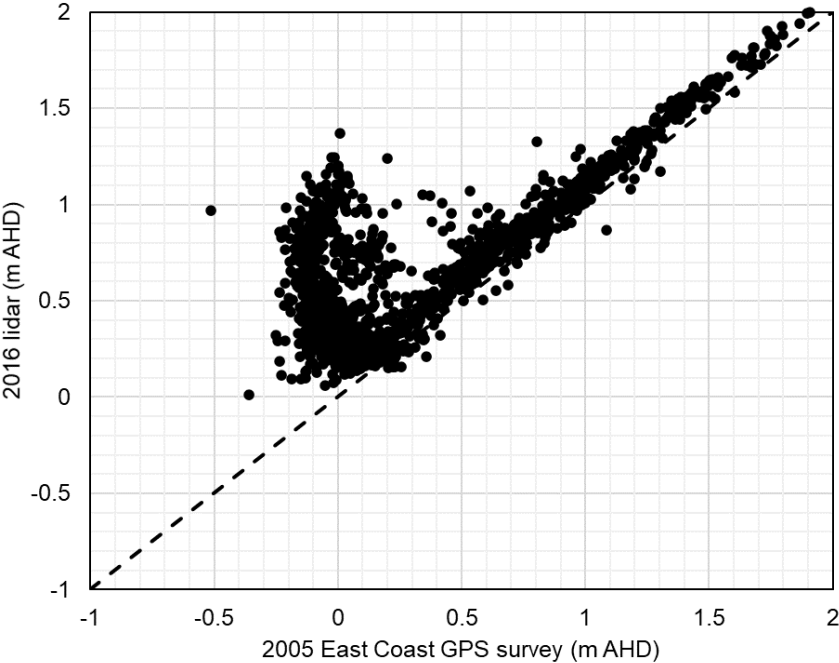
B.9: Comparison of the 2016 LiDAR data with survey data collected on 31 August 2005 by East Coast GPS Surveys (see locations in Figure B.10)

Comparison of the East Coast GPS Surveys from 2005 with the most up to date LiDAR data (including 2016 measurements for the west of the floodplain) found similar inaccuracies (Figure B.9). On average the LiDAR measurements were observed to be +0.33 m above the 2005 survey measurements with discrepancies up to 1.49 m at some locations across the floodplain (Figure B.10). It is likely these larger discrepancies are due to the LiDAR capturing the top of dense vegetation instead of the ground surface of the floodplain.

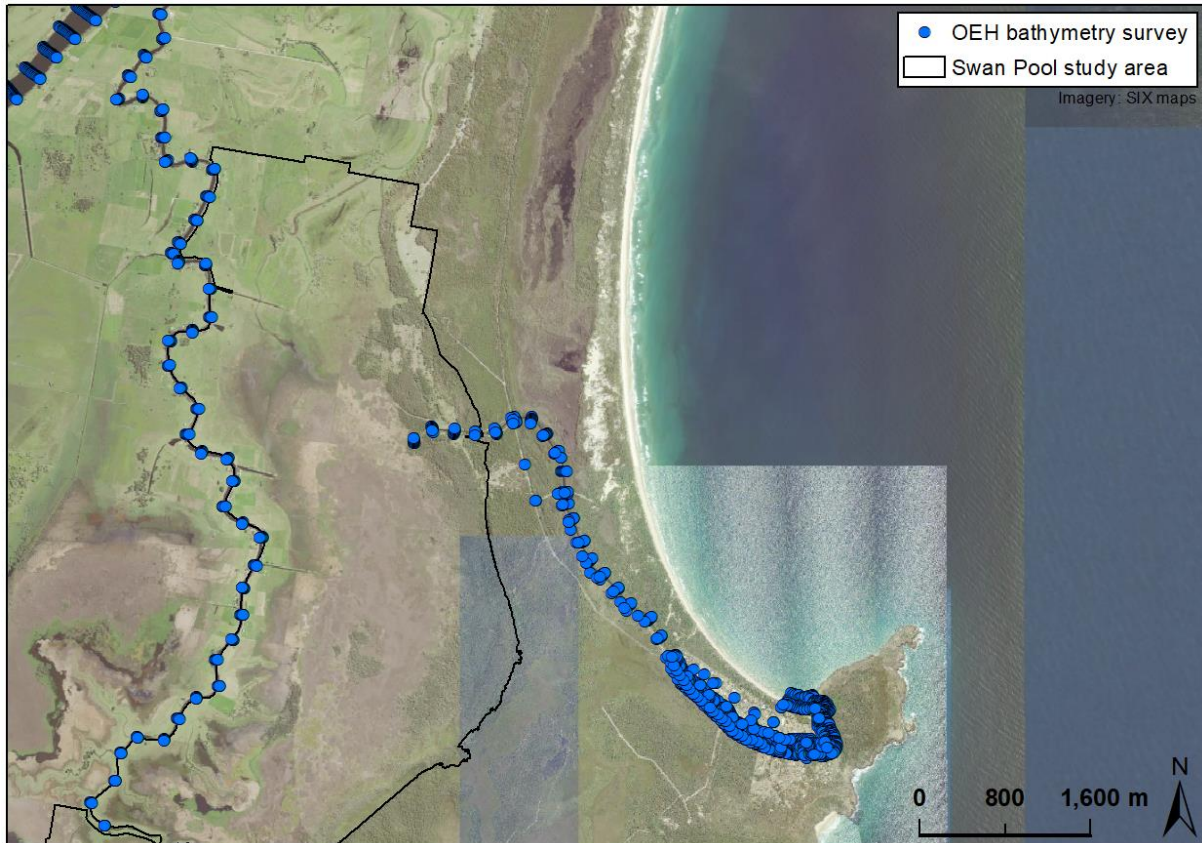
B.16: Bathymetry data collected by OEH

Bathymetry data collected by Environment, Energy and Science (EES, formerly the Office of Environment and Heritage) within the NSW Department of Planning, Industry and Environment is available for Kinchela Creek and Korogoro Creek (OEH, 2021) (Figure B.16). Data for Kinchela Creek was collected in 2003 and stretches from immediately downstream of The Lock to the creek's confluence with the Macleay River. Data for Korogoro Creek was collected in 2005 and includes the channel excavated during flood mitigation works and extends all the way to the ocean.

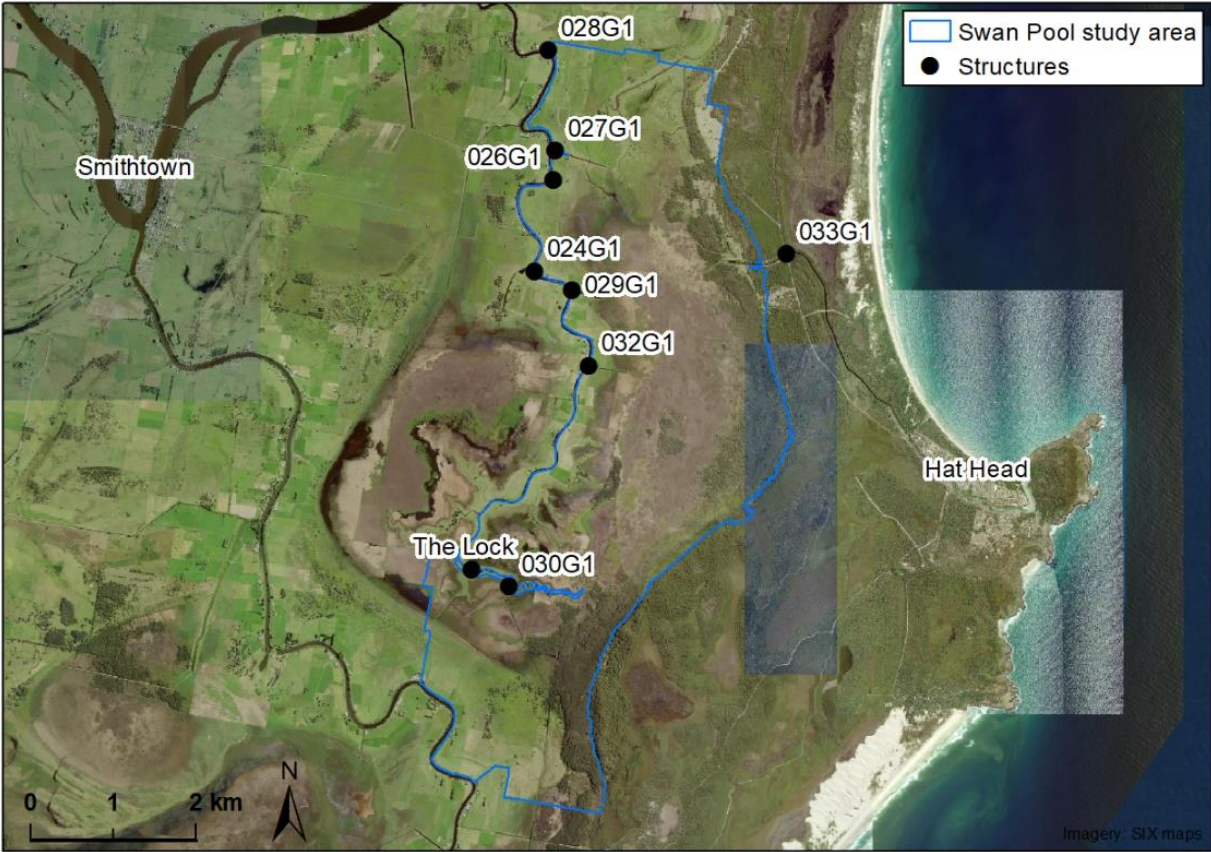
B.17 : Location of structures at Swan Pool

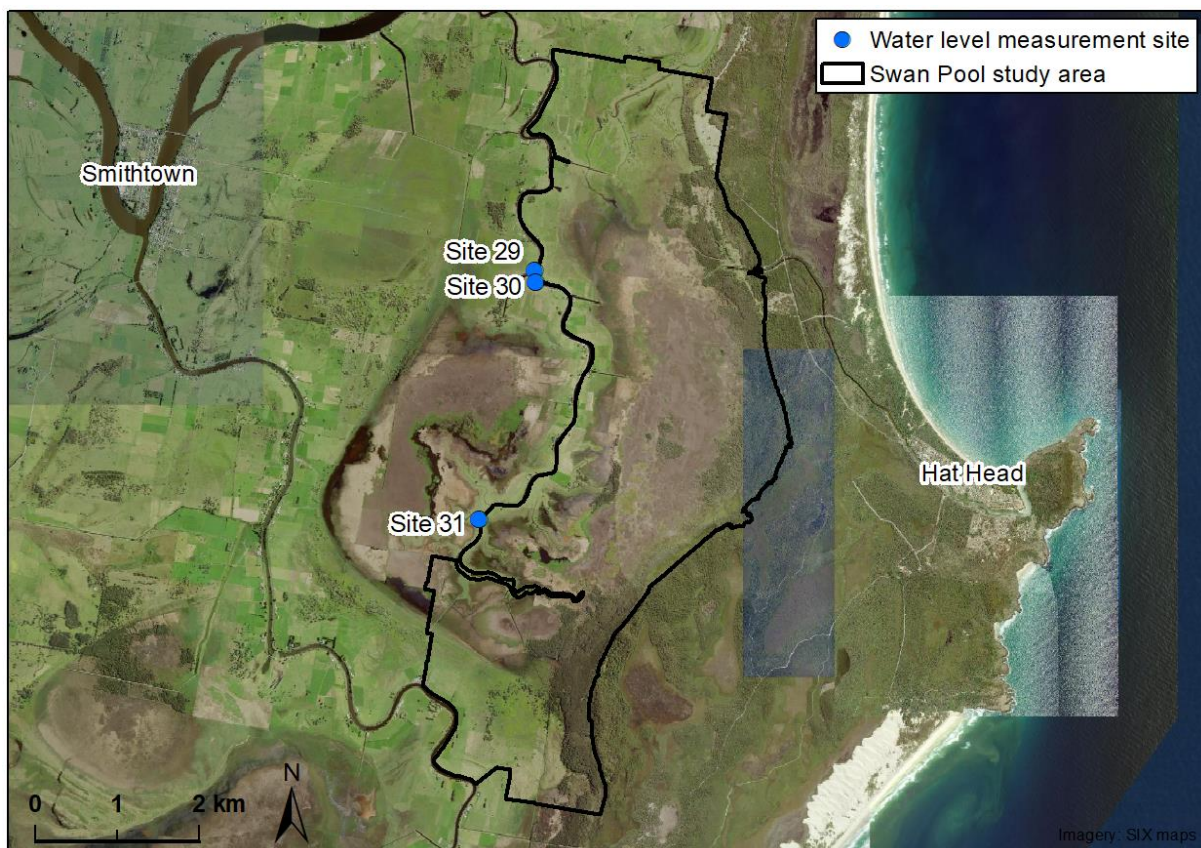
B.21: Location of Allsop and Kadluczka (2004) water level monitoring sites

Water levels within Kinchela Creek were measured by Allsop and Kadluczka (2004) at three locations between April and May 2003 (Figure B.21). Using this data Allsop and Kadluczka (2004) determined the tidal planes at each monitoring location (Table B.7, Table B.8 and Figure B.22). Comparisons were also completed to determine any differences in the tide phase between monitoring sites (Figure B.23). Note, Site 0 is the ocean tide levels as measured at Coffs Harbour and Site 3 is the tide level of the Macleay River measured at the Macleay Arm entrance.

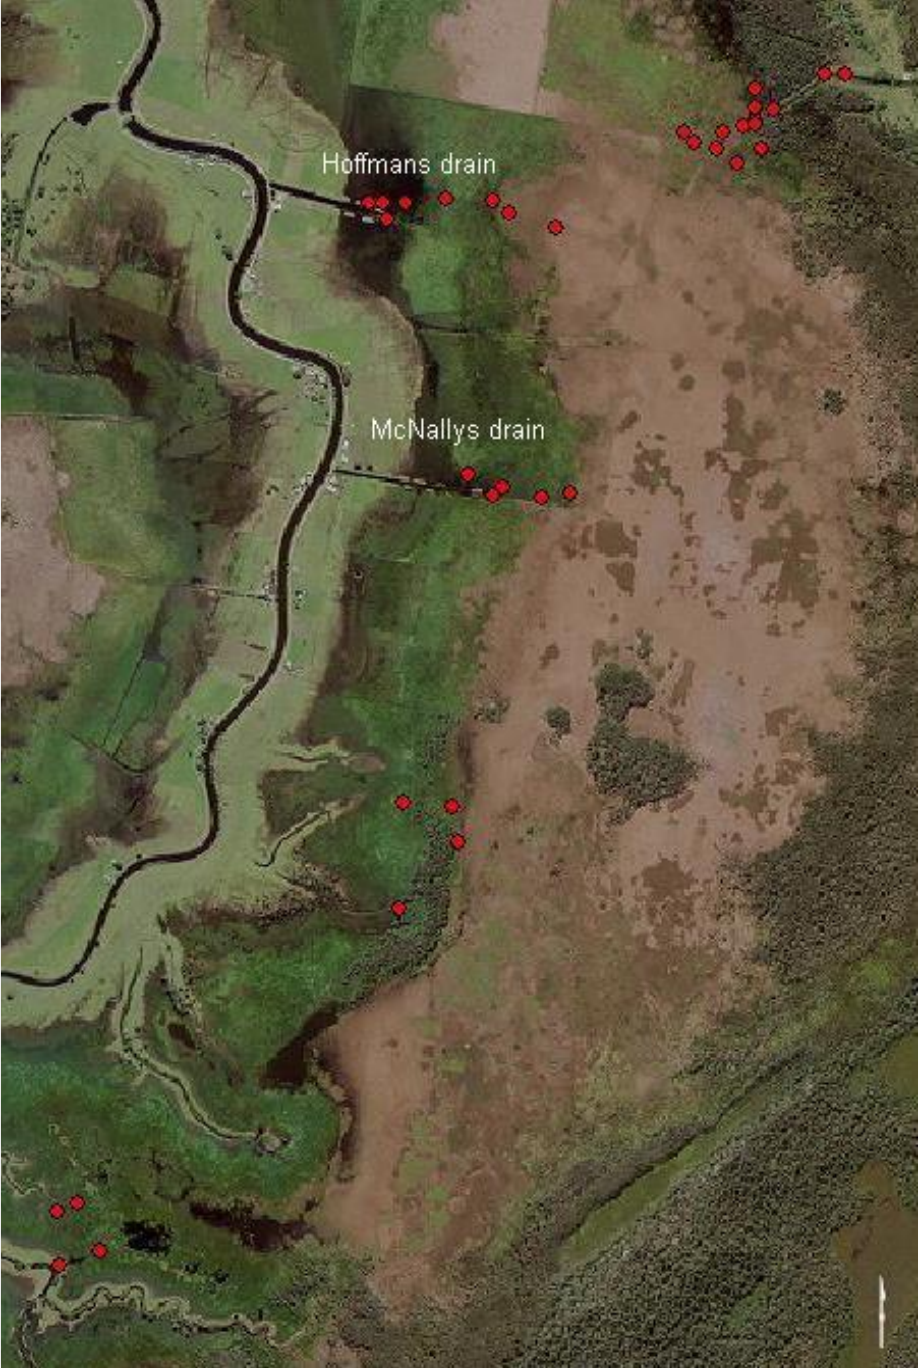
B.24: Water level observation sites in June 2013 (Tulau, 2013)

Tulau (2013) captured 38 water level measurements across the Swan Pool floodplain in June 2013 (Figure B.24). They used this data to develop a profile of water level elevations across the floodplain in the north-south and east-west directions (Figure B.25 and Figure B.26, respectively). Note, the weir on the upstream side of The Lock was still in place when these measurements were taken. A single water level measurement observed on North Drain during the site inspection conducted on 10 June 2021 observed the water level at -0.09 m AHD, compared to 0.24 m AHD during the Tulau (2013) survey.

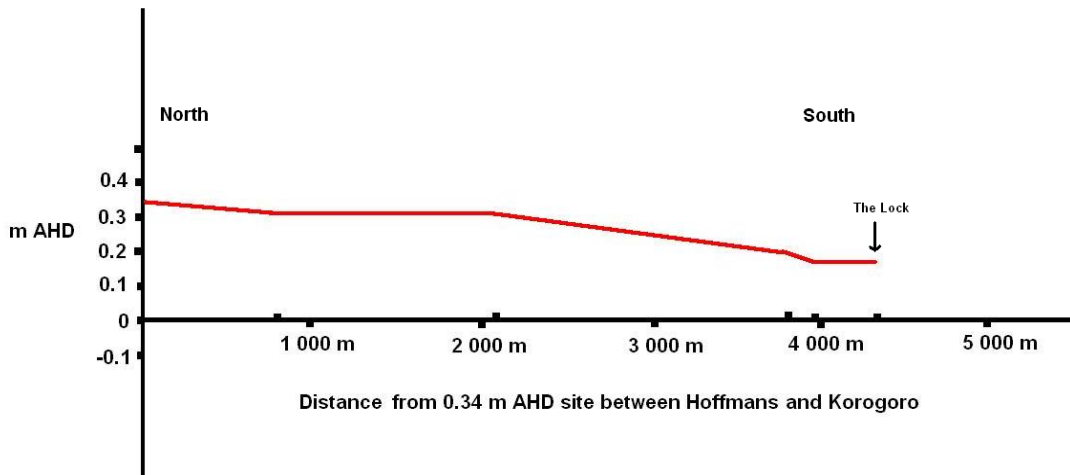
B.25: North-South water level elevation profile for Swan Pool (Tulau, 2013)
