## Wave Forces and Overtopping on Stepped Seawalls

**B Modra**<sup>1</sup>, I Coghlan<sup>1</sup>, J Carley<sup>1</sup>, G Blumberg<sup>2</sup>, W Boyd<sup>3</sup>

<sup>1</sup>Water Research Laboratory (WRL), School of Civil and Environmental Engineering, UNSW Australia, Manly Vale, NSW

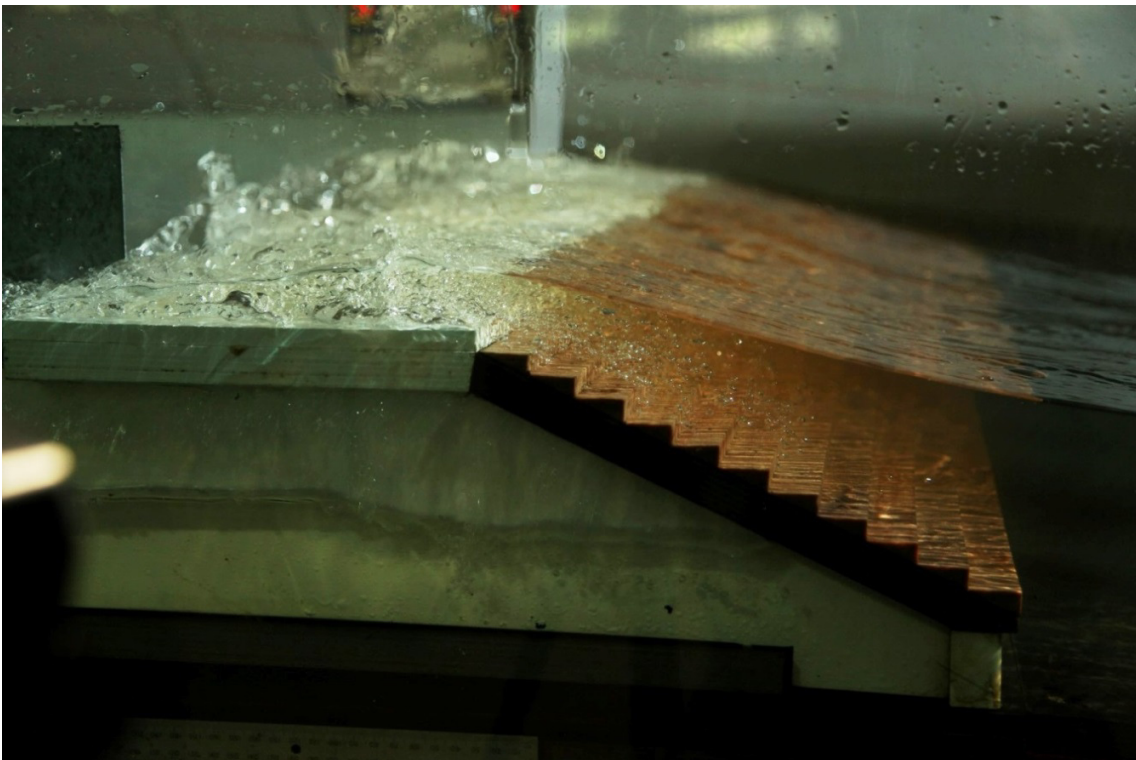
**Figure 3: Stepped concrete seawall - Configuration C (5.45 m AHD Crest, no wave return wall) during 500 year ARI event, present day**

The stepped seawall was constructed from marine grade plywood as a single unit spanning the flume (54 m prototype width), from -2 m AHD at the secant pile toe, to approximately 11.9 m landward of the top step. A 1 m high return wall was added for the adaptive modification to the structure. A 0.45 m step was added to the top of the structure to test the 5.45 m crest alternate design. The stepped seawall model was constrained with an array of hinged rods such that horizontal forces could be measured by two force transducers attached to each end of the structure section. Figure 2 and 3 show the model under test conditions.
