CONCEPT DESIGNS FOR A GROUYNE FIELD ON THE FAR NORTH NSW COAST

I Coghlan¹, J Carley¹, R Cox¹, E Davey¹, M Blacka¹, J Lofthouse²

¹ Water Research Laboratory (WRL), School of Civil and Environmental Engineering,
The University of New South Wales, Manly Vale, NSW

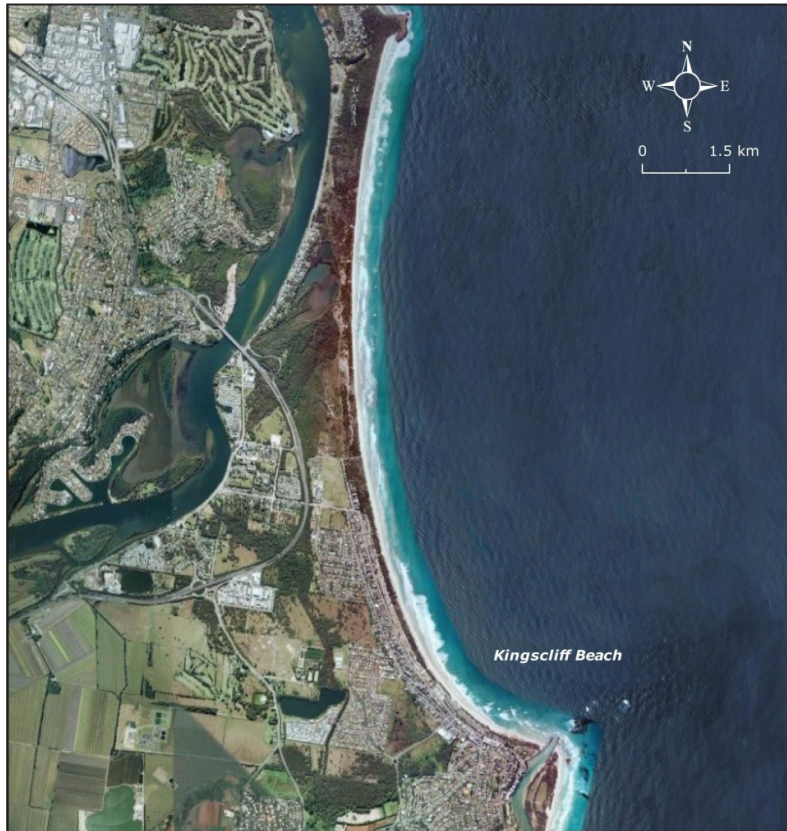
Figure 1: Location (Aerial Photo 23/06/2008)

Kingscliff Beach, located at the southern end of Wommin Bay on the far north coast of NSW (Figure 1), is a section of the Tweed coastline with built assets at immediate risk from coastal hazards. Ongoing erosion in the last few years has resulted in substantial loss of beach amenity and community land. Storm erosion episodes between 2009 and 2012 severely impacted the Kingscliff Beach Holiday Park (KBHP). This section is also affected by moderate ongoing underlying shoreline recession (WBM, 2001).

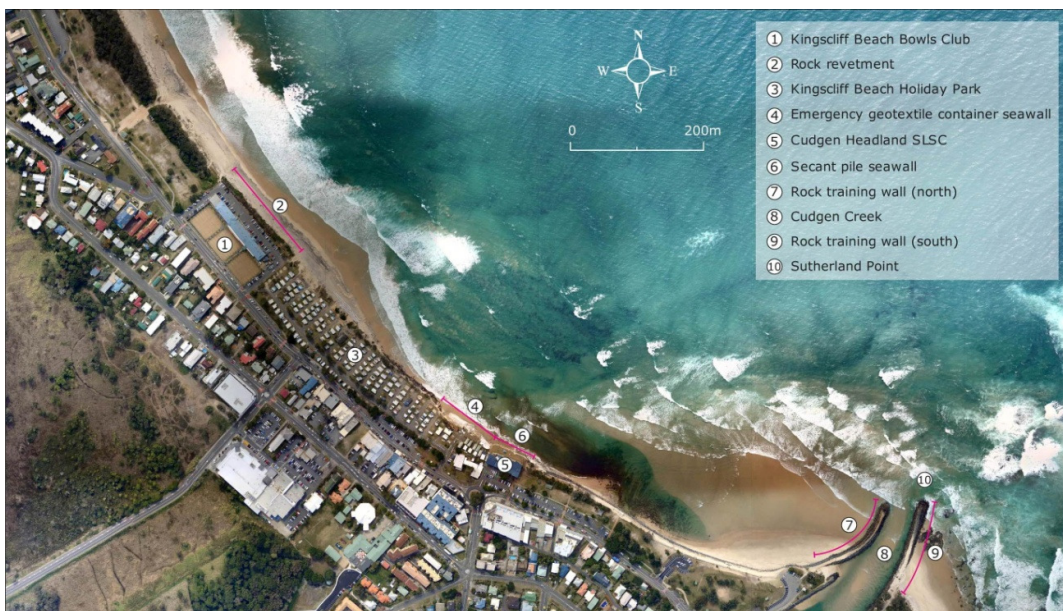
Figure 2: Site Details (Aerial Photo 21/07/2011)

To manage the Kingscliff Beach foreshore (Figure 2) in the longer term, Tweed Shire Council (TSC) is considering a combination of several of the following options:

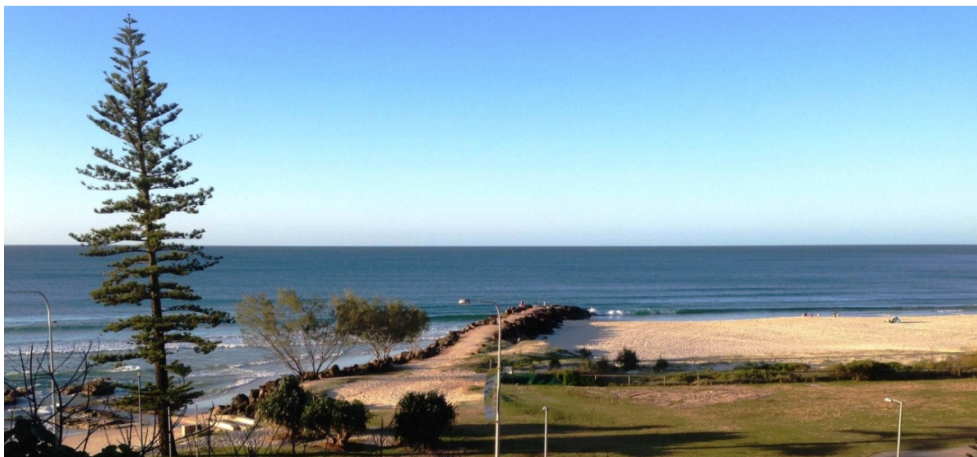
Figure 5: Kirra Point Groyne, Qld (Photo 07/07/2013, Prior to 2013 Restoration)

Kirra Point Groyne was originally constructed in 1972 extending seaward to -5 m AHD (Robinson and Patterson, 1975) with an approximate length of 180 m, but was then shortened by 30 m in 1996 (WorleyParsons, 2009). The groyne currently extends to approximately -3 m AHD (WorleyParsons, 2009) and is generally considered to be fulfilling its function of protecting Coolangatta/Greenmount Beach. At the time of writing, approvals were being sought to lengthen the groyne by 30 m to improve downdrift recreational surfing amenity, which would effectively return the structure to its original length. Miles Street Groyne, located approximately 500 m west of the Kirra Point Groyne, originally had a length of 120 m which was also shortened by 30 m in 1996 (WorleyParsons, 2009). Design parameters for the original Kirra Point Groyne (1972) are reproduced in Table 2.

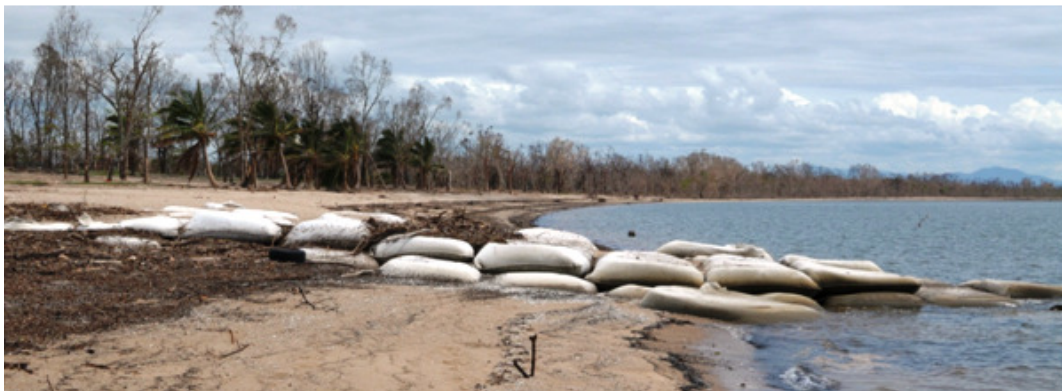
Figure 6: Cardwell Groyne (Qld) following TC Yasi

A short groyne (extending to -0.5 m AHD) composed of 2.5 m³ sand-filled geotextile containers exists at Cardwell in northern Queensland (Figure 6). As discussed in Carley et al (2011), Tropical Cyclone (TC) Yasi passed within 45 km of this structure in February 2011. While the structure was largely still in place following TC Yasi with minor displacement of some geocontainers, it does not have full exposure to the open ocean. The Cardwell Groyne has a crest level of 1 m AHD at the seaward end and 2.9 m AHD at the landward end. The toe level of the head of the groyne is -1 m AHD with a typical bed level at the head of approximately -0.5 m AHD.

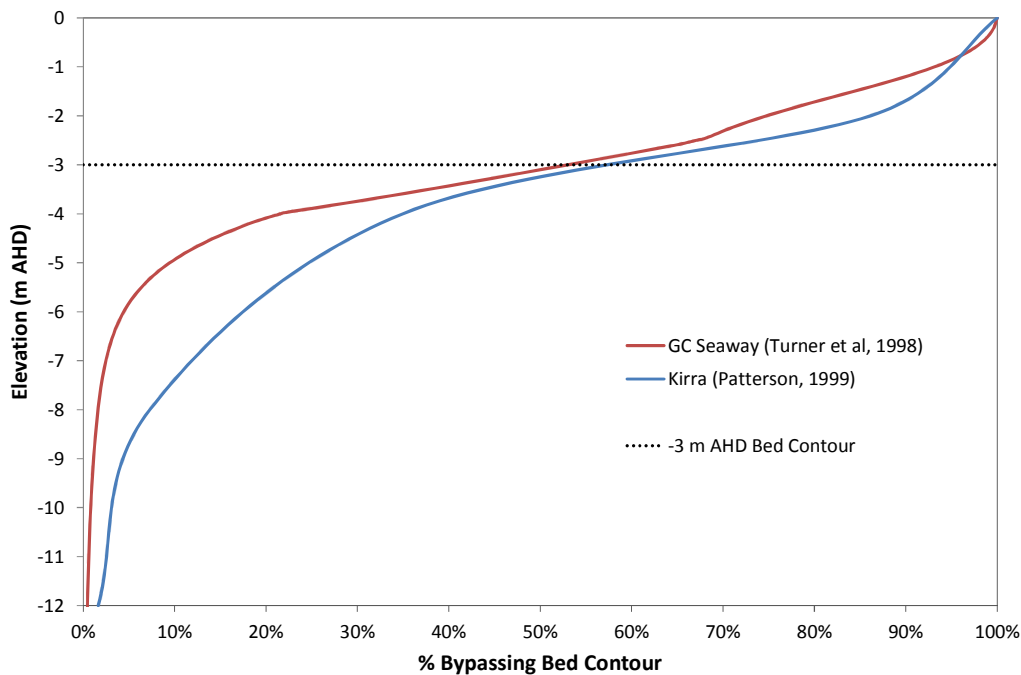
Figure 7: Comparison of the Cross-Shore Distribution of Longshore Transport from Two Studies

The cross-shore distribution of littoral drift transport at Kingscliff Beach was approximated from two other studies in the region. WRL previously modelled the cross-shore distribution of littoral drift transport at the southern Gold Coast Seaway (Turner et al, 1998). Patterson (1999) modelled the cross-shore distribution of littoral drift transport on selected Tweed and southern Gold Coast beaches. Figure 7 compares the cross-shore distribution of littoral drift transport at the southern Gold Coast Seaway found by Turner et al (1998) with the distribution derived by Patterson (1999) at one representative location, Kirra.

While some differences exist between the two distributions, good agreement was found for bed contours between -2 and -4 m AHD. In reality, the bypass curves shown in Figure 7 would be further modified by rip action against the groynes.

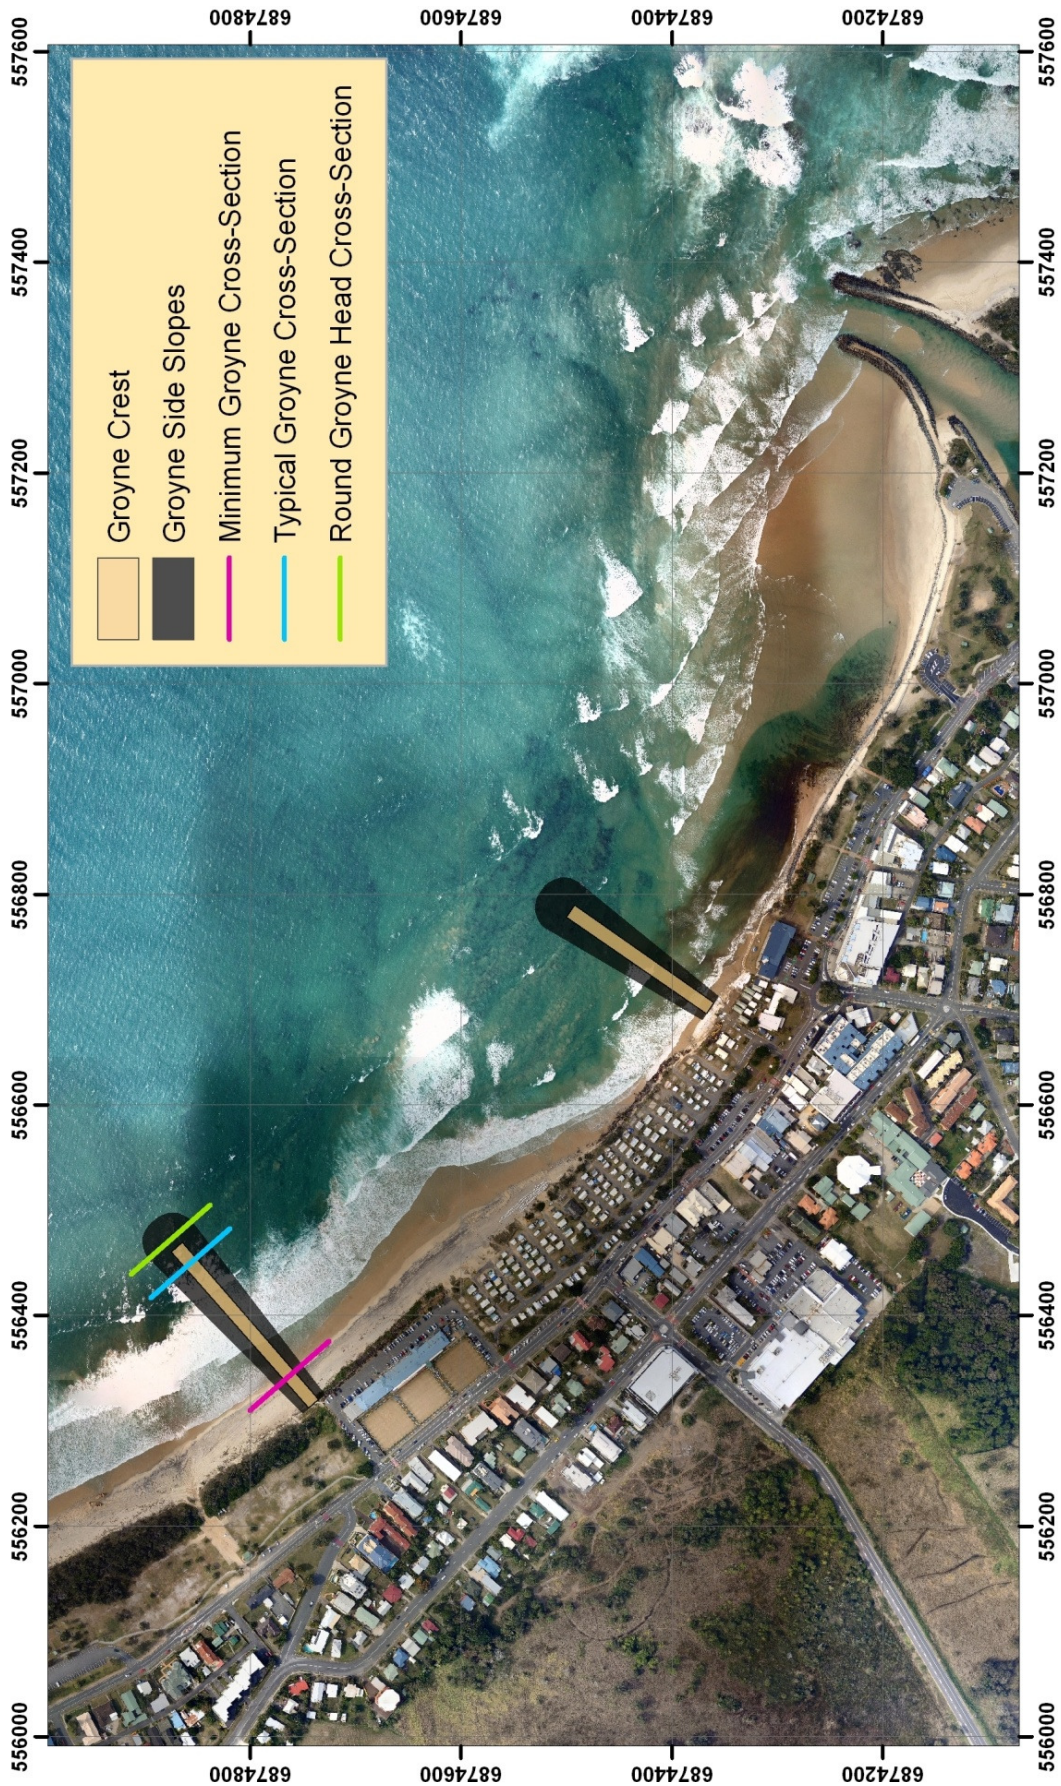
Figure 9: Long Term Groyne Field Layout 1 – Large Scale Beach Nourishment

Groyne locations were determined through consideration of the location of existing structures. For both groyne field layouts, one groyne would be located at the northern end of the KBBC rock revetment. As such, down drift erosion/recession effects would impact the unprotected section of Kingscliff Beach to the north of Kingscliff Beach Bowls Club. A second groyne would be located approximately co-linear with the entrance road to Kingscliff Beach Holiday Park at the southern end of the park.

The target criterion of the groyne spacing not being more than four times the effective length has been complied with for both groyne field layouts (Table 4). Note that the two groynes for Layout 1 (with large scale beach nourishment) are longer than those for layout 2 (with a terminal seawall). This is because the nourished -3 m AHD contour is located approximately 50 m further seaward than the un-nourished -3 m AHD contour. Groyne Field Layout 1 is shown in Figure 9. Note that approximate positions of three typical groyne cross-sections (which are discussed in the following section) are also shown on Figure 9. Groyne Field Layout 2 has not been shown for brevity.

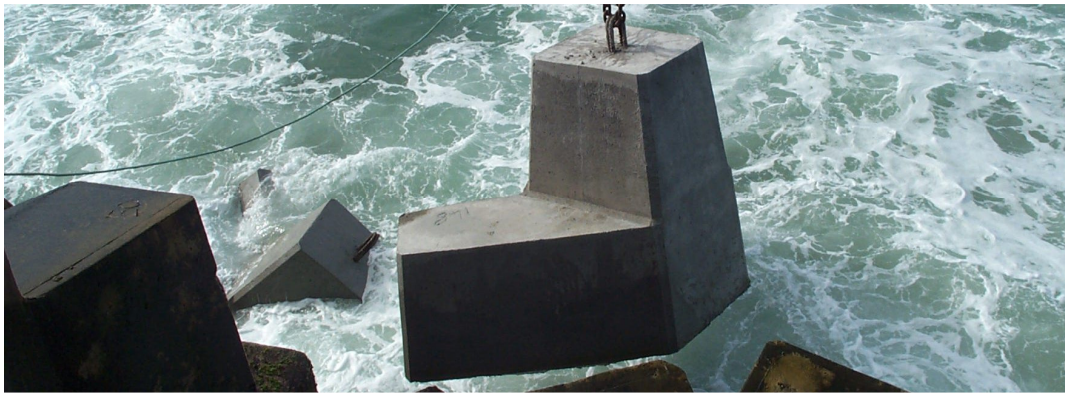
Figure 12: Placement of a Hanbar Armour Unit at Coffs Harbour, NSW

Enquiries with several quarries indicated that there was an abundance of greywacke rock but that the supply of basalt was more limited. However, it was not possible to acquire greywacke rock in sufficient quantities for construction with a median mass greater than 7.0 t. On the basis of hydraulic stability (Carley et al, 2011), sand-filled geotextile containers were found to be unsuitable for the groyne field if the design working life is 50 years. Since no evidence was found of long-lasting impermeable pile structures made from timber or concrete during the literature review, they were not considered further as construction materials. Hanbars are three-legged, pre-cast unreinforced concrete armour units (Figure 12) which provide a non-proprietary means of gaining stable armour on coastal structures where it is impractical to use quarry rock and are more economical than concrete cubes providing the same degree of protection. These armour units have been widely used in NSW.
